BARTON HOUSE

STRUCTURAL ROBUSTNESS ASSESSMENT - PHASE 2

February 2024

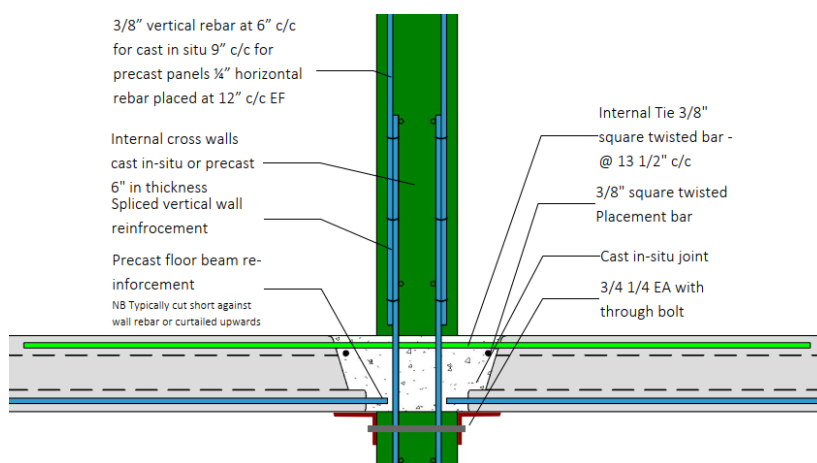
Figure 5: Observed Internal Wall to Floor Detail of Barton House

The internal walls supporting the floor slabs are joined together with a cast in-situ joint as shown in Figure 5. Each beam is being supported by either a 3 ¼ " (≈82mm) steel angle either side or, at party walls, by a masonry wall on one side and a steel angle on the other. Record drawings suggest that these angles are part of the original design intent predating the 1970's strengthening works. It is likely that the steel and masonry supports were acting as temporary supports to the precast floor beams. Architectural record drawings suggest that the internal masonry walls are 2 ½" (63.5mm) thick with 3/8" (9.53mm) plaster applied on them. However, this was not confirmed via measurement on site. Where measured, masonry walls appear to vary and, in some cases, walls measured up to 3" in thickness.

The precast floor beams are stopped short from the internal walls by 1" (25.4mm) with the steel reinforcement of the beams either curtailed upwards or cut short against the wall's vertical rebar. Typically, in between flats, the walls appear to be cast in situ whilst all the walls within the flat are precast. The former cannot be confirmed through the floor plate as the middle units were not accessed.

Steel ties located at this joint appear to be as described in the record information. These ties consist of straight 3/8" square twisted high yield bars. The ties extend, typically, 800mm either side of the walls and are located in all flats surveyed. They are spaced, typically, at 13 ½" (≈343mm) centres and are located on every other trough of the precast floor units. A horizontal bar, located at the top of the floor slab, is placed just underneath the internal ties within the cast in-situ joint. This bar is believed to serve as a placement bar and has no other structural benefit.

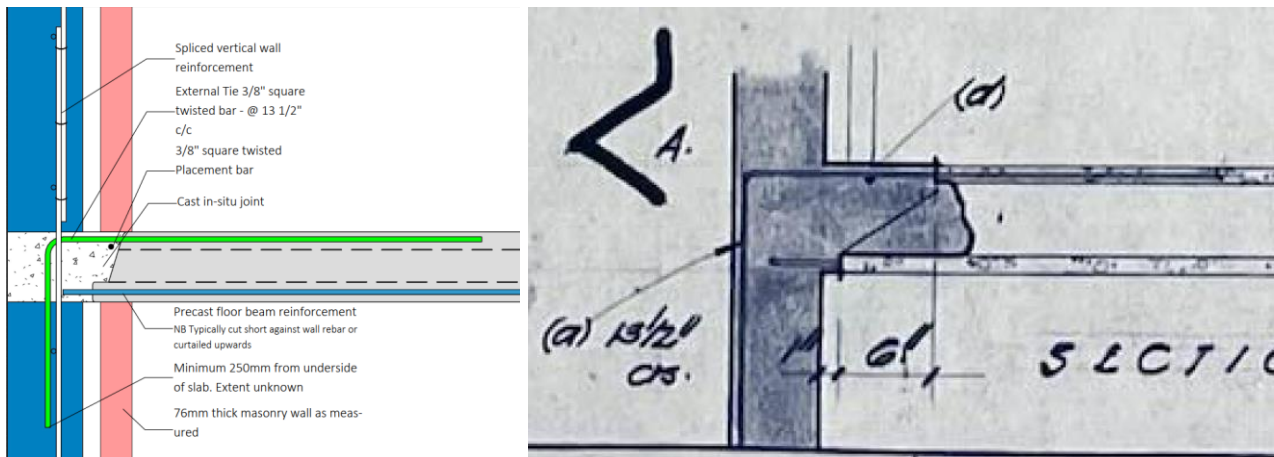
Figure 6: Observed External Wall to Floor Detail as Observed (left) as Intended, extract from record drawings (right)

Similar, to the internal wall joints, flank wall to floor joints are also cast in-situ joints as shown in Figure 6. In this location, floor beams are being supported by a masonry wall with approximately 40mm air void between the two. Where measured, this wall appeared

Steel ties located at this joint appear to be as described in the record information, however, their location within the element is not as per the original design intent as they are typically placed closer to the inside face of the walls. The ties consist of L-shaped 3/8" square twisted high yield bars. The ties extend, typically, 800mm beyond the wall towards the slab. Opening up works in the ceiling were carried out to determine the length of the horizontal bars into the walls below. Although the ends of each bar were not exposed to their full length, it was observed that each bar is anchored into the lower walls by at least 250mm below the underside of the floor slab.

Typically, horizontal bars are spaced, at 13 1/2" (≈343mm) centres and are located on every other trough of the precast floor units. A horizontal bar, located at the top of the floor slab, is placed just underneath the internal ties within the cast in-situ joint. This bar is believed to serve as a placement bar and has no other structural benefit.

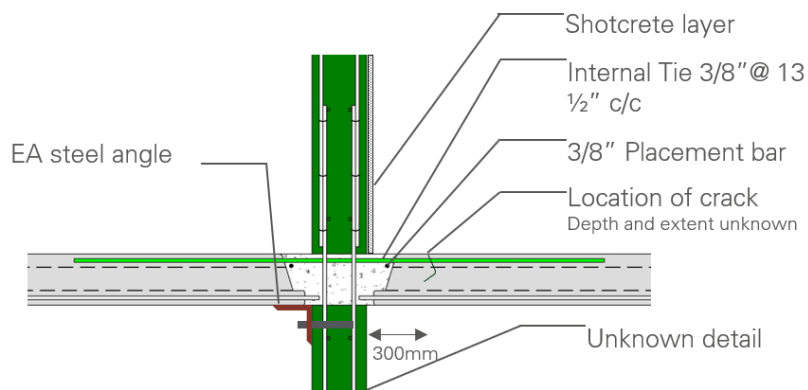
Figure 7: Observed Internal Wall Detail at Flat No. 91

During intrusive investigations in Flat 91, a horizontal crack was discovered in one end of the floor slabs Figure 7. The crack is located approximately 300mm away from the face of the support and is formed relatively parallel to the wall. A visual check was carried out on the flat below to establish whether the crack has penetrated the floor slab in its full depth or is restricted to the top layer. From the visual inspection carried out on the flat below it appears that the crack is limited to the top layer of the slab and has not penetrated through. It is unknown when this crack was formed and whether it is a historic defect or a result of any intrusive investigations carried out on the floor above. Although the structural team did not inspect the area until the screed was removed, areas where the screed was not removed in the vicinity of this defect suggested that the screed might also have been affected. If the crack is indeed historic it is likely that it was formed due to localised hogging moments experienced close to the support rather than due to excessive shear forces. This is because, shear failure is typically brittle and does not provide warning. It is recommended that this defect is repaired by installing additional reinforcement between every other trough that is not currently occupied by existing horizontal ties.

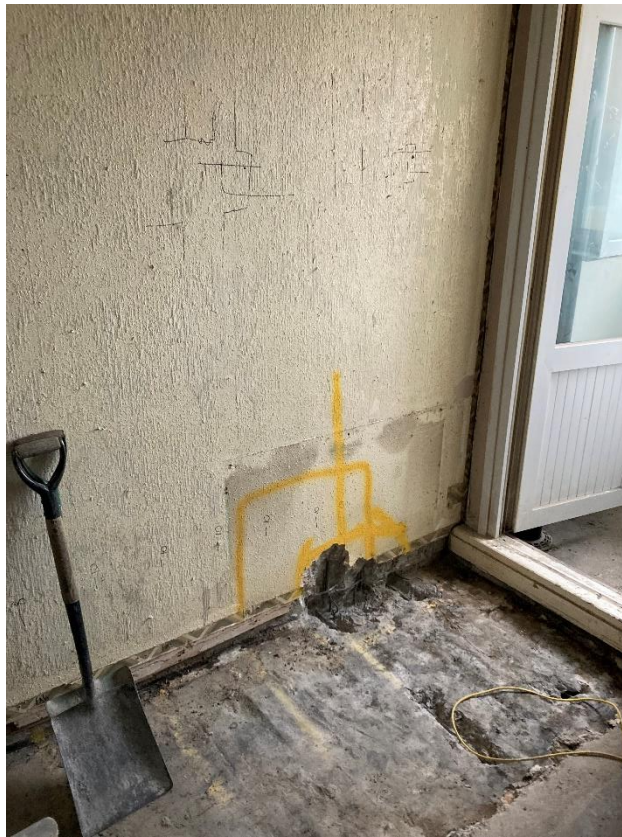
Photograph 1: Internal Wall Junction Horizontal Tie

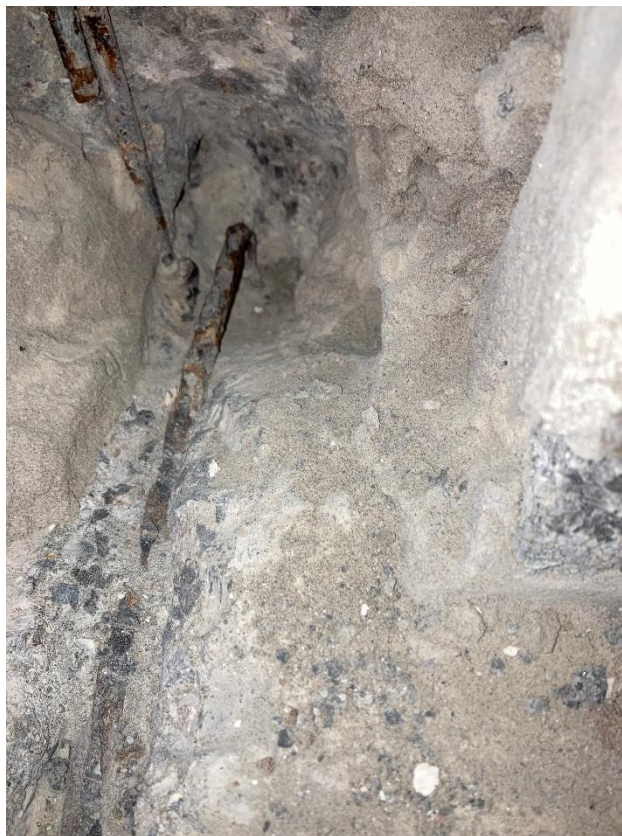
Photograph 2: External Wall Junction Horizontal Tie

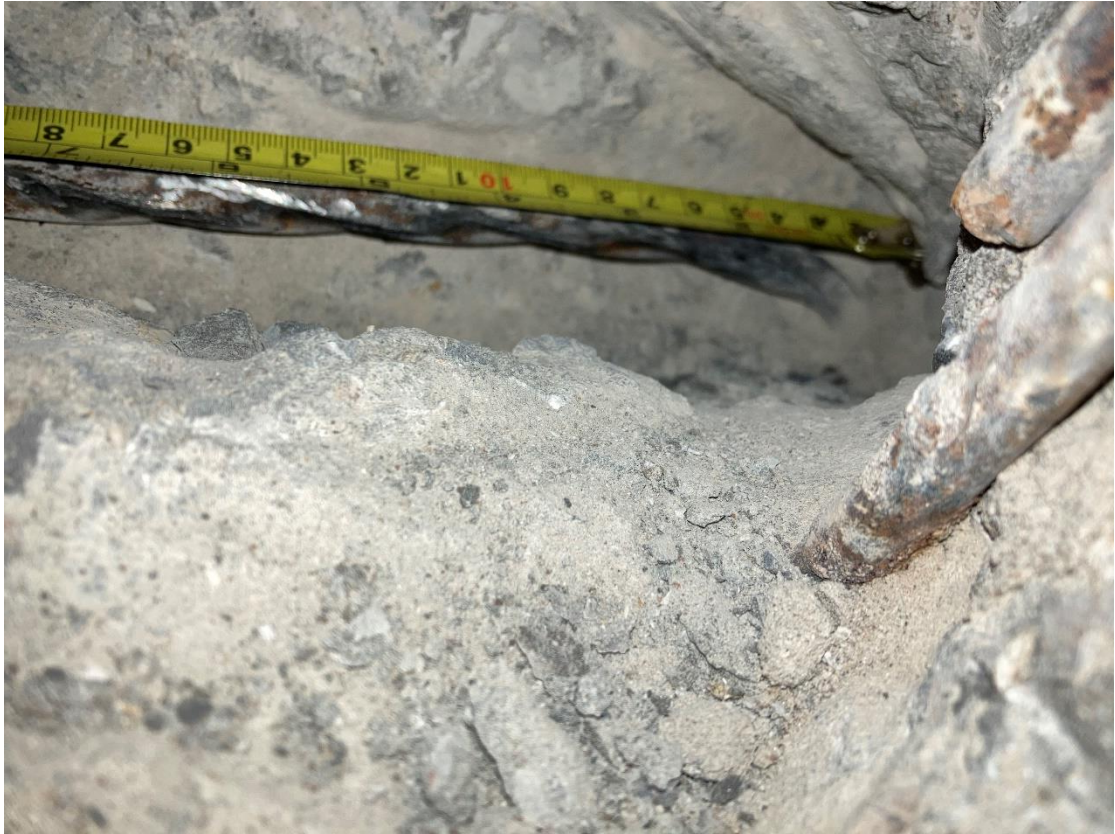
Although the majority of ties have been provided as intended, a workmanship error was consistently observed when exposing the flank wall horizontal ties (Scenario 1). The original design intent was for the horizontal ties to be lapped at the rear face of the wall (Figure 6 left). Doing so would have ensured that the force applied in the ties would be equal throughout the tie itself. However, the as built condition suggests that the horizontal ties were installed just at the back of the front face wall reinforcement (Figure 6 right) providing an embedment of approximately 60 mm. The location of the flank wall ties in relation to the front of the wall exacerbates the force experienced by the ties. The method to analyse such condition and its effects is described below.

Photograph 3: External Wall Junction Curtailment of Tie

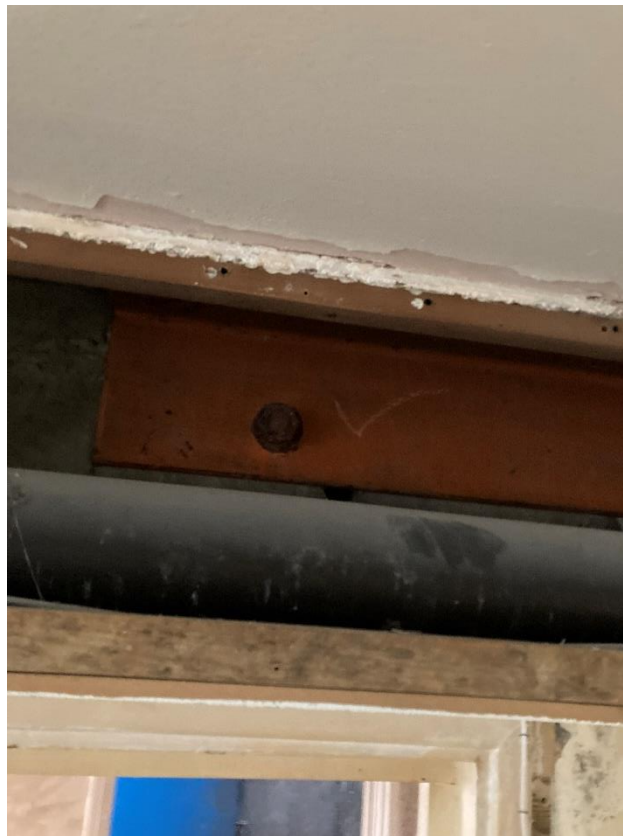
Photograph 4: Typical Temporary Support Angles

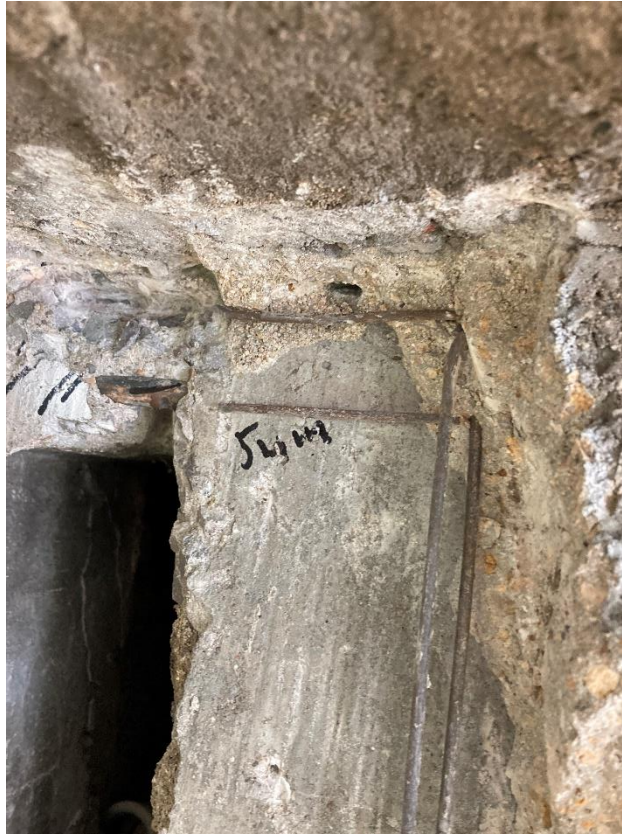
Opening up works on some walls suggests that initially cover levels might not have been satisfactory. In some areas cover depths were measured as low as 5mm; however, in all observed affected areas a layer of 40mm thick shotcrete was installed in front of the wall providing sufficient cover for durability purposes. This type of defect was observed in flats No. 91 and 78. The time of the installation of this additional layer is not known as it could be part of quality control during construction or installed during the 1970s strengthening works.

Photograph 5: Typical Layer of Shotcrete in front of Low Cover Panel

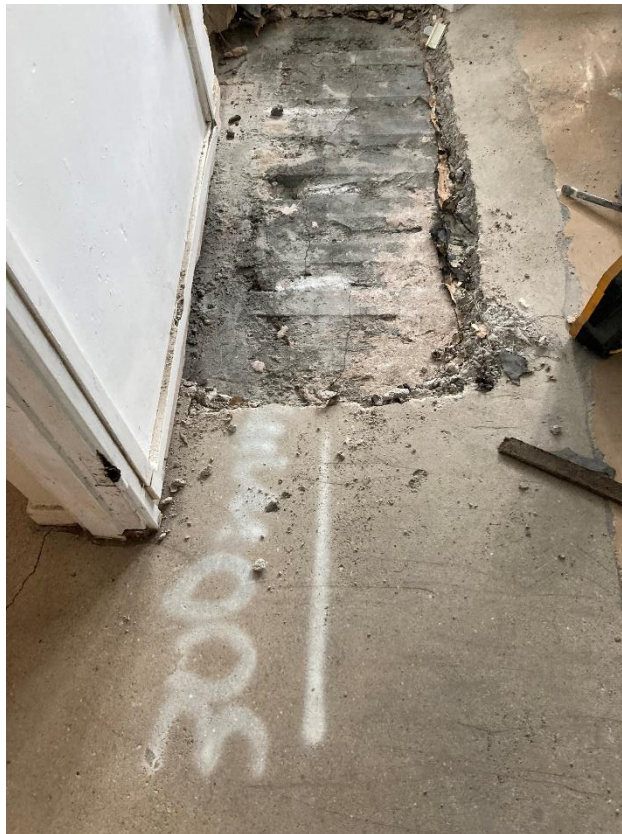
Photograph 6: Flat No. 91 Floor Crack

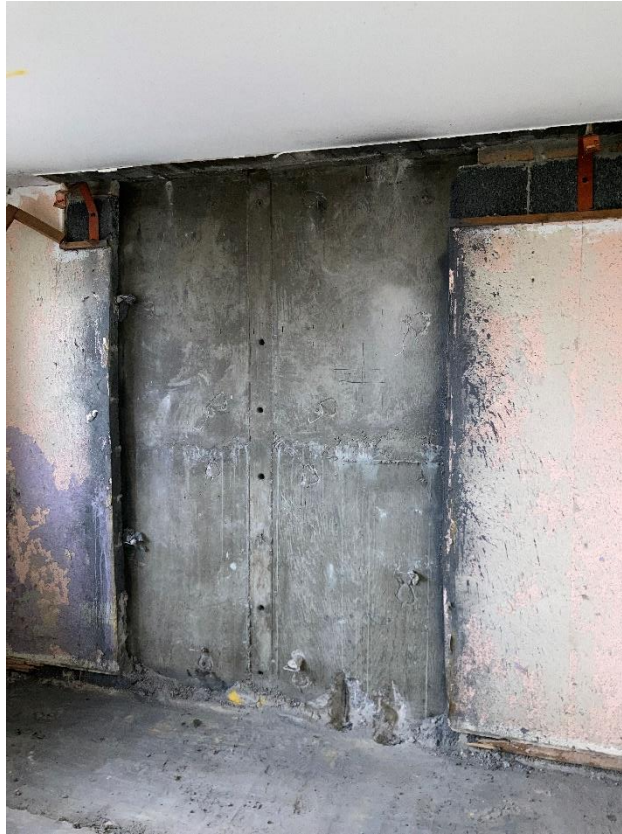
Photograph 7: External (Flank) Wall Cast In-situ Panel with Masonry Wall

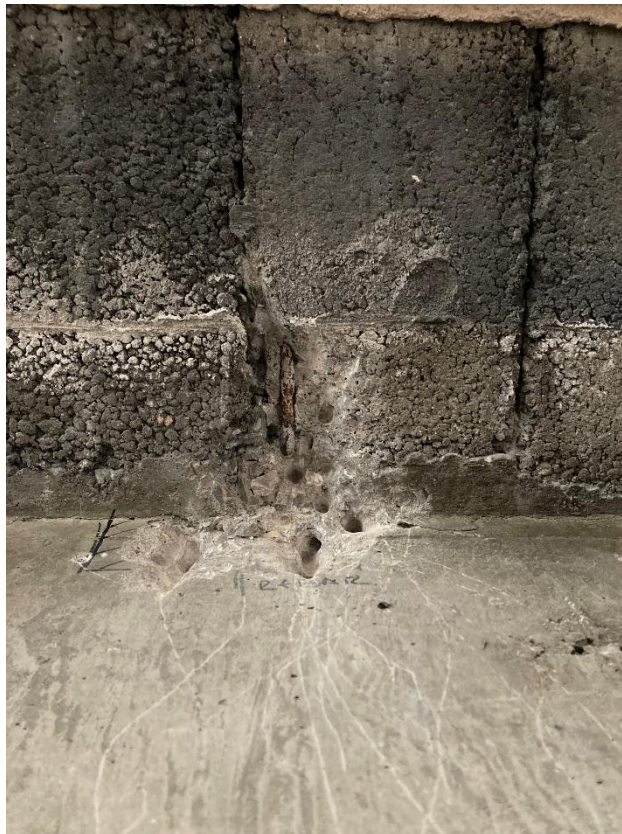
Photograph 8: Precast Floor Beams Reinforcement Provision

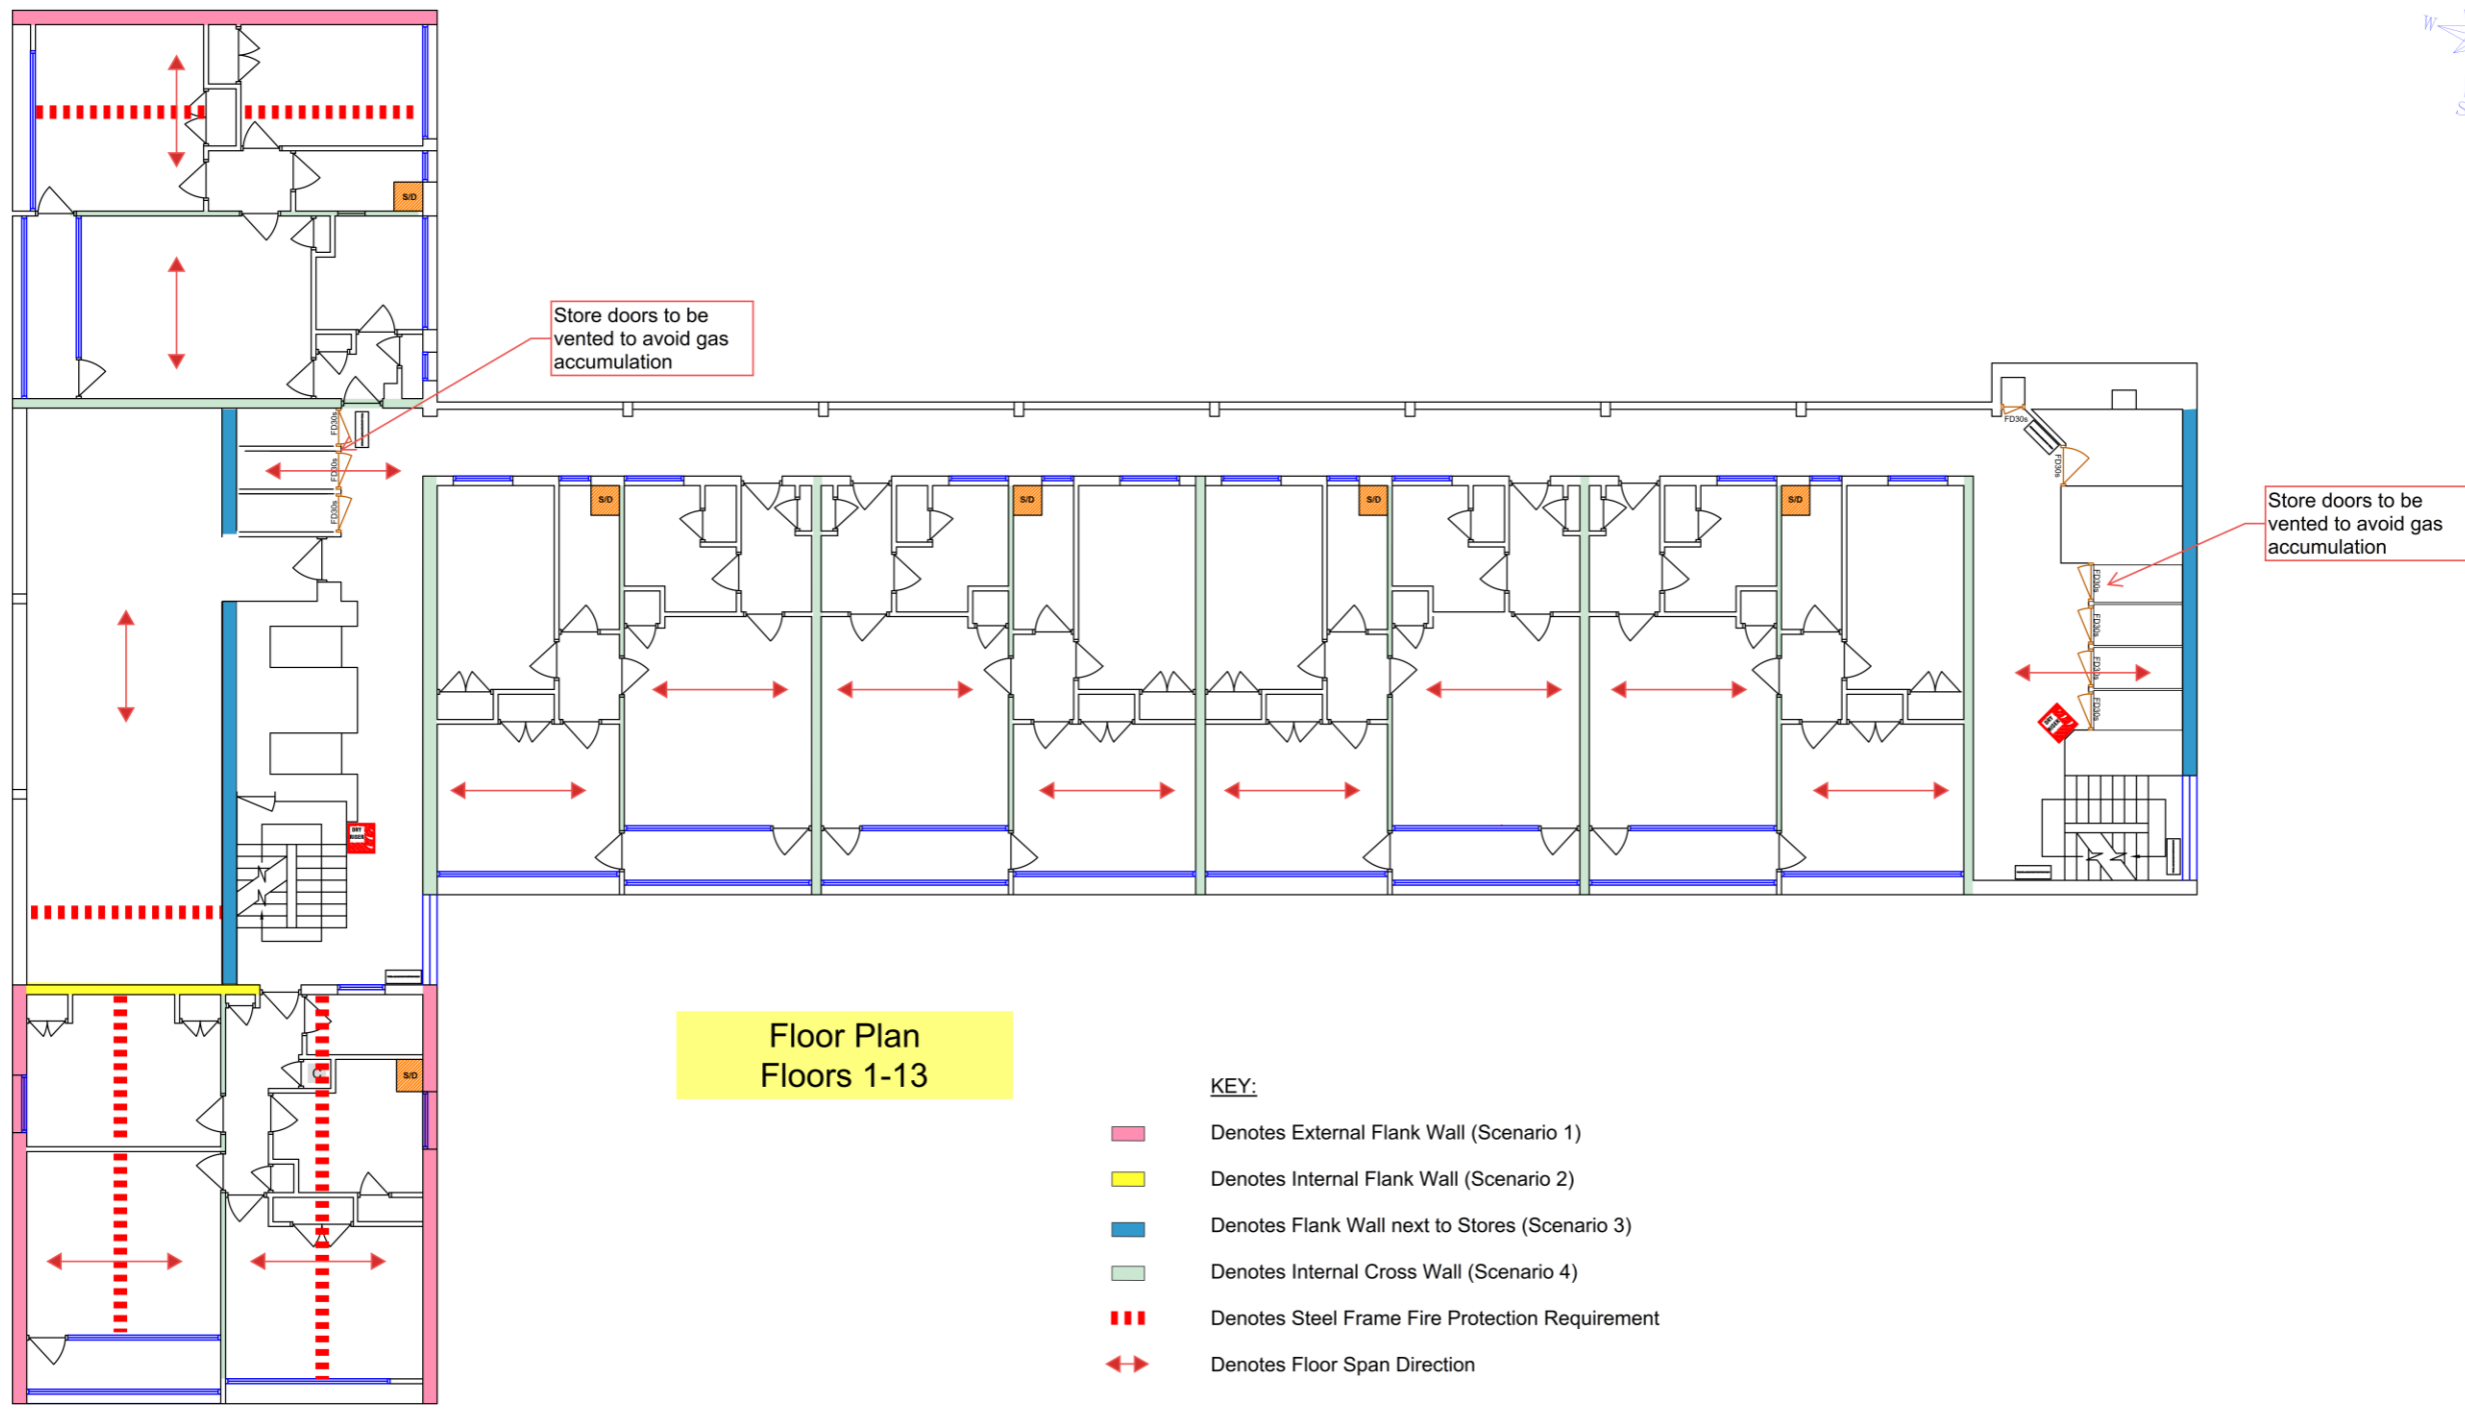
Figure 10: Plan of steel frame fire encasement requirements

As the external wall ties were found to be marginally ineffective, it is suggested that the contribution of the steel frames at flank wall locations, for Scenarios 1 and 2, is utilised to ensure that the building performs satisfactorily against disproportionate collapse throughout. In doing so it is paramount that the steel frames adjacent to any flank walls, shown in Appendix C, Figure 10, are fire treated to ensure that they perform adequately in the event of a fire.

As these elements are being used to perform a structural function it is recommended that all steel frames adjacent to flank walls, internal or external (Scenarios 1 and 2) are fire treated in accordance with the fire specialists' recommendations and that any fire protection is installed by qualified and competent persons. An exception to this is the internal flank wall, adjacent to both core stores, where the exposure to an accidental load case is not considered to be significant and as such no intervention is currently recommended.

- It is recommended that historic strengthening works at flank wall locations are utilised to protect against the effects of disproportionate collapse due to accidental loads for Barton House. Doing so will require for steel frames to be adequately protected against corrosion and fire. These frames have been annotated in Appendix C, Figure 10.
- It is recommended that strict measures are adopted in banning the use of any liquid gas devices (such as mobile heaters) that might be currently in operation at Barton House and that these are monitored on a regular basis.
