21 December 2023  
Project No. 5013240  
Rev 3  
John Smith  
Growth and Regeneration  
Bristol City Council

**Barton House**

**Brief, Background and Method**

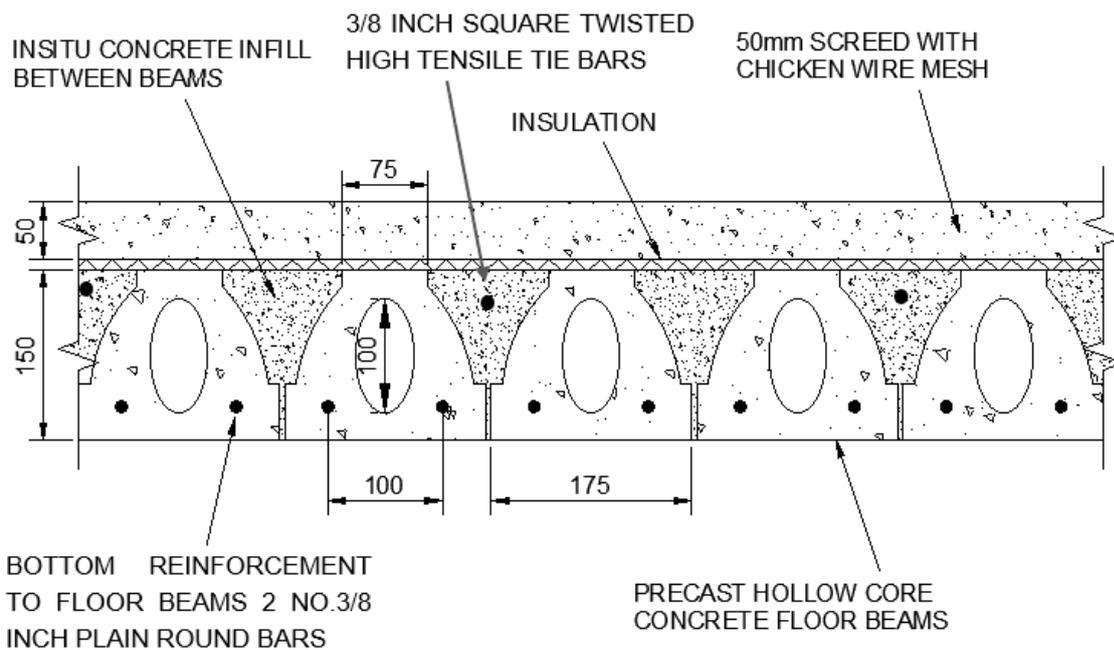
In general, the Gothic beam arrangement as shown below was found to be consistent with the original drawings and as expected, cover varied but was generally found to be at just over 1/2 inch on average which is consistent with the original design intent.

*Sketch is approximate only based on site measured dimensions.*
