BARTON HOUSE

STRUCTURAL ROBUSTNESS ASSESSMENT

BRISTOL CITY COUNCIL

July 2022

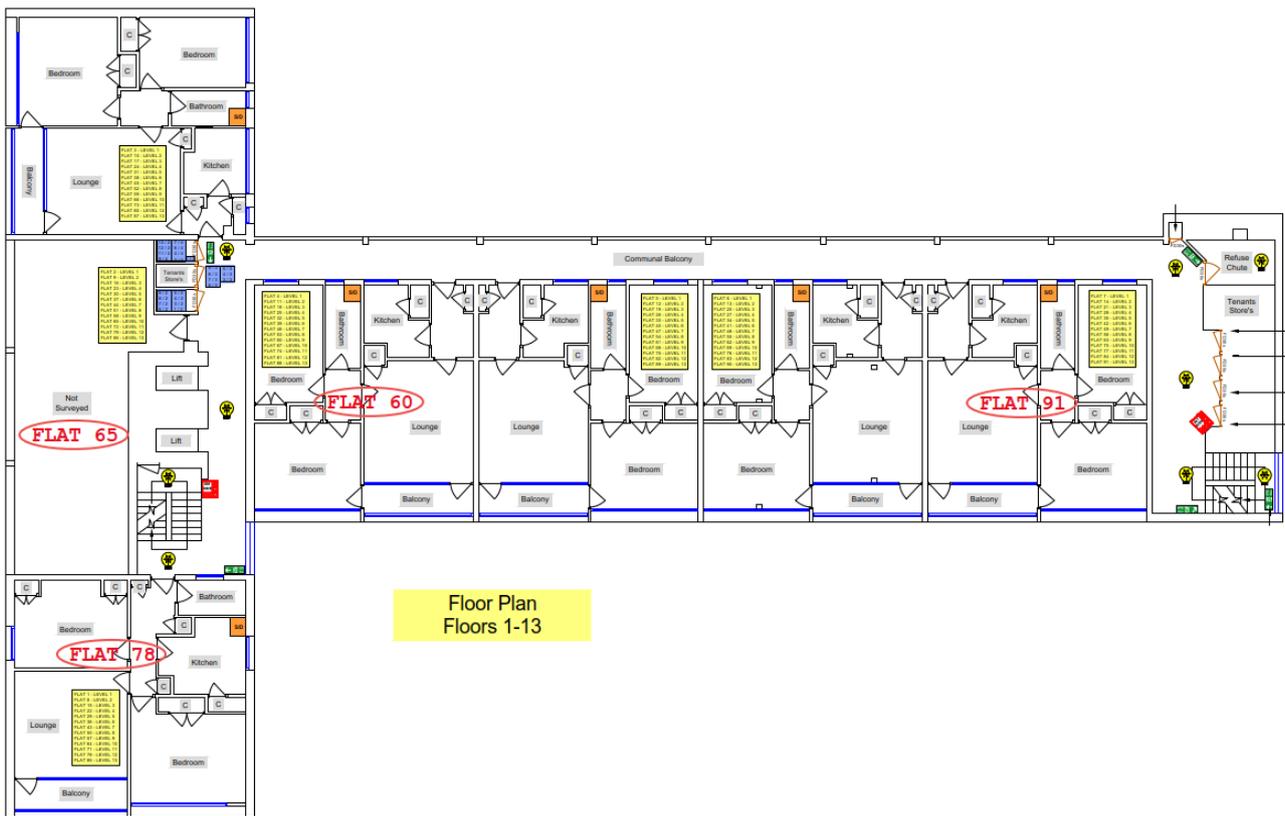
Figure 3 – Typical floor plan for Barton House showing the locations of the

The floor plan shown in Figure 3 shows the locations of the investigations undertaken within the block. Flats 60, 65 and 78 were subjected to the intrusive opening up works. Flat 91 had been selected as it was believed this may have a flank wall. However, inspection on site found that the floor slab extended the other side of the wall to form the external walkway (making this a cross wall). Therefore, only the scanning and visual inspection phase undertaken, as we required a flank wall for the investigations (78 being chosen instead).

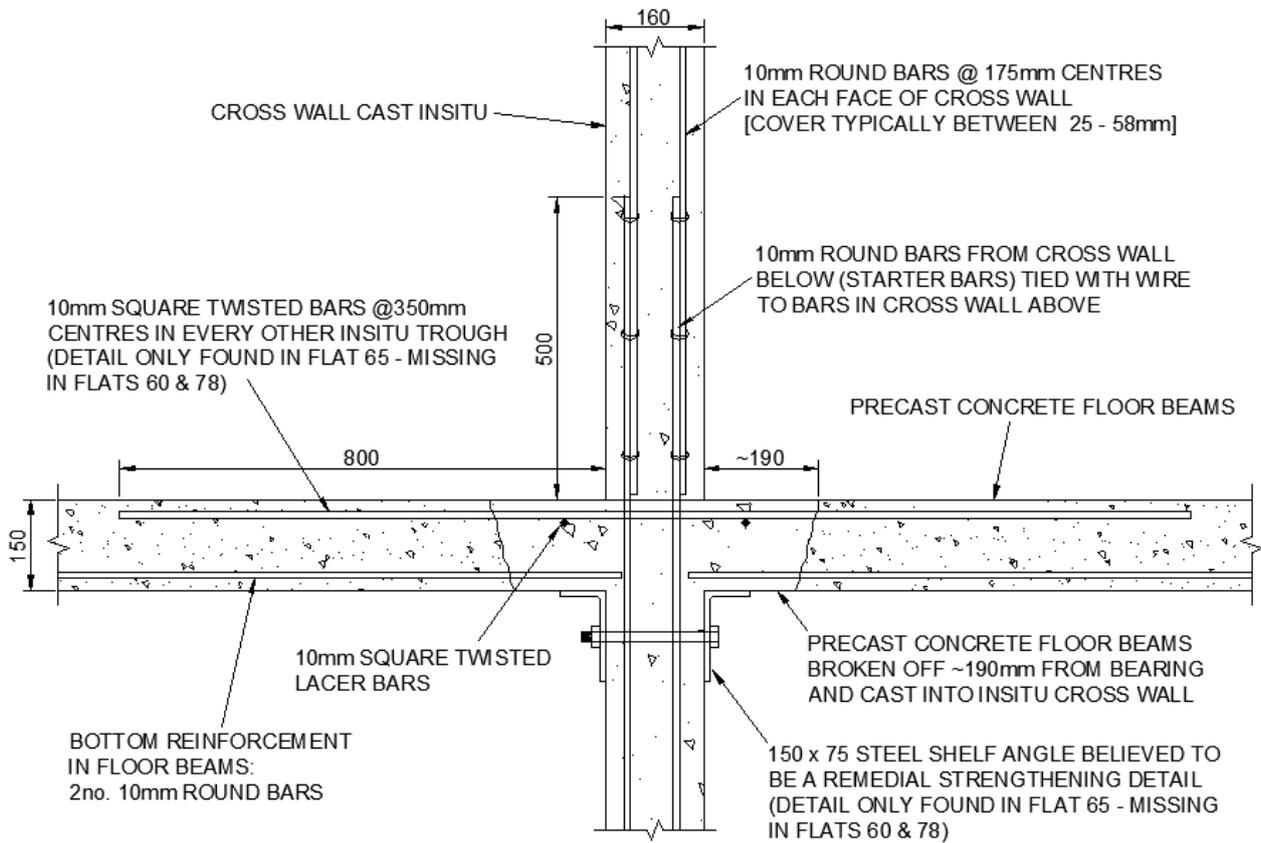
Figure 4 – Cross wall / floor slab joint

The floor beams were noted to have been broken off at their ends and had been incorporated into casting of the walls, likely to ensure a degree of homogeneity and to allow ties to be created between the elements.

The reinforcement within the columns extend from one wall into the one above, with a lap length of circa 500mm. For a 10mm diameter bar the required lap length to today's standards is $45d$, $\therefore 450\text{mm}$. This is therefore consistent with today's standards.

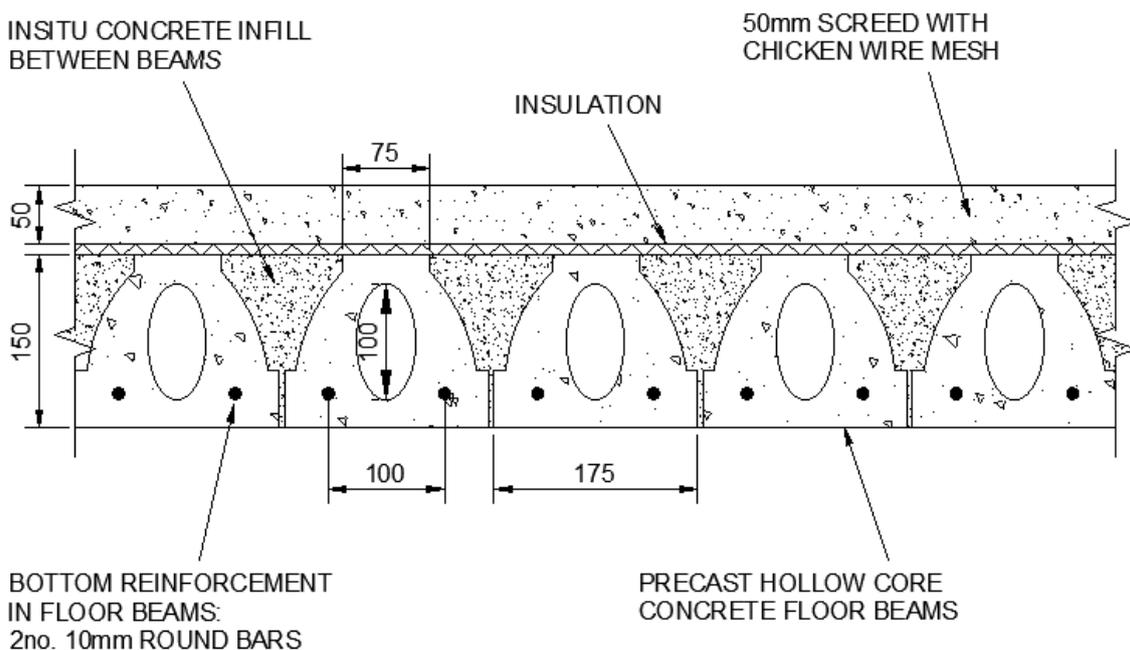
Figure 5 – Floor construction

In flat 65 it was found that there were horizontal tie bars inserted into every other grouted trough between the concrete beams. The beams were cast with a smooth face and as such friction between the ground and the precast beams is likely to be low. In the event of an internal gas explosion, it is likely that the tie bars would act sufficiently to resist disproportionate collapse.

Also, as noted prior, the horizontal ties which were found to be present in every other trough in flat 65 were not observed in the other flats investigated. In these locations, therefore, the assumption for this assessment is that no tie have been provided during construction.

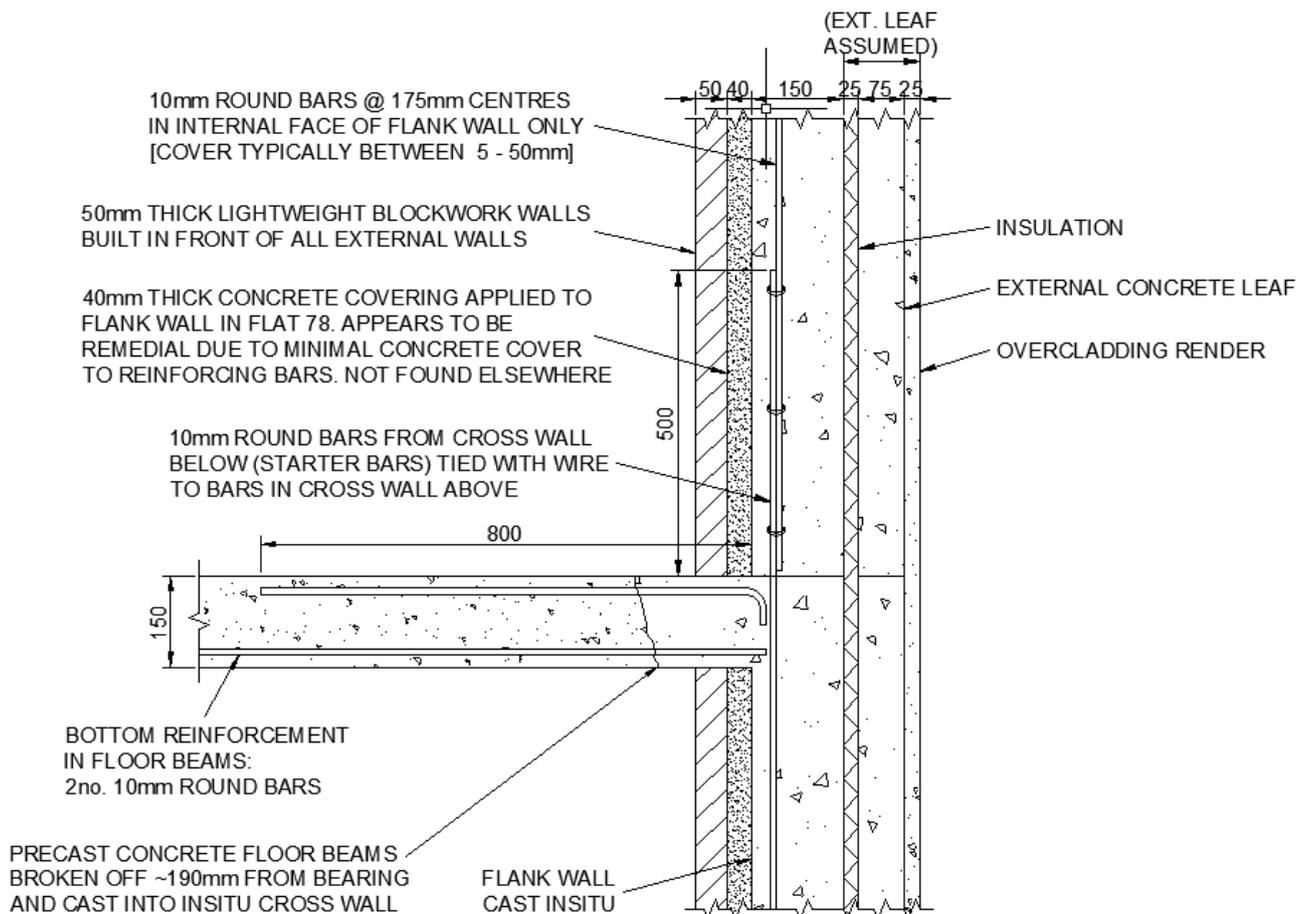
Figure 6 – Flank wall / floor slab joint

The investigations into the flank wall joint in flat 78 appear to show that the flank wall was reinforced in the internal face only, with no reinforcement in the outer face. The flank wall has an internal lightweight blockwork wall built in front of it (as did many of the cross walls whose otherside was to the exposed communal areas). However, with these flank walls it was also found that a 40-50mm layer of concrete had been roughly applied to the face of the flank wall, likely as a remedial action. It was found that the reinforcement in the two walls inspected had significantly low concrete covers (<5mm) so was likely applied for durability to prevent corrosion to the reinforcement (it is unlikely the wall would gain any additional strength from its application).

The investigation into the flank wall / floor slab joint suggested that there was no apparent effective horizontal ties provided. The connection appears to rely on a loop bar extending

from the precast section into the insitu concrete. However, no lacers wrapping around were observed.

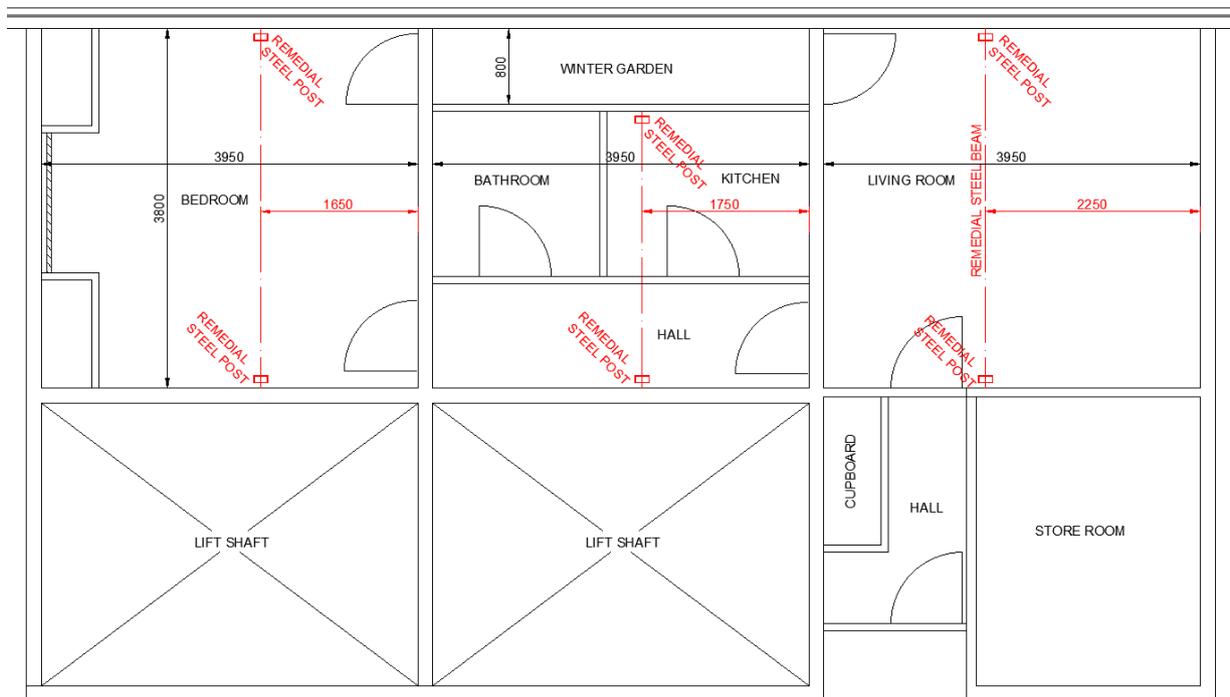
Figure 7 – Flat 65 floor plan showing location of strengthening beams and columns

It was also clear from the on-site investigations that the building, at some point during its history, had been strengthened with a combination of steel beams and columns. In some of the flats the cross walls / floor slab joint had been strengthened using steel angle brackets, likely to increase the bearing length on the floor slabs. However, these were noted to be missing on the cross wall in flat 78.

Figure 7 shows the floor plan in flat 65 with the locations of the strengthening works highlighted. It can be seen from the dimensions taken on site that the installed works have divided the span of the floor slab in half (roughly). Figure 8 shows the details observed of the remedial strengthening works.
