# FIRE RISK ASSESSMENT

## John Cozens House

St Jude's, Lamb Street, Bristol, BS2 0DX

CLIENT	Bristol City Council
ASSESSED BY	Bob Birtles
ASSESSED ON	08/08/2024
ASSESSMENT REF.	LS 422855
RECOMMENDED REVIEW DATE	08/08/2025
VERSION	1

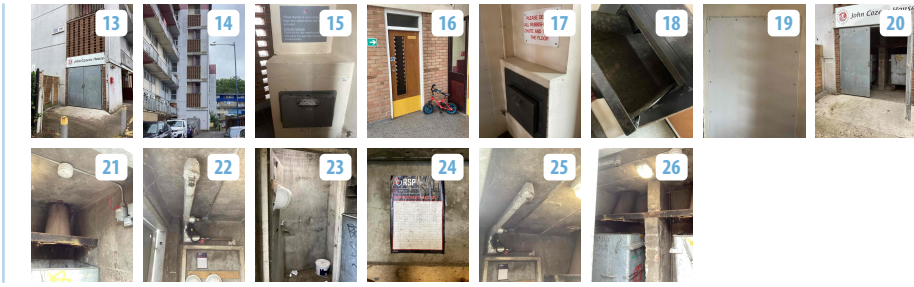
● There is a refuse chute system installed with hatches accessed directly within the stairwell or at the end of the deck access, with a refuse chute room at ground floor level accessed externally.

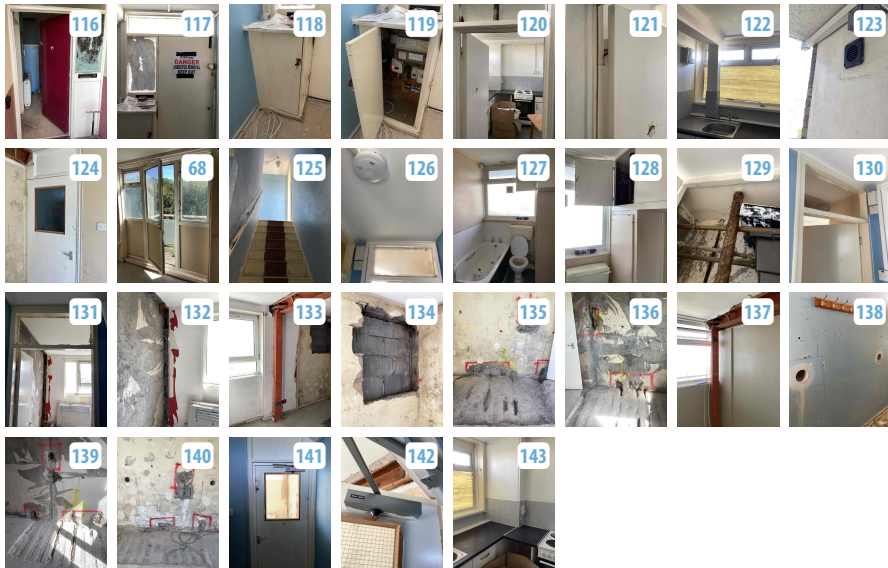
LOCATION Void flat 33, 17/9/2024

● Duplex hallway protected layout (questionable timber panelling and glazing), hallway, kitchen, lounge leading to balcony, stairs. Kitchen door no self closer, but includes rising butt hinges. Lounge door has a self closing device and Georgian wired glazing. Stairs up to landing, 2 bedrooms, bathroom. Detection, smoke only in hallway and landing, (nothing in lounge or bedrooms, no heat detector in kitchen). Electrical heating. Electrical distribution board in hallway, within timber construction with nominal fire resistance. Ventilation from kitchen is via openable windows, extract fan and an air brick. Ventilation from bathroom is via openable windows and an extract fan. Pipework hidden behind boxing construction in kitchen and bathroom above. A number of intrusive structural assessments have been started.

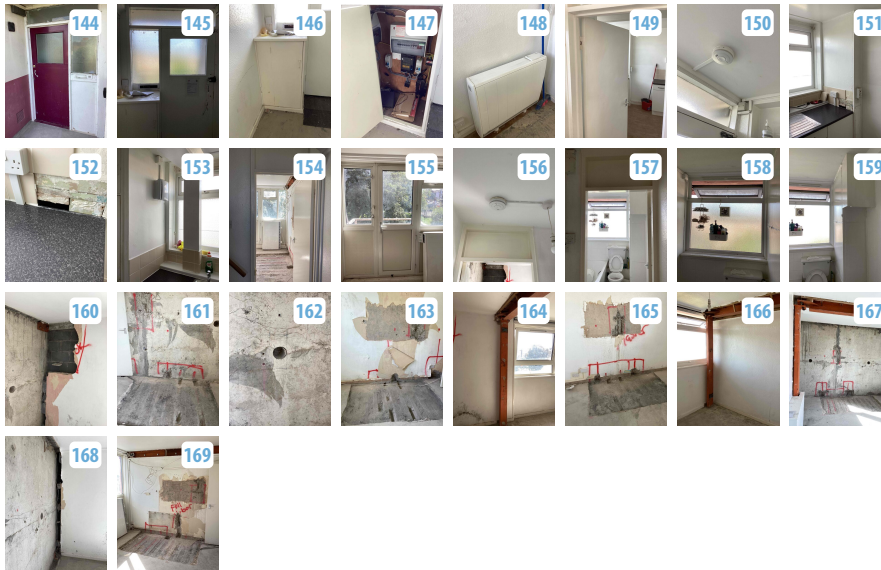
LOCATION Void flat 18, 17/9/2024

Duplex hallway protected layout (questionable timber panelling and glazing), hallway, kitchen, lounge leading to balcony, stairs. Kitchen door no self closer, but includes rising butt hinges.

Stairs up to landing, 2 bedrooms, bathroom.

A number of intrusive structural assessments have been started.

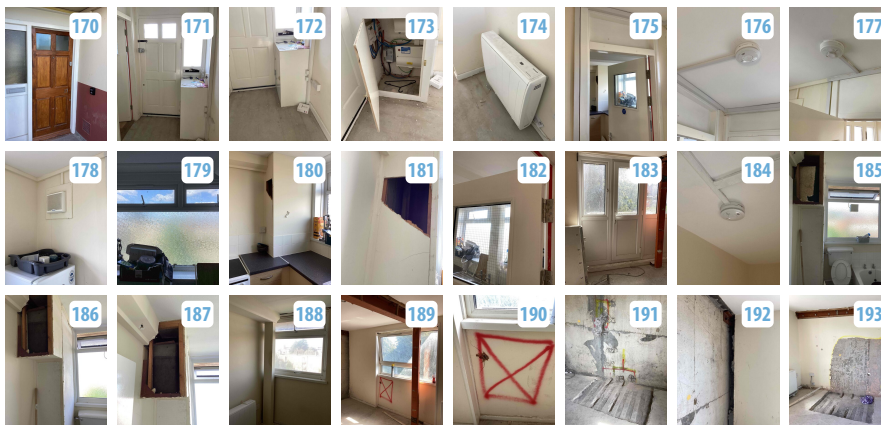
LOCATION Void flat 17, 17/9/2024

Duplex hallway protected layout (questionable timber panelling and glazing), hallway, kitchen, lounge leading to balcony, stairs. Kitchen and lounge doors have no self closer, but includes intumescent strip and Georgian wired glazing.

Stairs up to landing, 2 bedrooms, bathroom.

A number of intrusive structural assessments have been started.

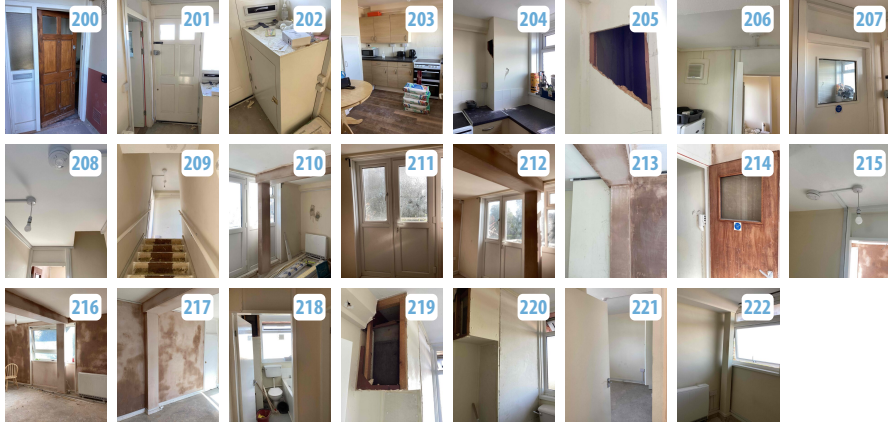
LOCATION Flat 17, 17/10/2024

Intrusive works completed, preparing for reoccupation.
