**ST JUDES – CHARLETON HOUSE
STRUCTURAL ROBUSTNESS ASSESSMENT**

BRISTOL CITY COUNCIL
December 2024

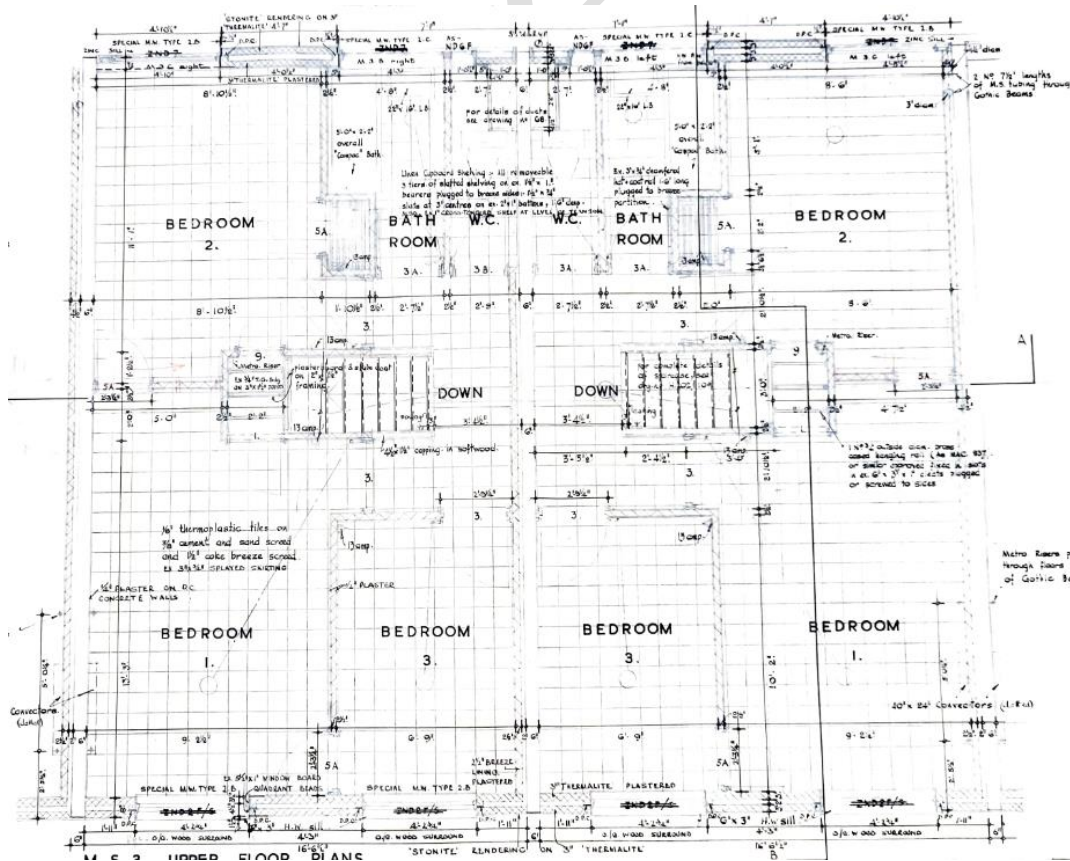
Figure 5 - Charleton House upper floor record drawings

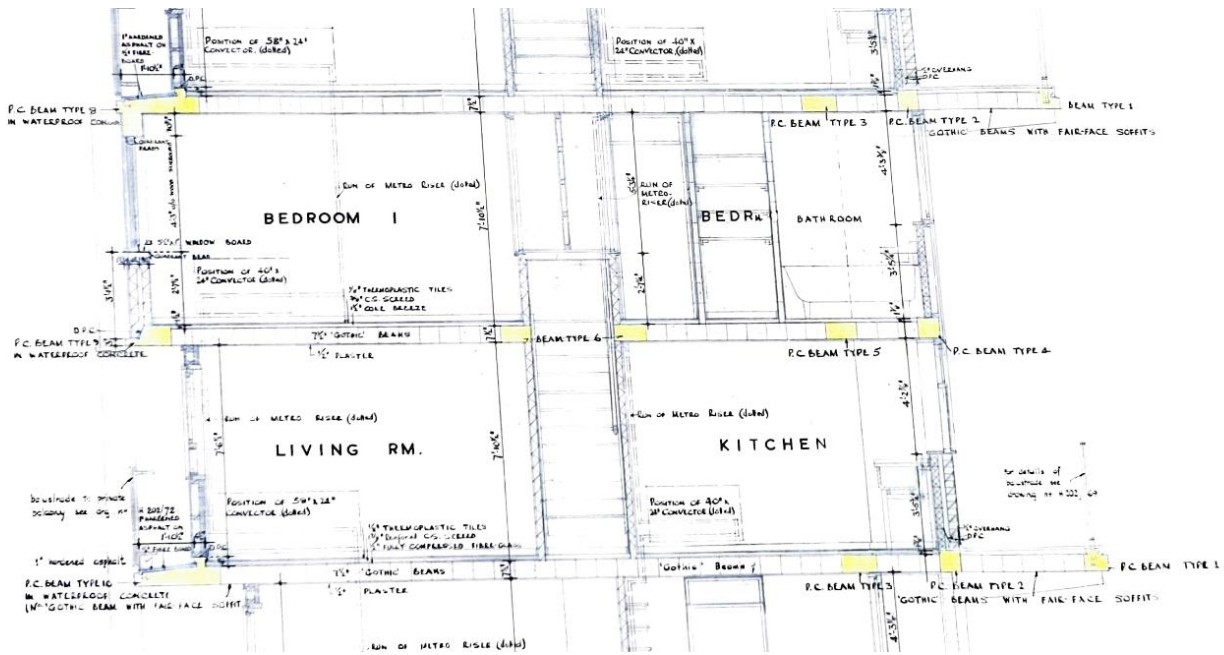
Figure 6 – Charleton House typical record drawings section.

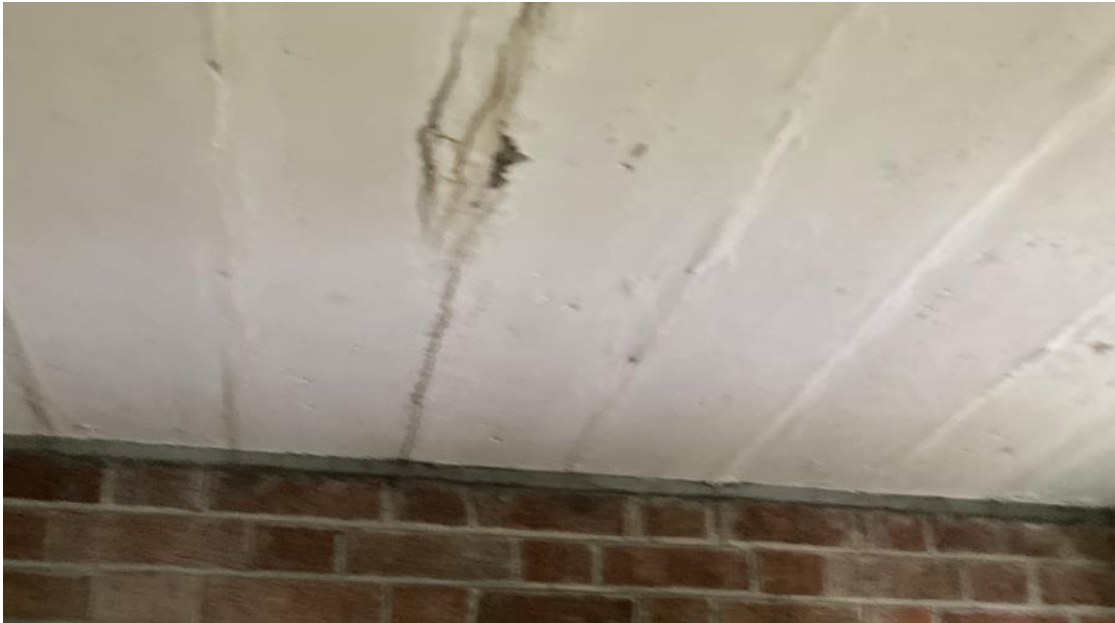
Figure 11 – Individual gothic beam floor found to be of poor quality with poor compaction widely noted.

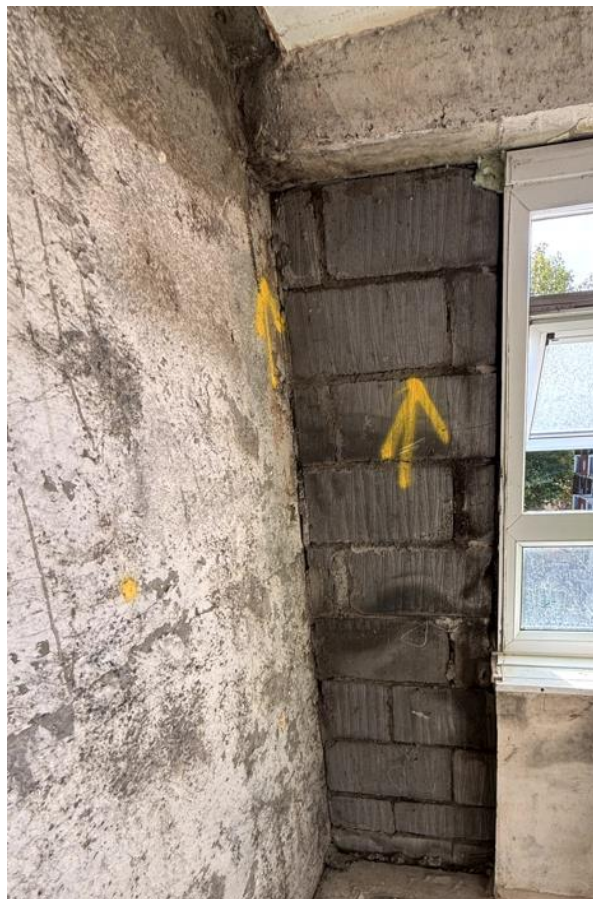
Figure 12 - No wall ties installed between blockwork and cross walls – Flat 18.

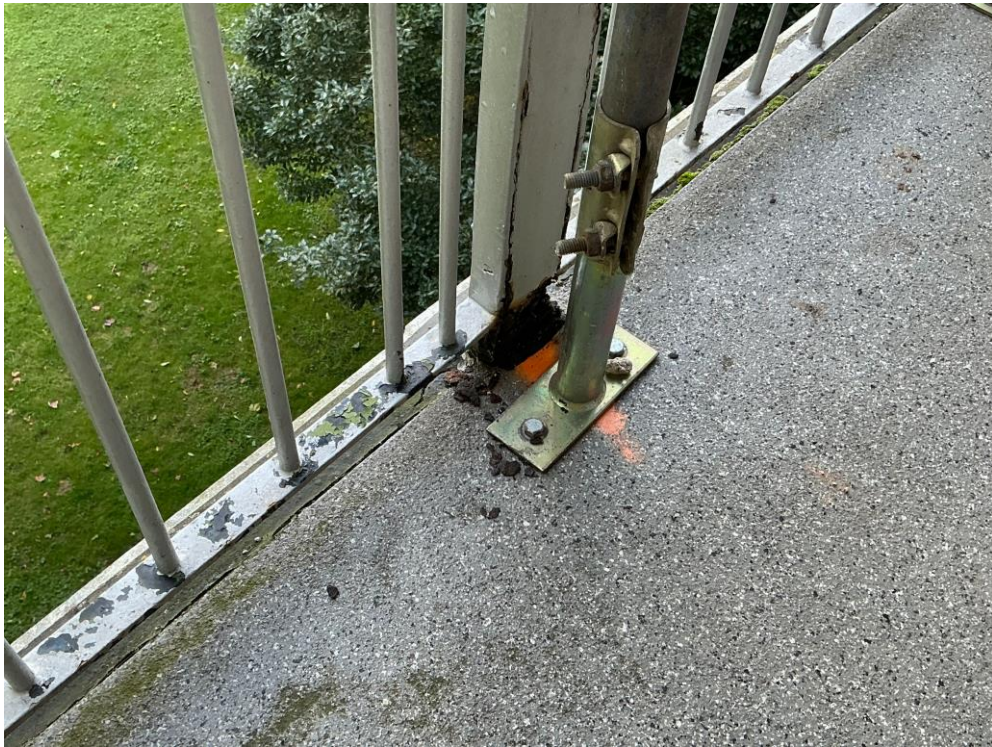
Figure 13 - Corroded balustrade connection.

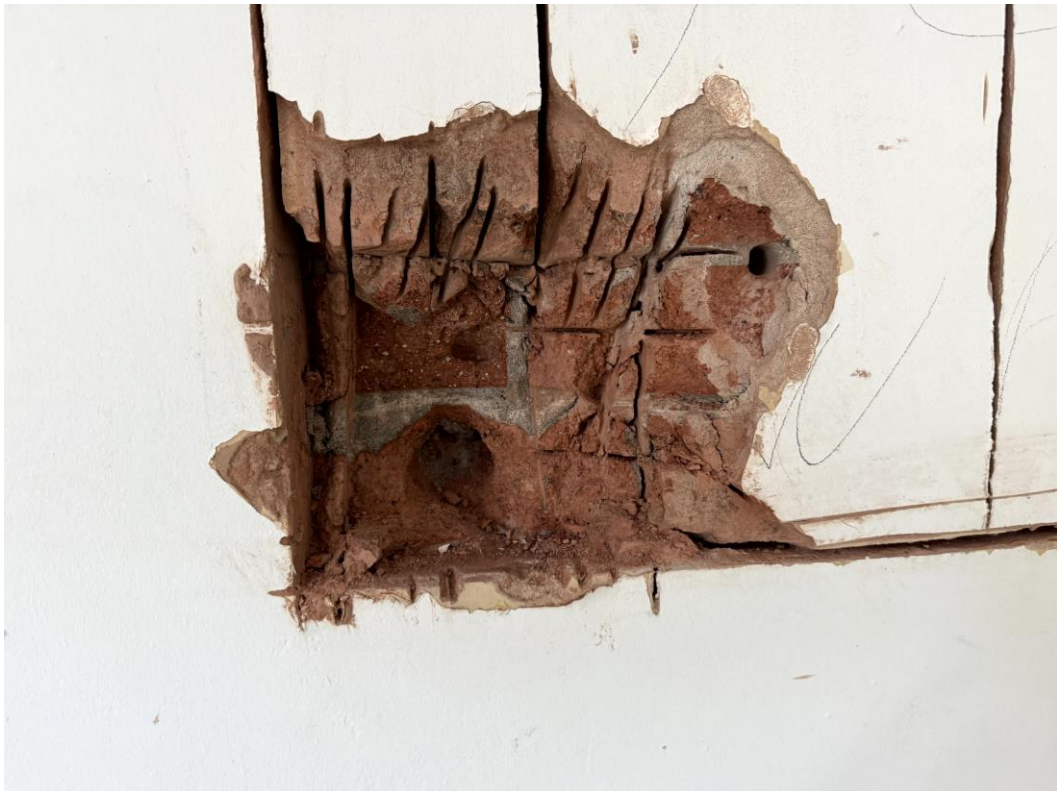
Figure 14 - Flat 14 brickwork external skin breaking out and 22mm depth check hole.

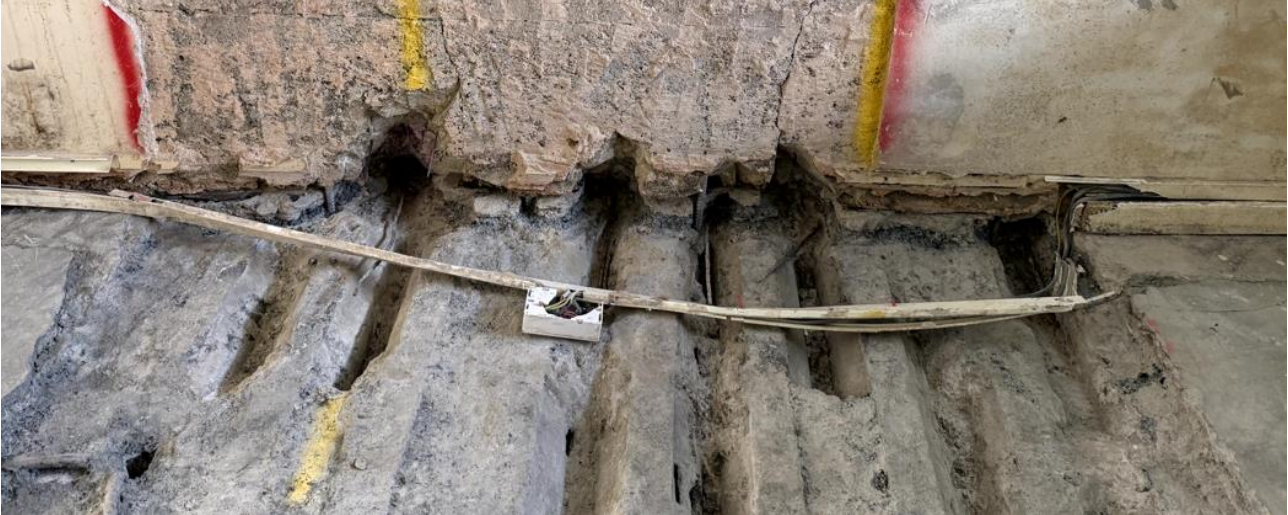
Figure 15 - Flat 20 flank wall inconsistently installed floor ties

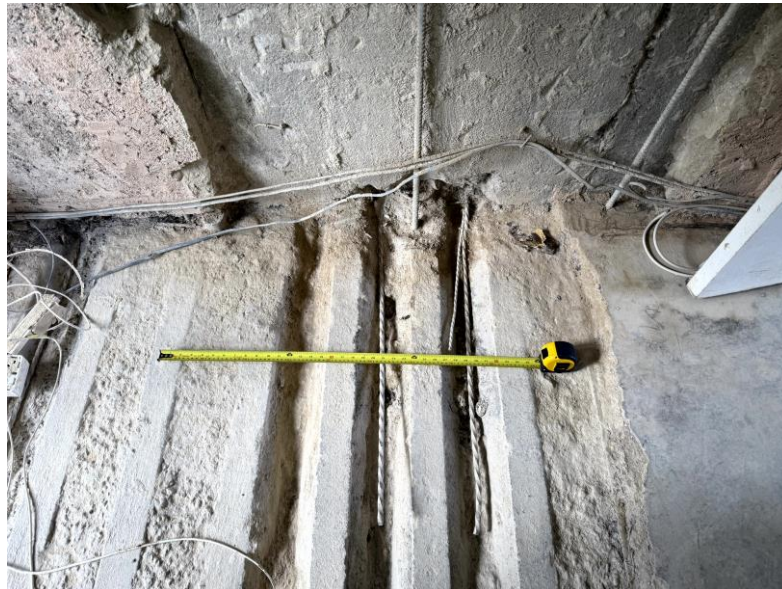
Figure 16 - Shotcrete lining with reinforcing projecting through the floor.

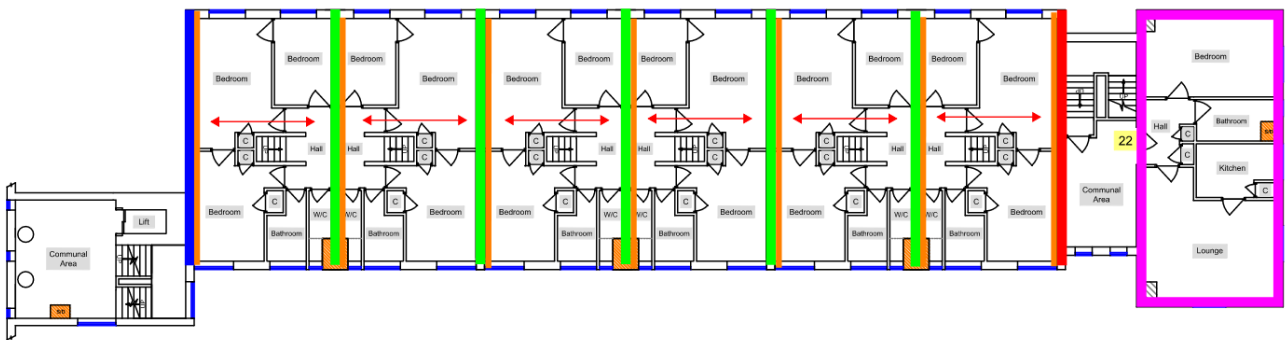
Figure 21 – Charleton House typical floor layout showing "key element" locations

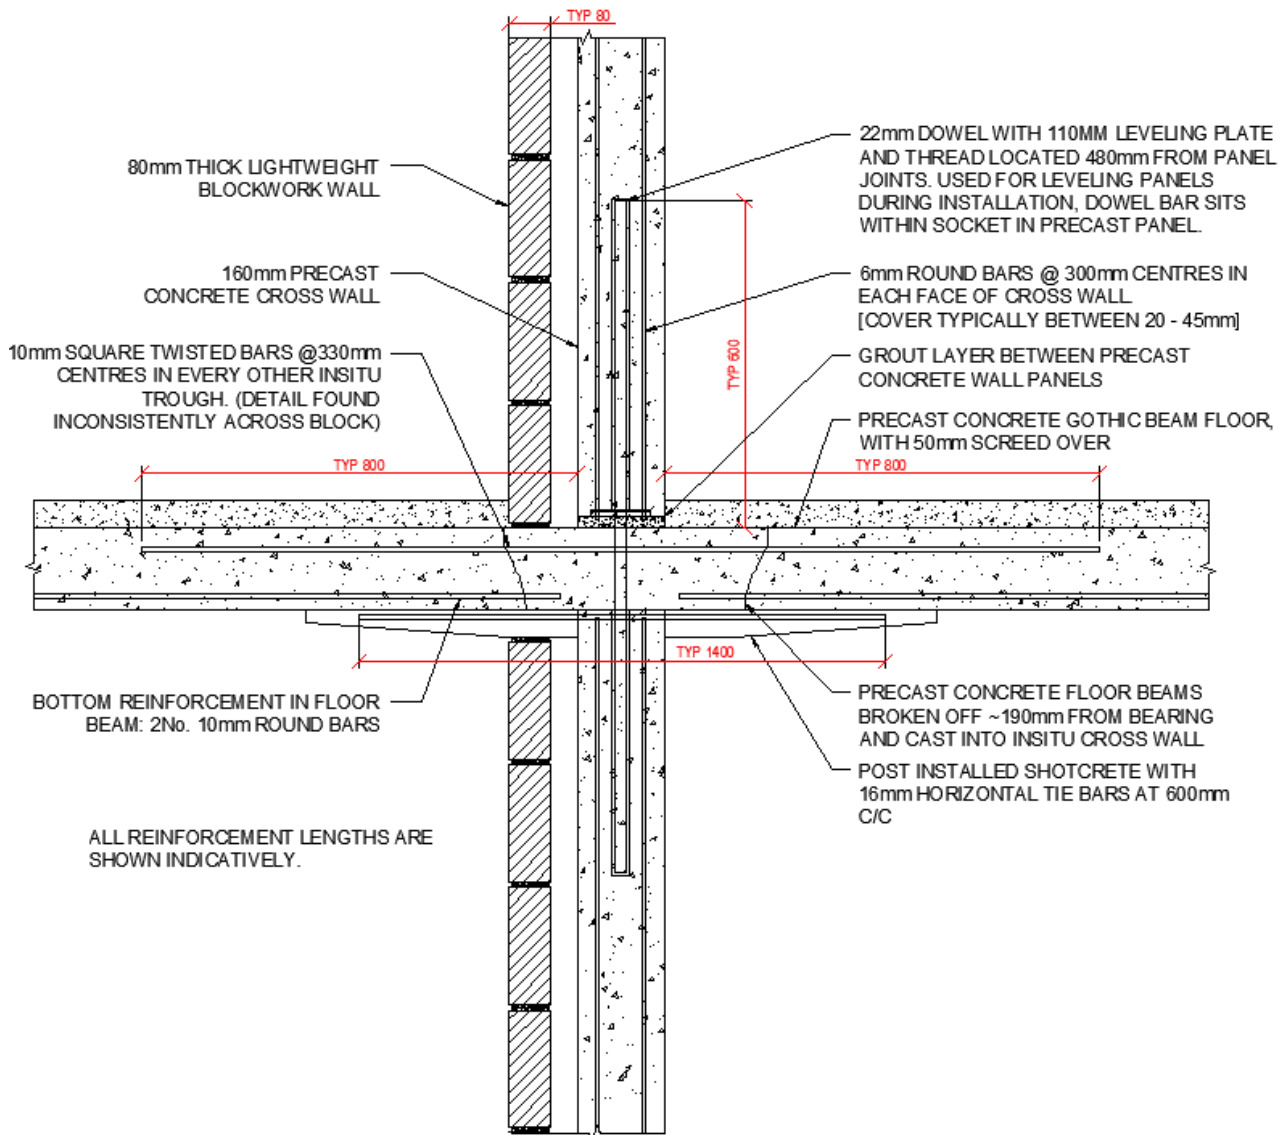
Figure 22 – Cross wall / floor slab joint

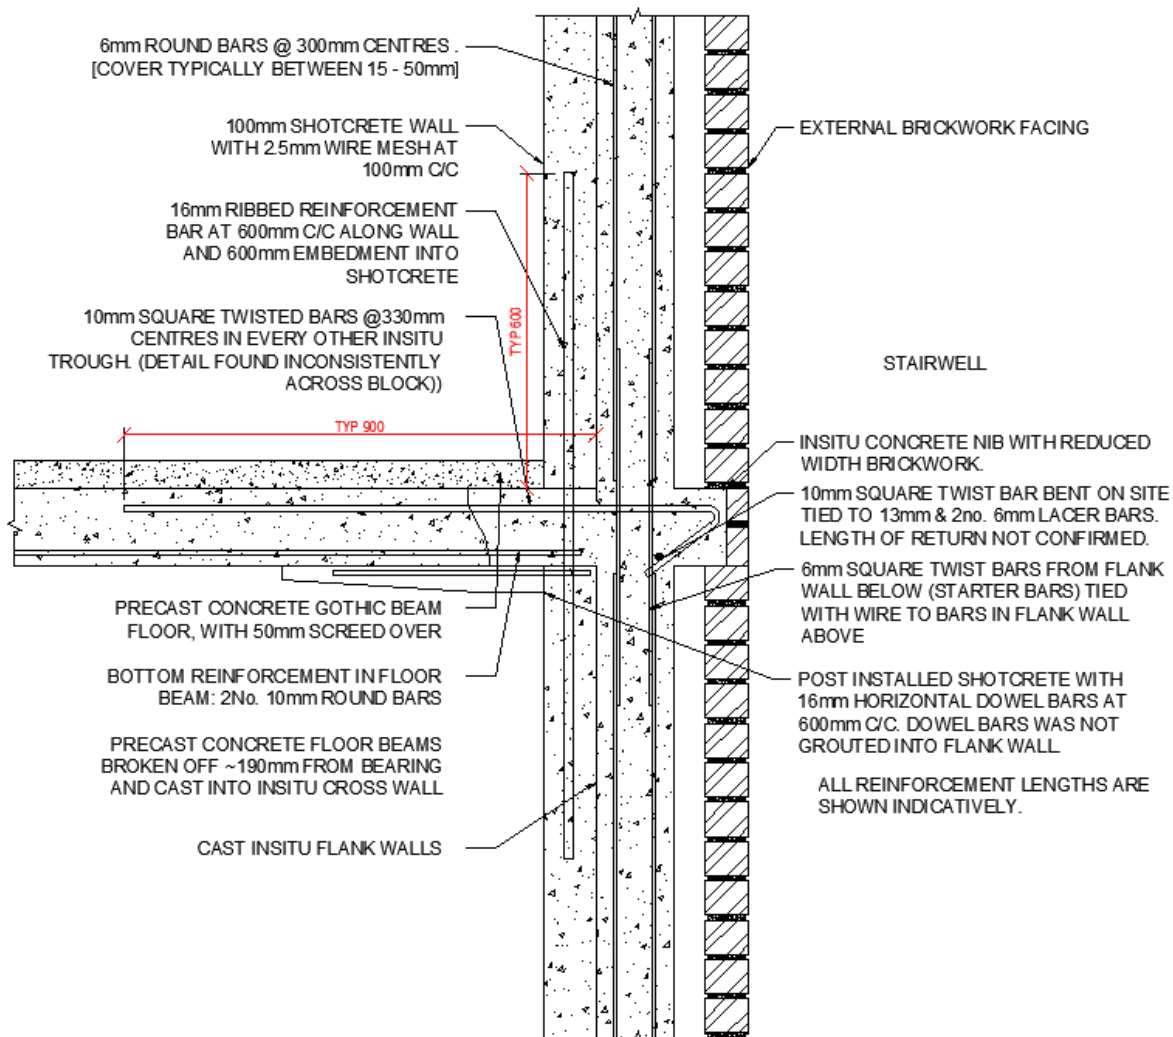
Figure 23 – Typical In-situ flank wall to floor slab joint

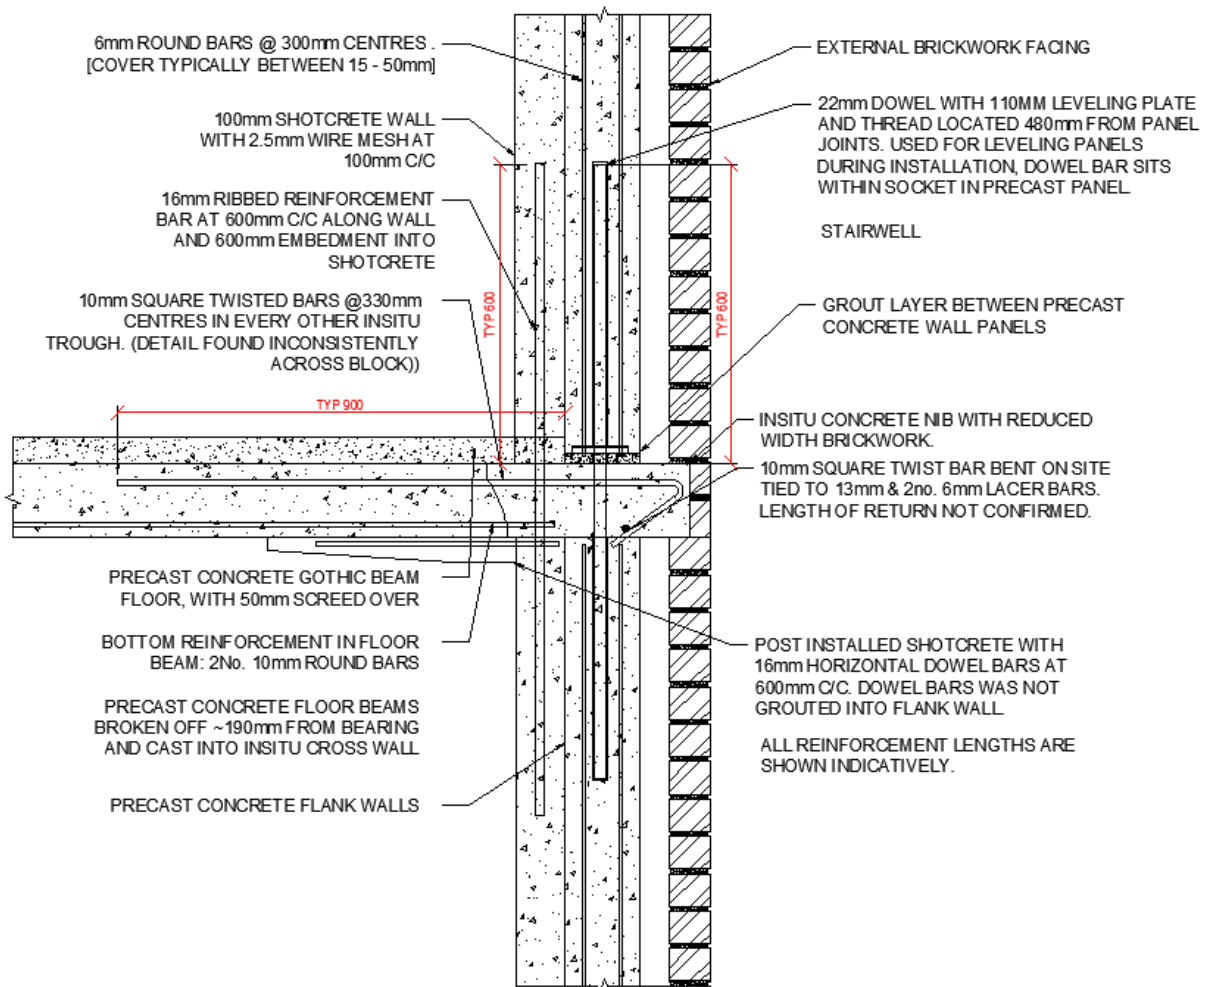
Figure 24 - Precast concrete flank wall/ floor slab joint

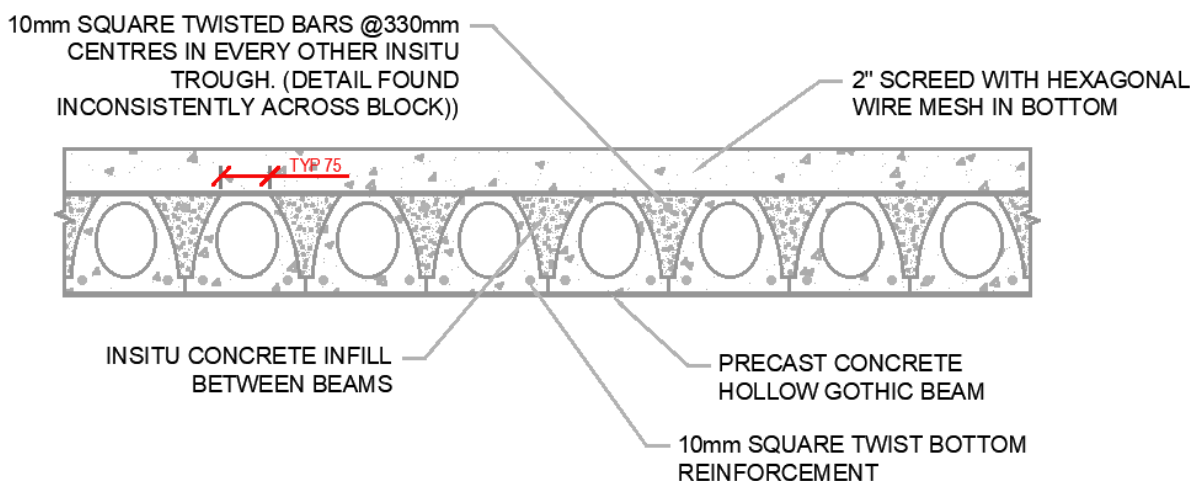
Figure 27 – Typical Gothic beam floor to wall joint construction detail.

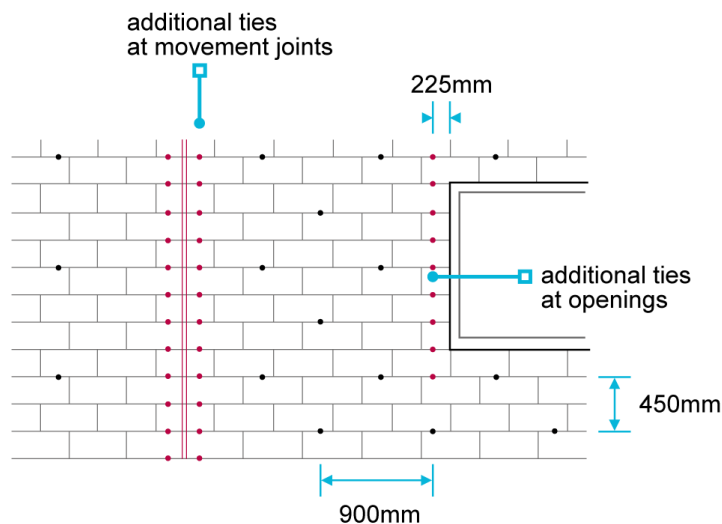
Figure 28 - Typical Wall tie detail (Ref NHBC Standard 6.1.18)

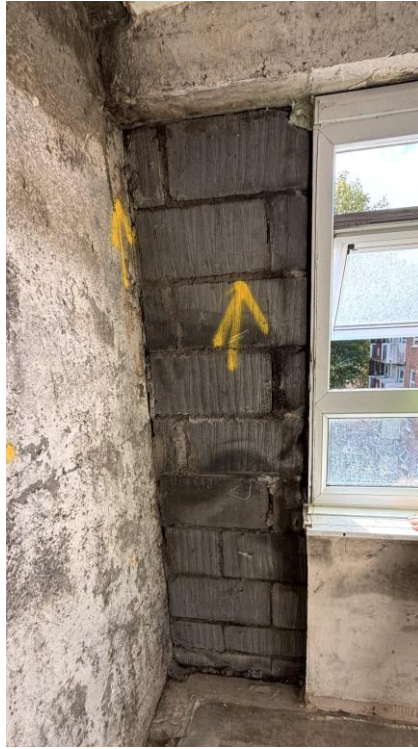
Figure 29 - Removed blockwork showing missing or unused wall tie

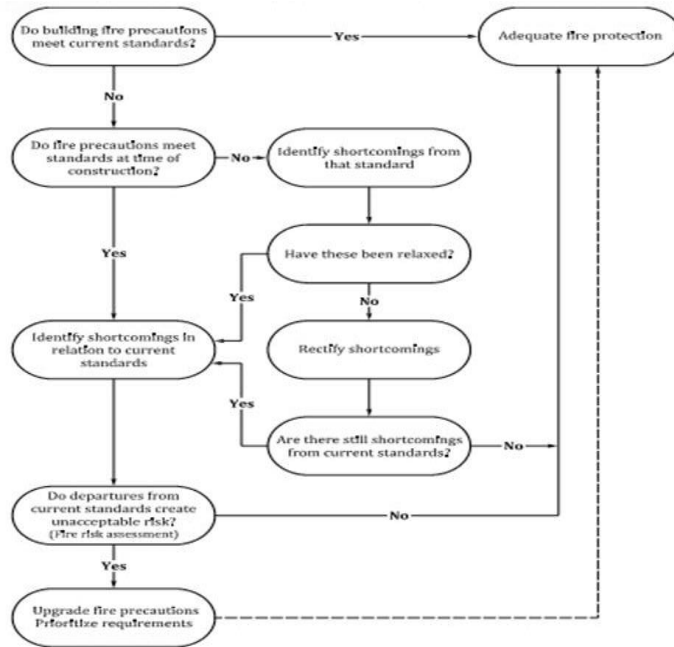
Figure 31 – Decision tree in relation to the requirement to upgrade fire precautions

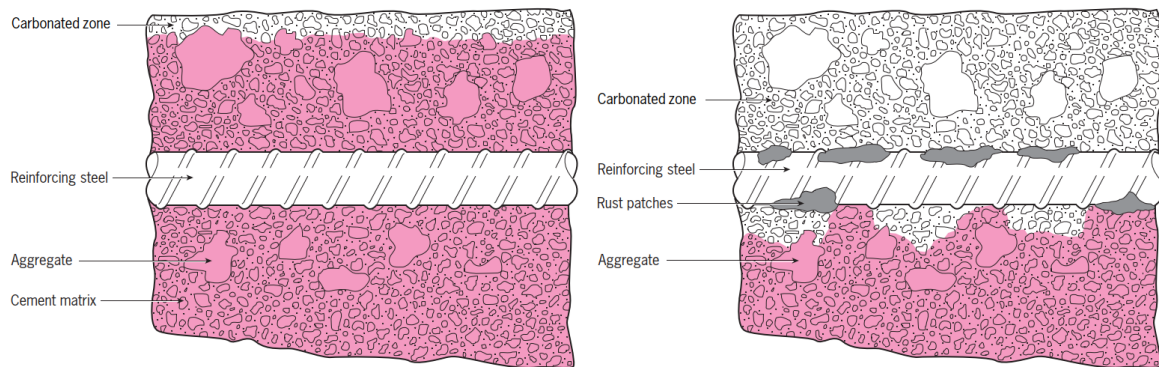
Figure 32 – (Left) Diagrammatic view of steel protected from carbonation-induced corrosion in partially carbonated concrete, (Right) Diagrammatic view of steel corroding in carbonated concrete.

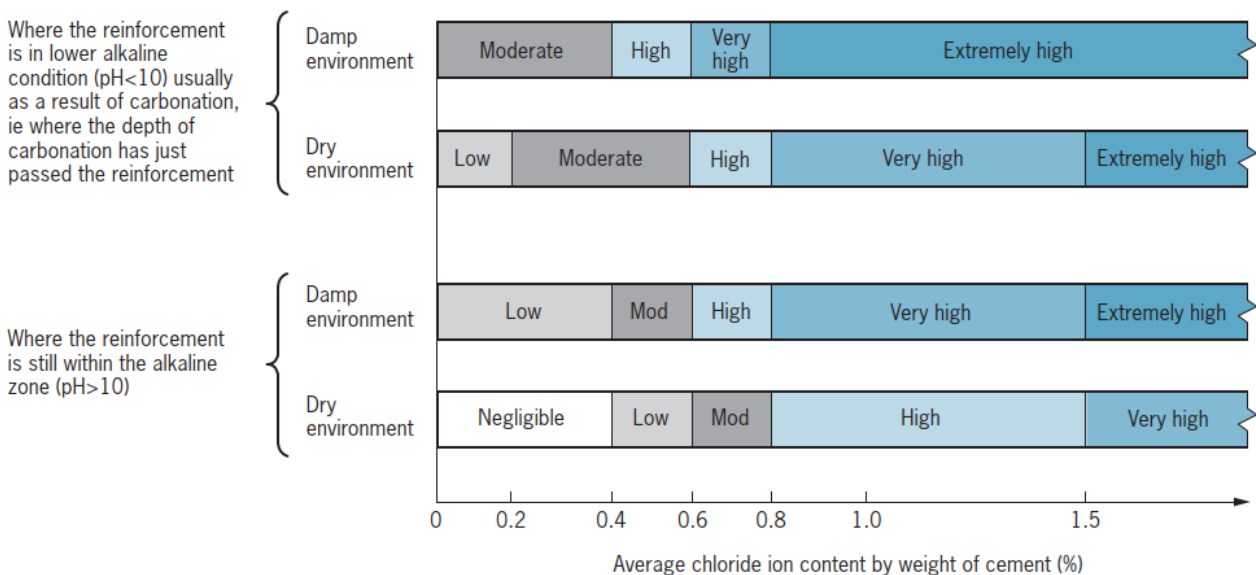
Figure 33 – Estimated risk of corrosion associated with carbonation, chloride content and environment.

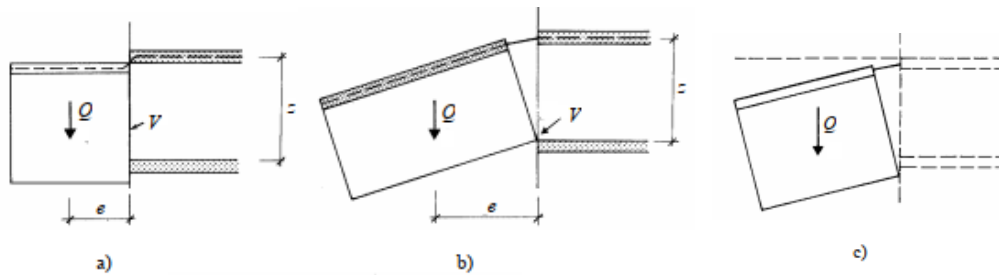
Figure 36 - Examples of collapse mechanisms for a cantilevering wall above a damaged area, a) joint slip mechanism, b) rotation mechanism, c) combined slip-rotation (fib, 2008)

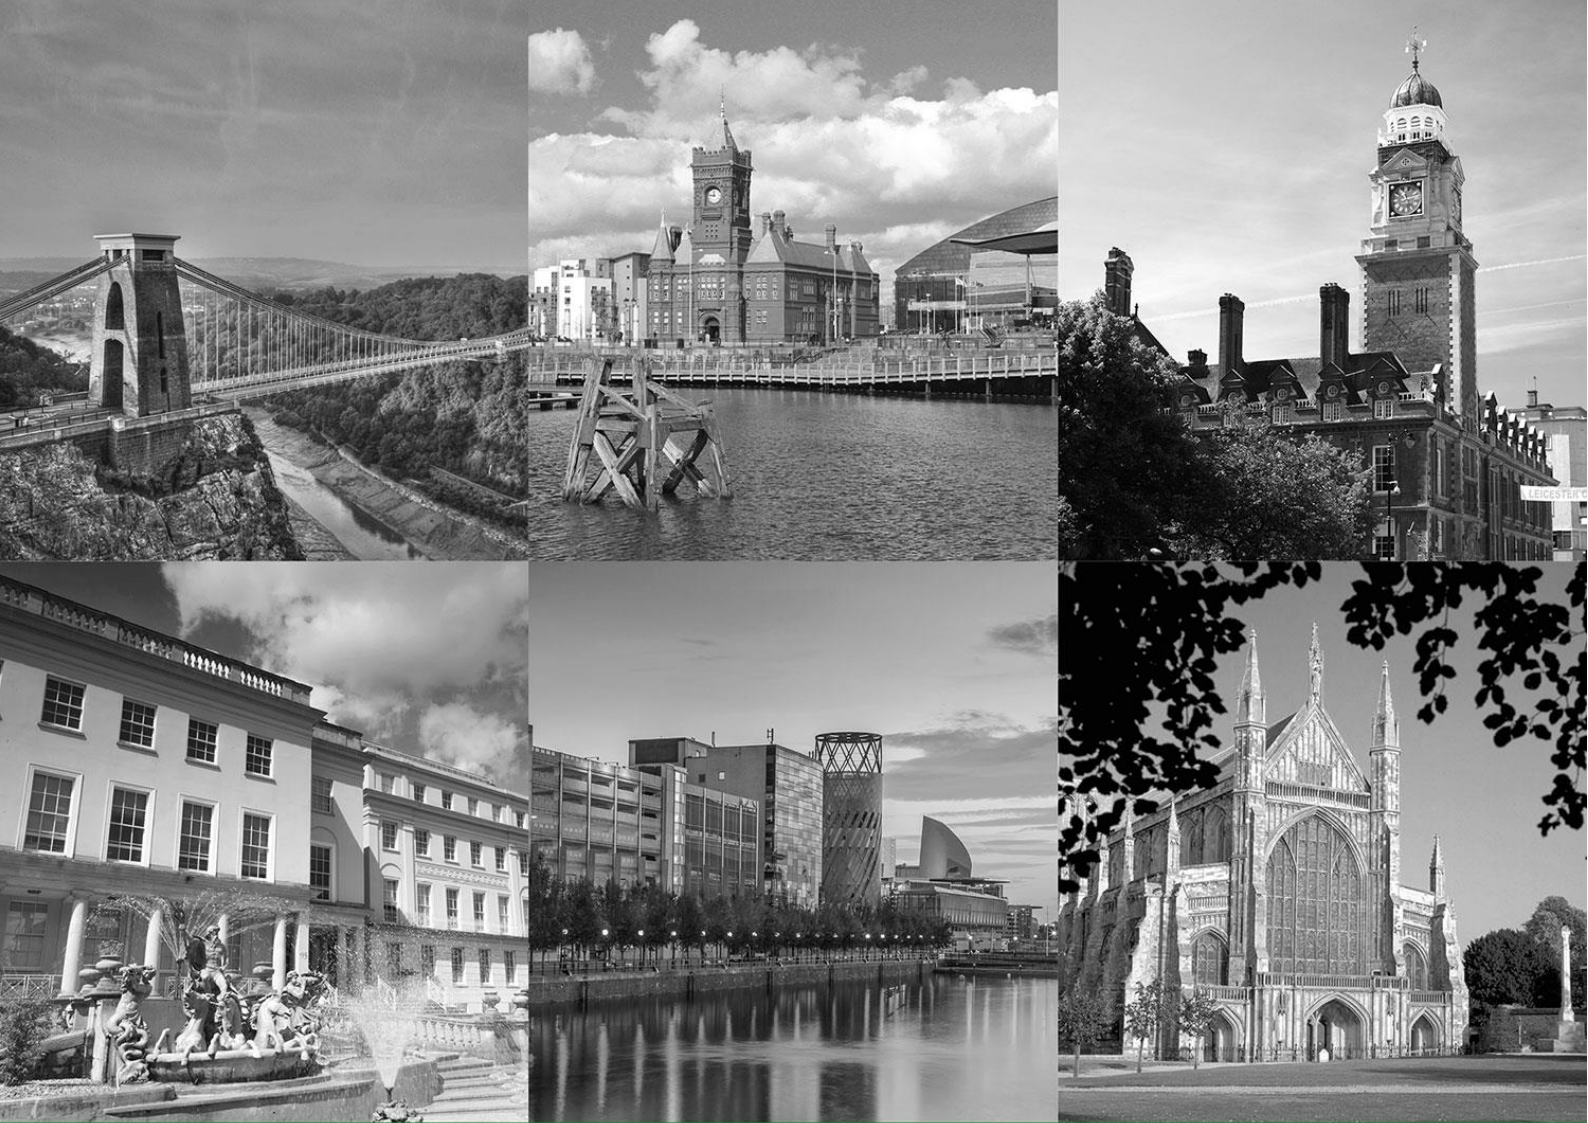
Should the risk reduction measures proposed not effectively limit the residual risk of disproportionate collapse to acceptable levels, and investment into strengthening works prove uneconomically viable, demolition of the block might be considered as a final long-term approach for the block. However, we would recommend that this decision should only be taken following the completion of a remedial strengthening design review, supported by the risk and cost benefit analyses recommended above to ensure that demolition is the best approach.
