**ST JUDES – HAVILAND HOUSE  
STRUCTURAL ROBUSTNESS ASSESSMENT**

**BRISTOL CITY COUNCIL**  
October 2024

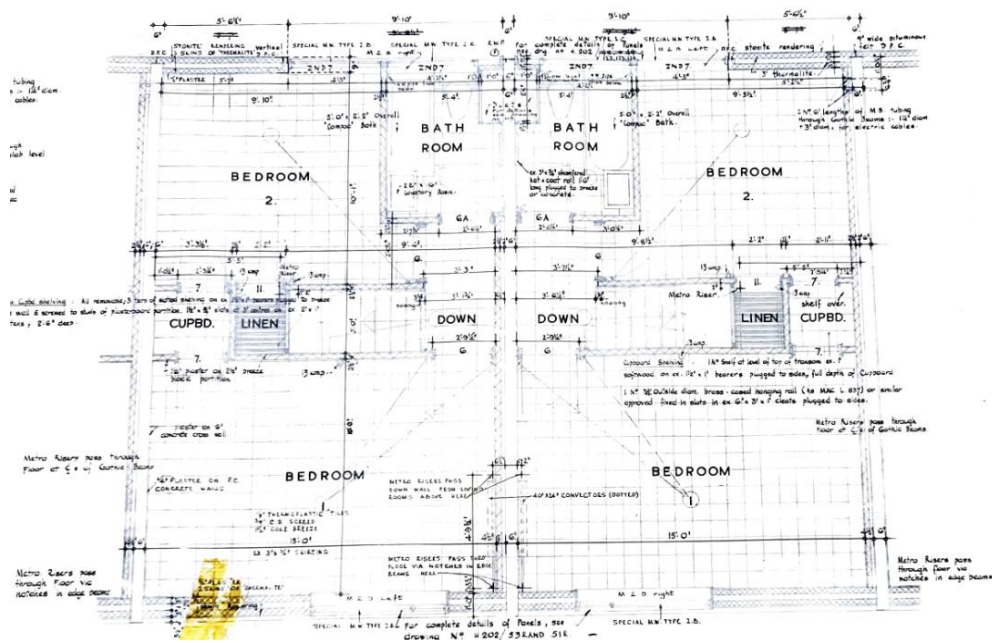
Figure 5 - Haviland House first floor record drawings

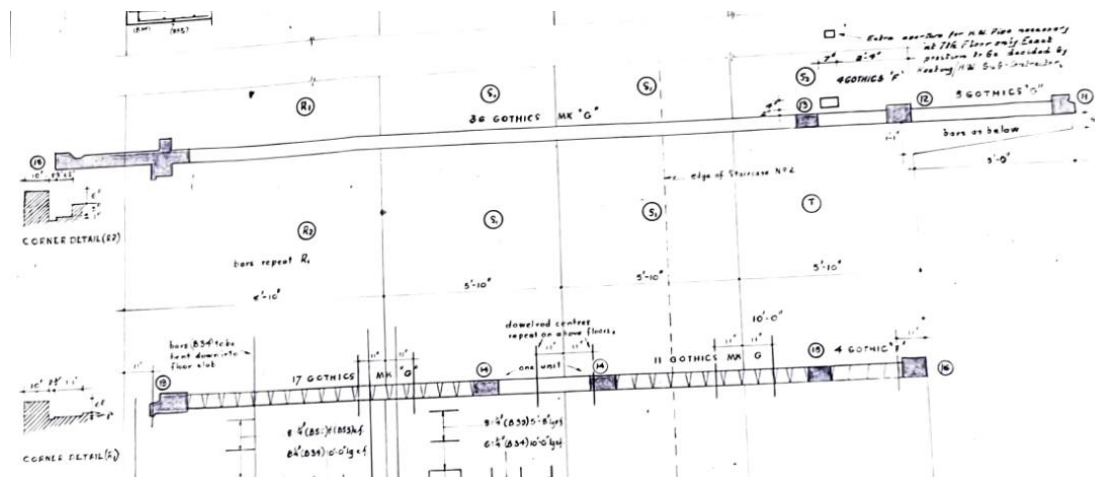
Figure 6 - Haviland House typical record drawings section.

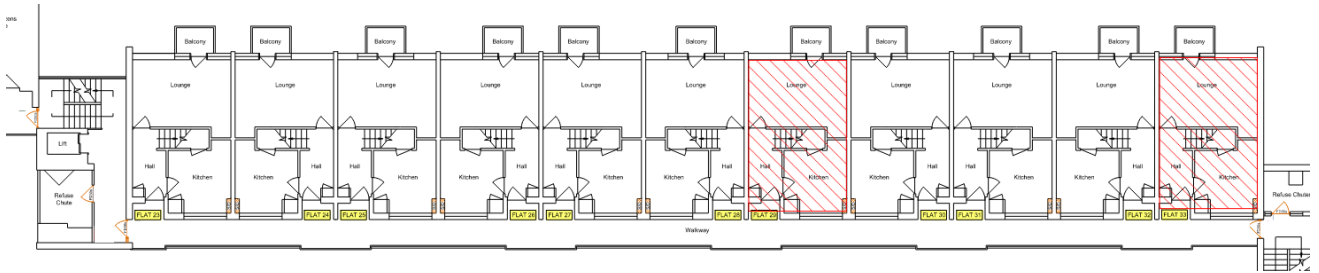
Figure 9 - 5th Floor Plan of Haviland House showing the flats inspected.

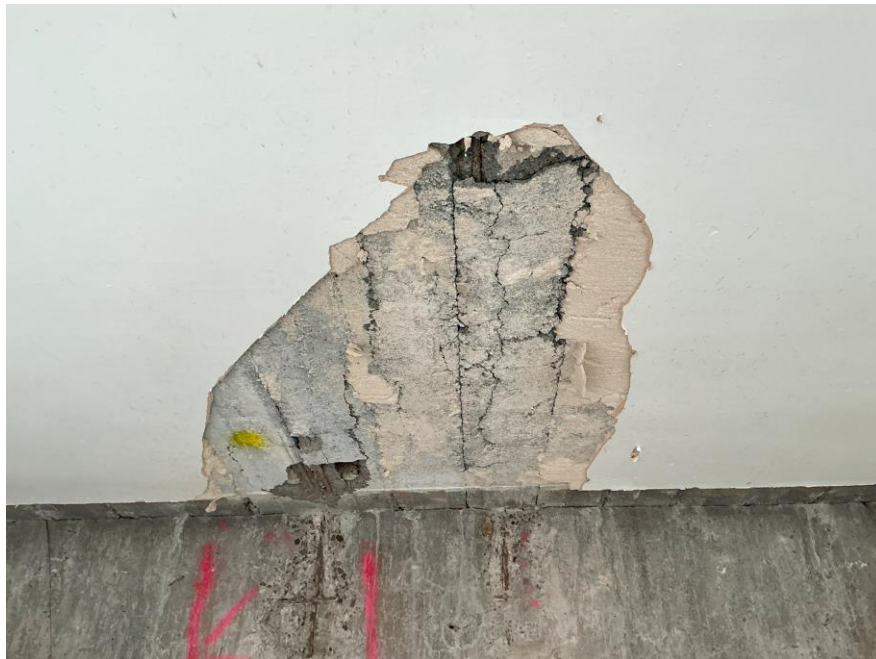
Figure 10 – Individual gothic beam floor found to be of poor quality with extensive concrete spalling.

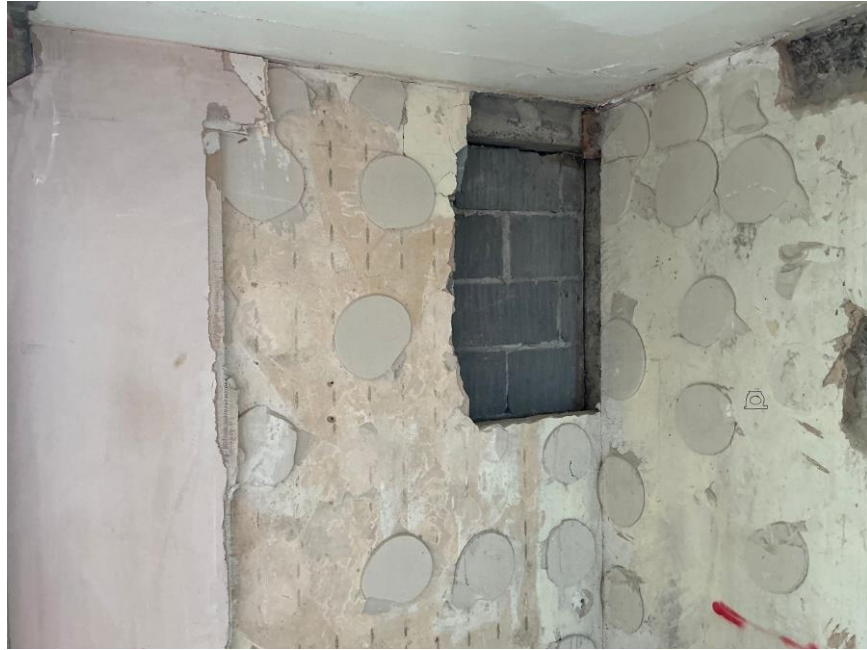
*Figure 11 - No wall ties installed between blockwork and cross walls.*

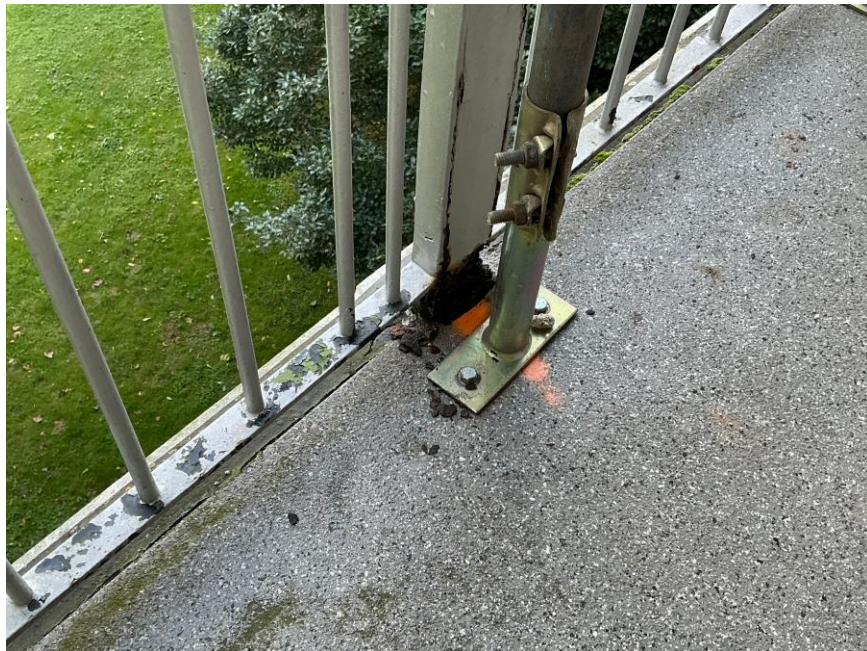
*Figure 12 - Corroded balustrade connection with temporary support installed.*

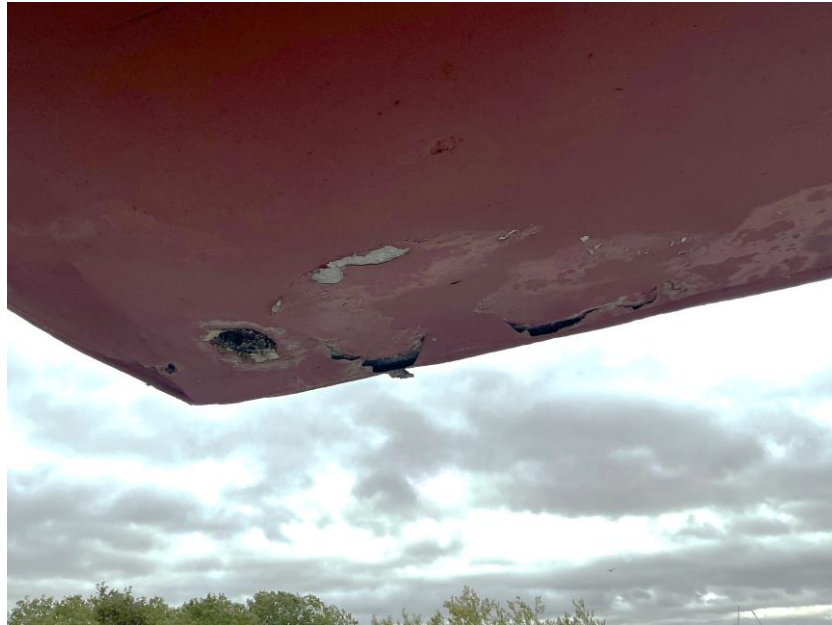
Figure 13 - Place Holder Images for balcony spalling reinforcement

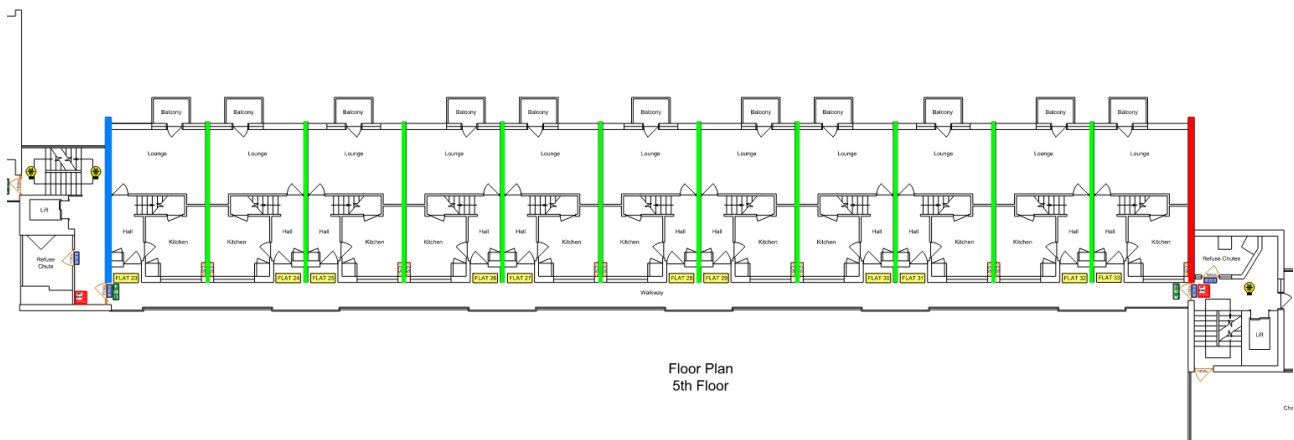
Figure 17 - Haviland House typical floor layout showing "key element" locations

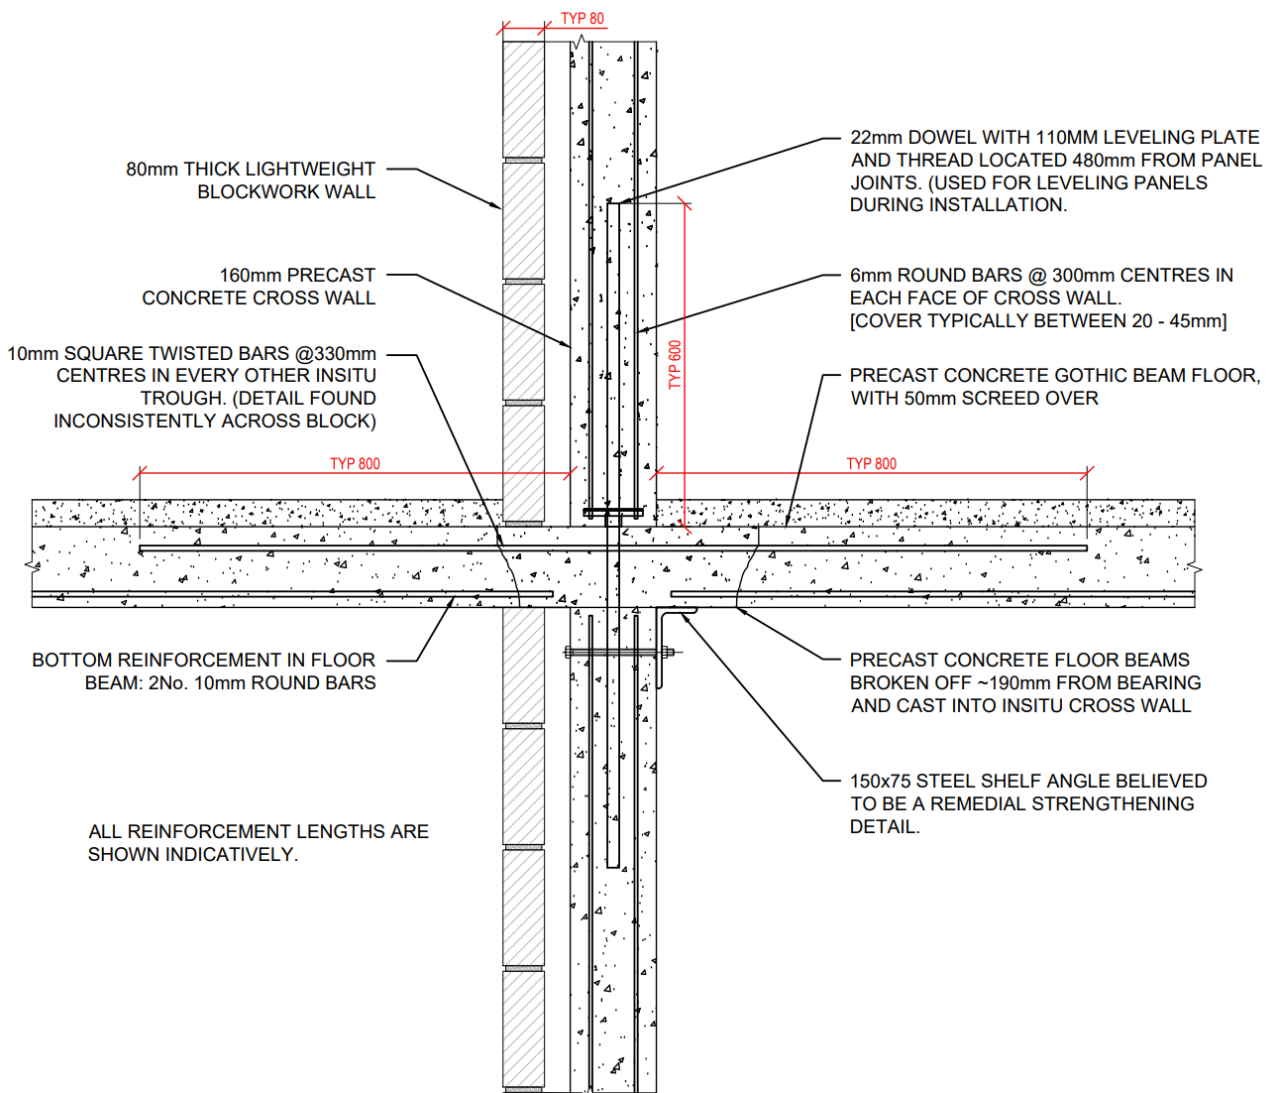
Figure 18 – Cross wall / floor slab joint

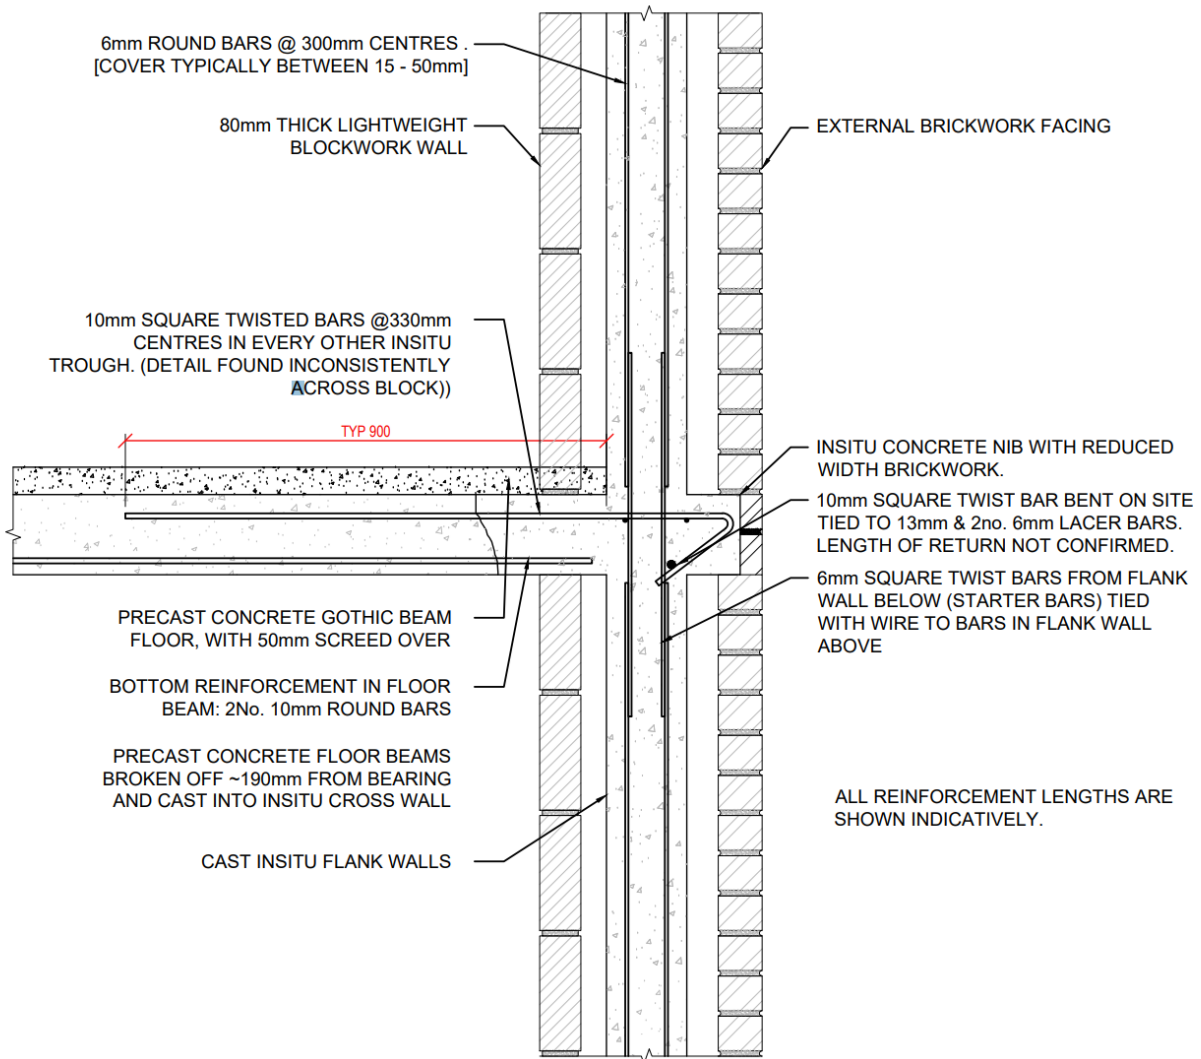
Figure 19 – Typical In-situ flank wall / floor slab joint

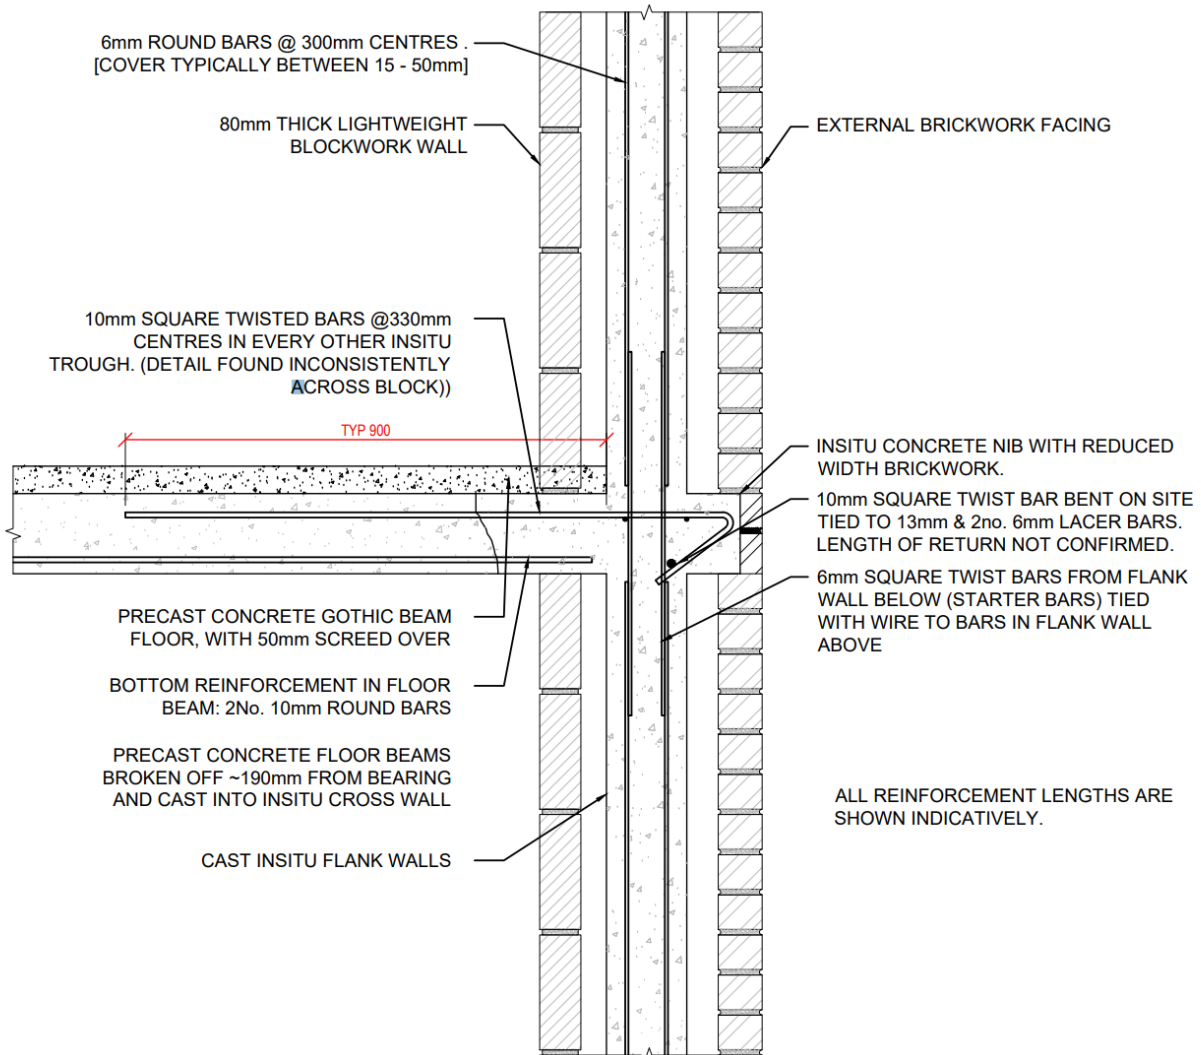
Figure 20 - Precast concrete flank wall/ floor slab joint

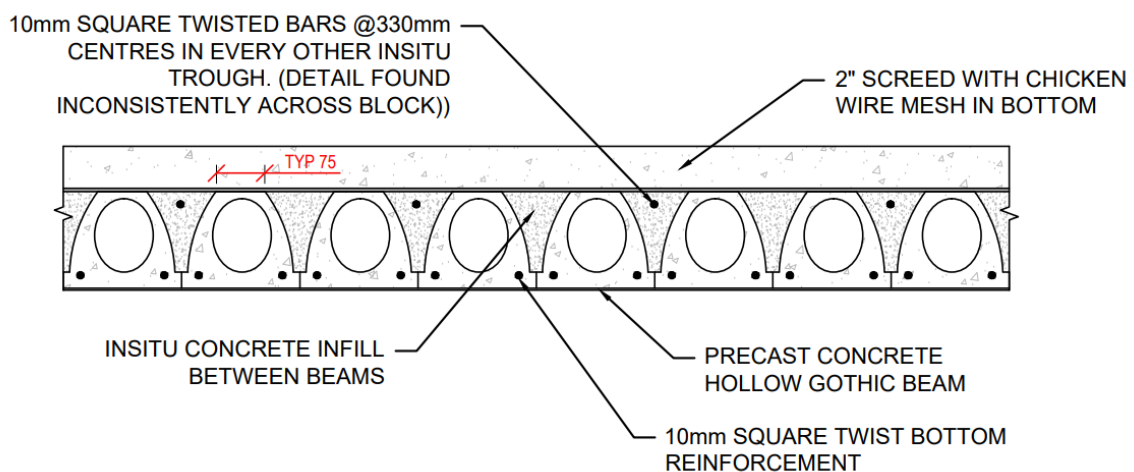
Figure 23 – Typical Gothic beam floor to wall joint construction detail.

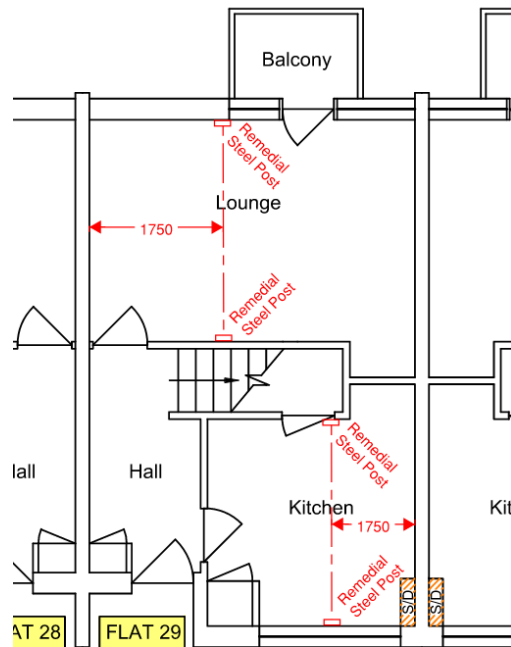
Figure 24 – Flat 29 floor plan showing location of strengthening beams and columns

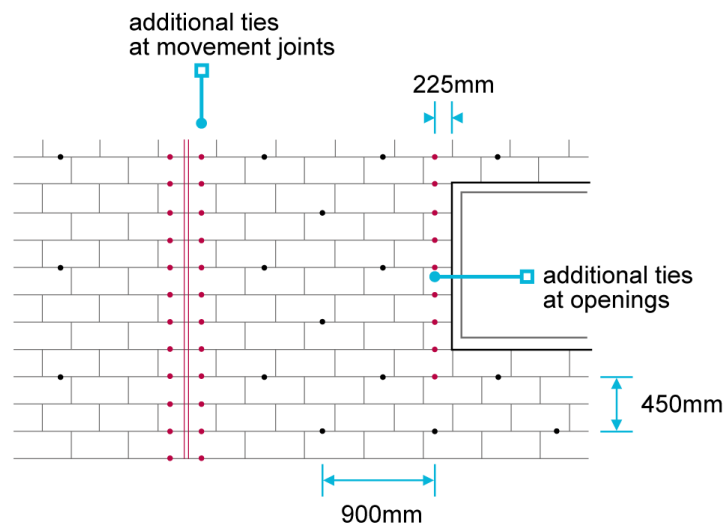
Figure 26 - Typical Wall tie detail (Ref NHBC Standard 6.1.18)

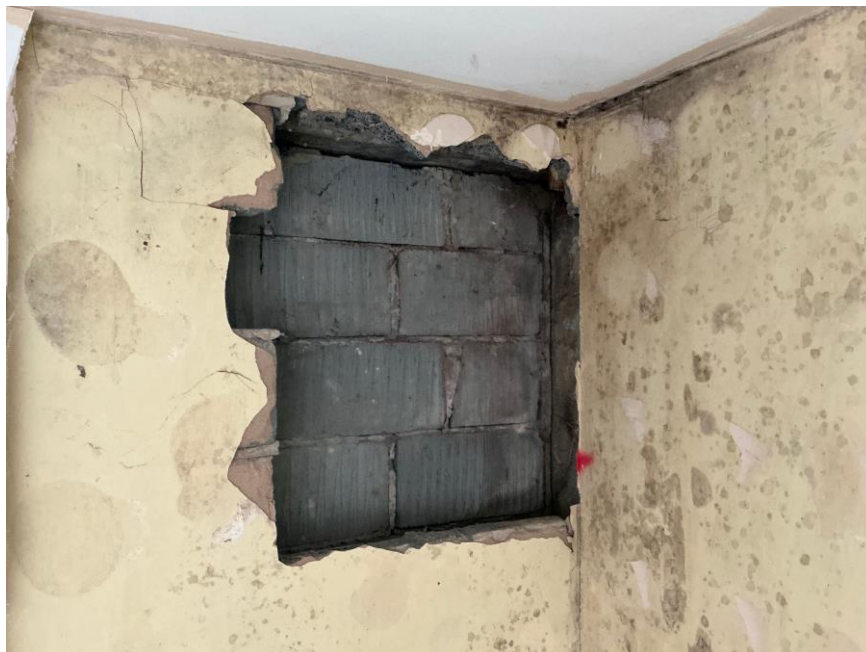
Figure 27 - Removed blockwork showing missing or unused wall ties

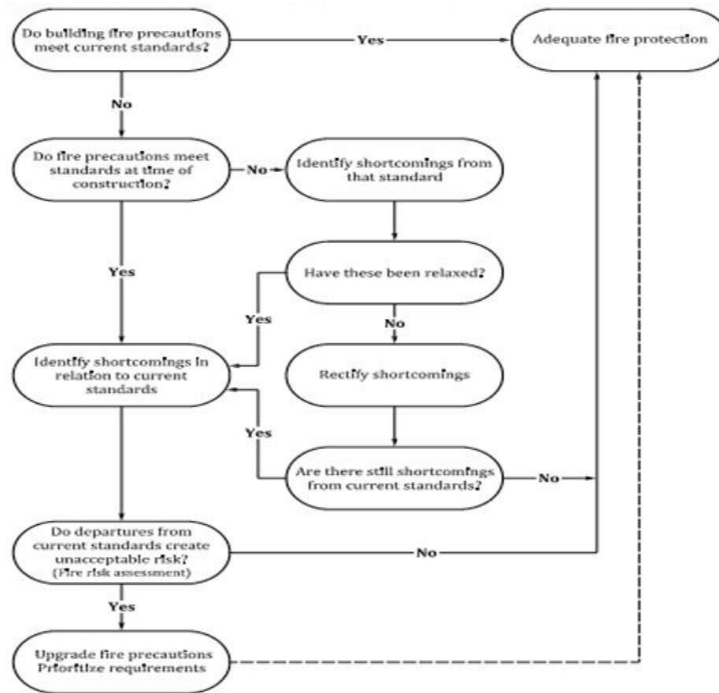
Figure 29 – Decision tree in relation to the requirement to upgrade fire precautions

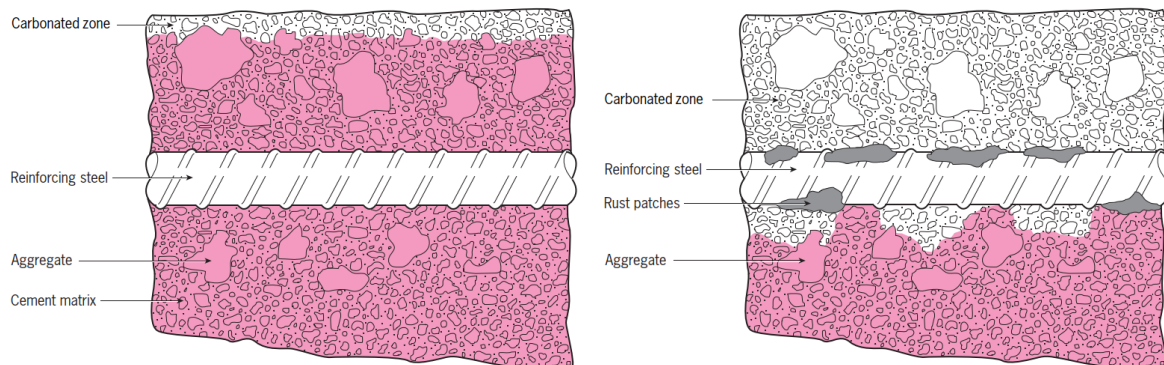
*Figure 30 – (Left) Diagrammatic view of steel protected from carbonation-induced corrosion in partially carbonated concrete, (Right) Diagrammatic view of steel corroding in carbonated concrete.*

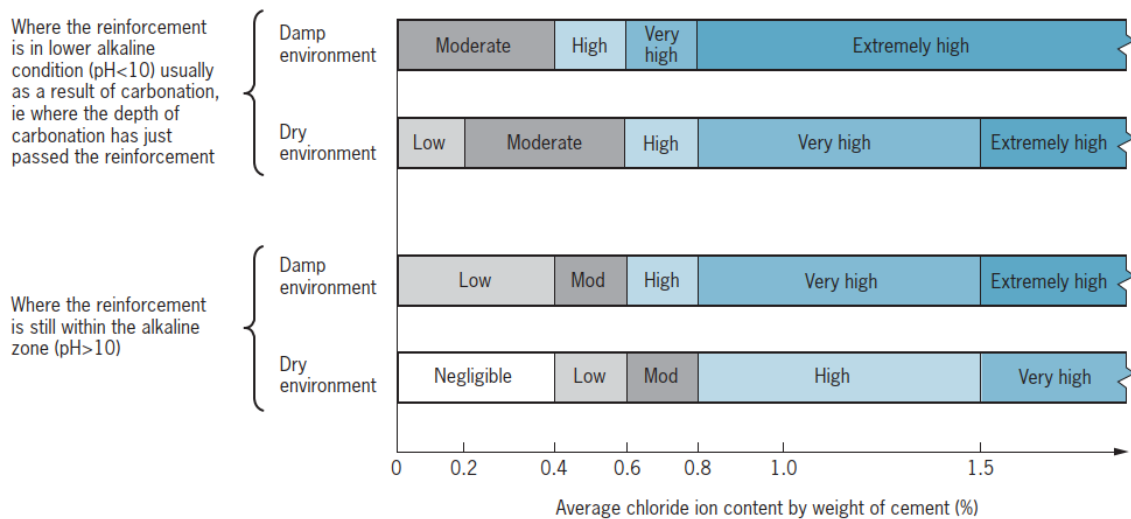
Figure 31 – Estimated risk of corrosion associated with carbonation, chloride content and environment.

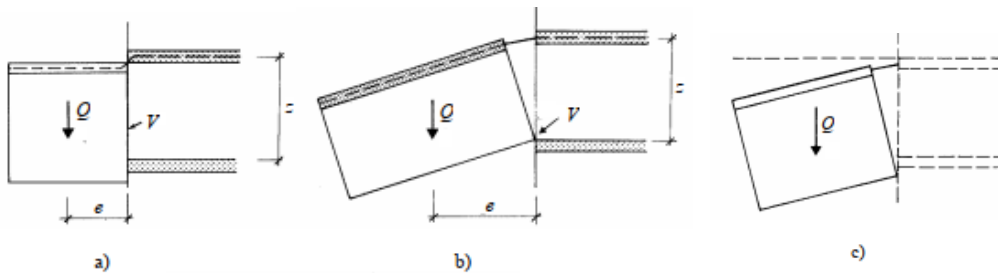
Figure 34 - Examples of collapse mechanisms for a cantilevering wall above a damaged area, a) joint slip mechanism, b) rotation mechanism, c) combined slip-rotation (fib, 2008)
