**ST JUDES – JOHN COZENS
STRUCTURAL ROBUSTNESS ASSESSMENT**

BRISTOL CITY COUNCIL
November 2024

ST JUDES- JOHN COZENS STRUCTURAL ROBUSTNESS ASSESSMENT

November 2024

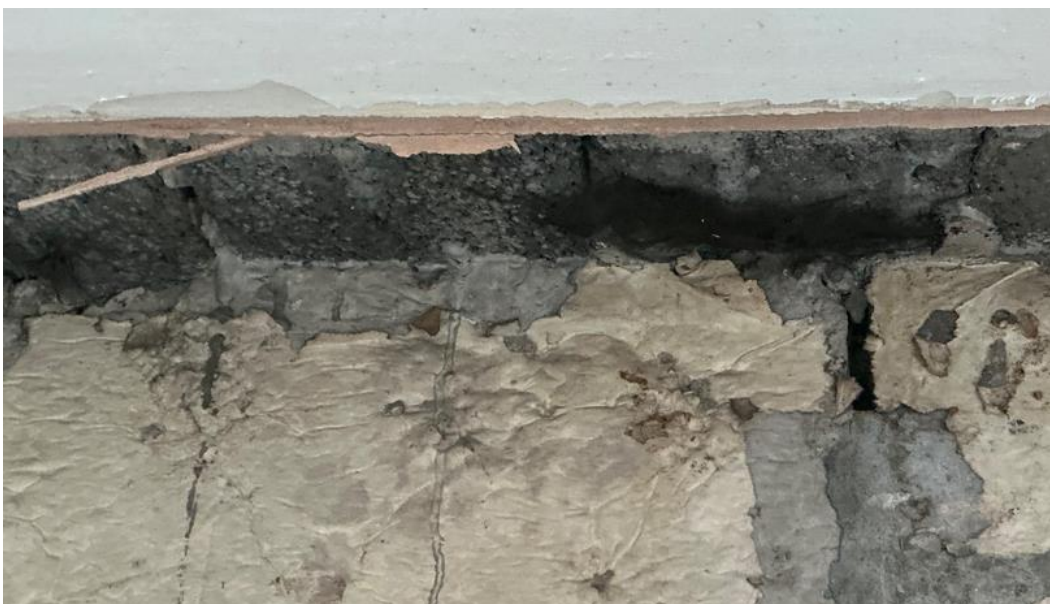
Figure 10 – Individual gothic beam floor found to be of poor quality with poor compaction widely noted.

- Poorly quality concrete to gothic beams in the soffit of multiple flats but most notably flat 18. Poor compaction can be seen by the void space in the beams.

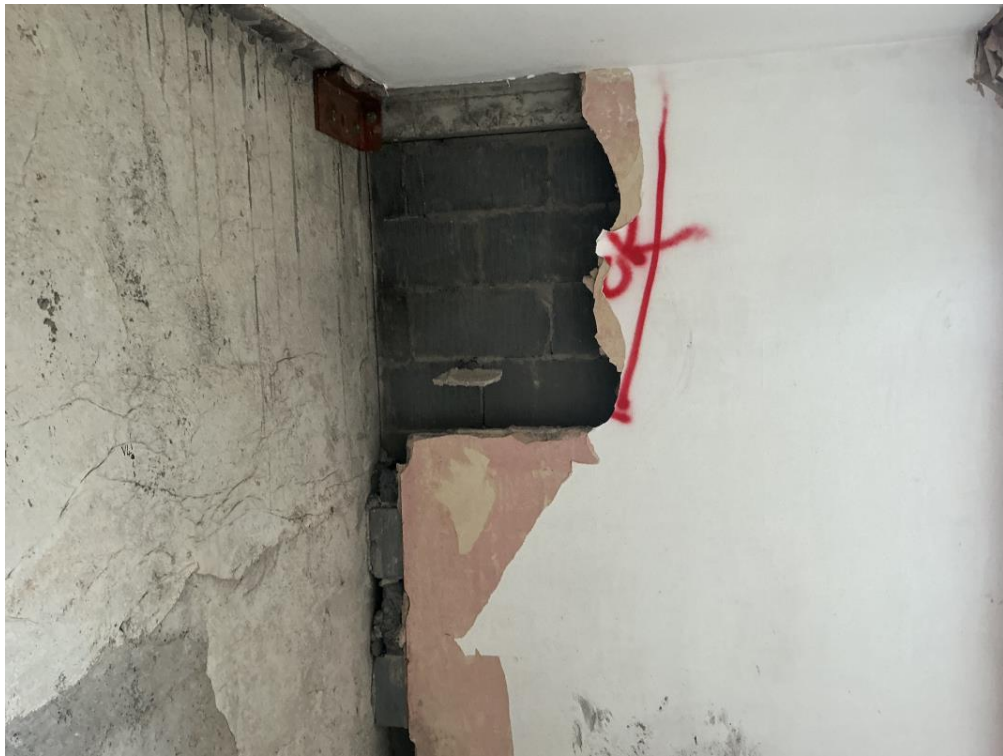
Figure 11 - No wall ties installed between blockwork and cross walls – Flat 18.

- Missing or unused masonry ties joining the masonry infill panels to the structural precast & insitu walls.

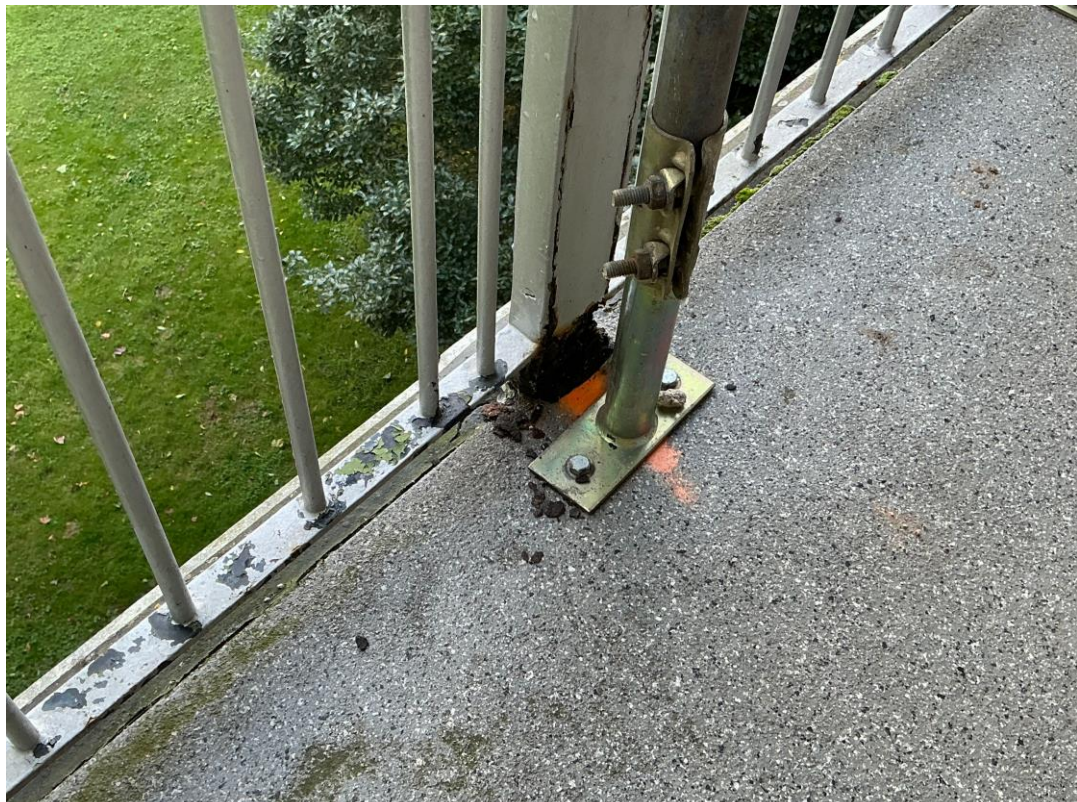
Figure 12 - Corroded balustrade connection with temporary support installed.

Balustrades Condition of metal balconies	Insufficient	Balustrades around the building, particularly along the shared access walkways, were noted to be severely corroded with several instances of temporary propping being used to support the balustrades. The condition of the balustrades requires replacement of the full system.
Balconies	Insufficient	The visual condition of the concrete balconies, combined with carbonation results indicate that carbonation level is high increasing the risk of spalling. The increased risk category of the nursery below should be considered as part of any following risk workshops.

- Heavily deteriorated handrails with extensive oxidisation and corrosion at the connection to the shared balconies and walkways in many areas. It is evident temporary support has been installed prior to our commission to reduce the risk of failure of the balustrade.

5. Full condition survey of the balustrades around John Cozens, temporary support provided to those in a critical condition with a design and programme developed to replace all the balustrades.

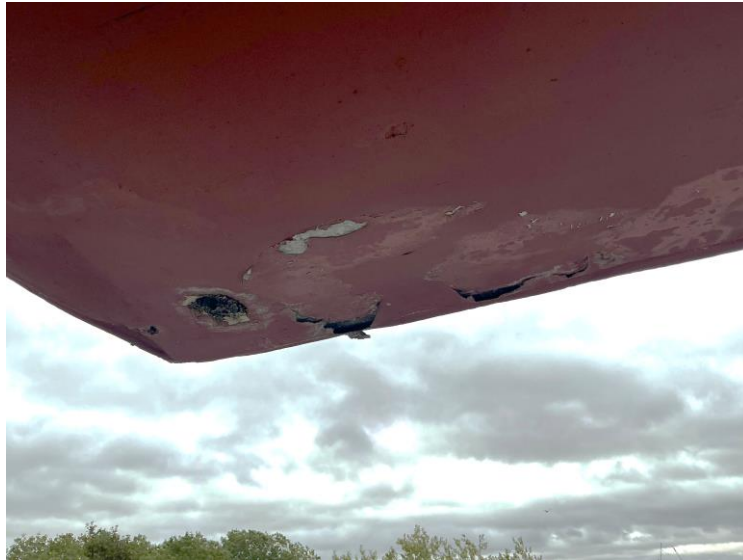
Figure 13 – Poor condition to underside of balcony

- Spalling reinforcement on the individual flat balconies was noted in several locations.

6. Detailed condition surveys of the balconies and walkways due to carbonation of the concrete to identify deteriorated and degraded areas or the structure to enable repairs as necessary.

4. Repairs and or replacement of the residential balconies due to deterioration from carbonation.
5. Remedial repairs to the escape walkways following detailed surveys.

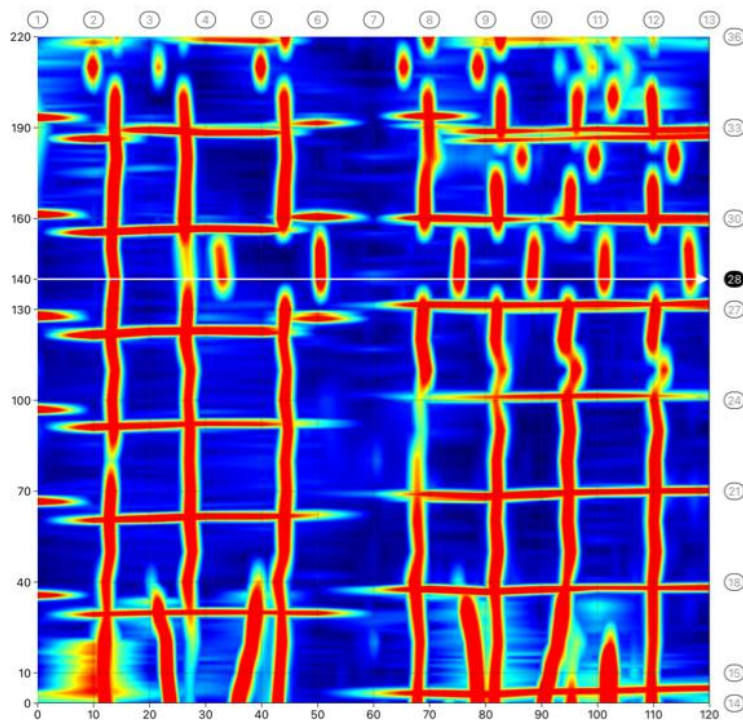
Figure 14 – Sample of GPR Scan results for a precast cross wall in John Cozens

- Precast concrete cross walls:
Cross walls were shown through GPR scans to have 2 layers of reinforcement at 300mm c/c. The GPR scans also indicated that reinforcement was not continuous or linked across panel joints.

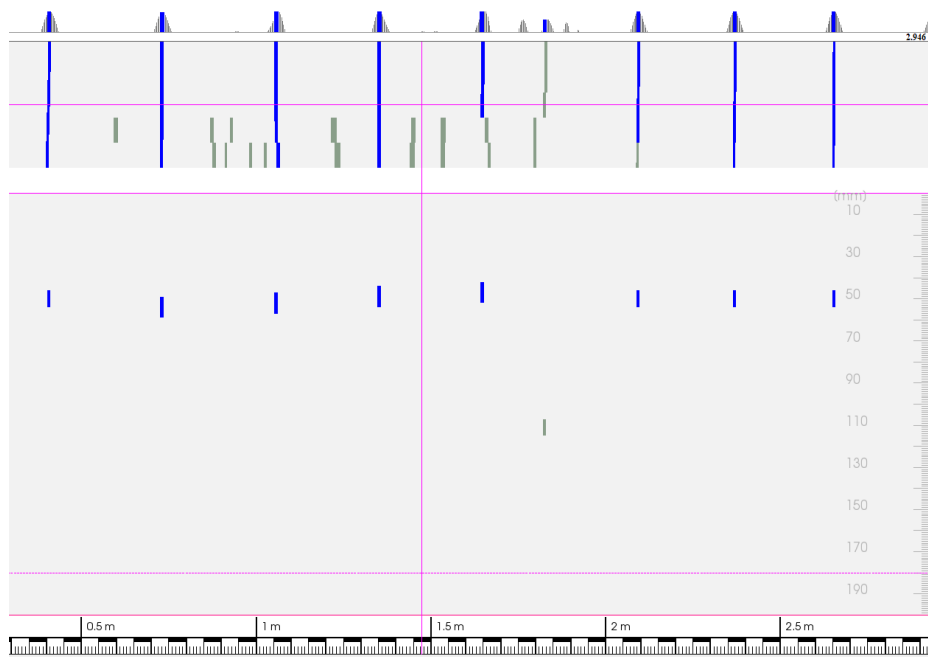
Figure 15 – Sample Ferro scan results of precast cross wall

- Through Ferro scanning the diameter of the reinforcement was indicated to be 6mm with the spacing confirmed as 300mm c/c.

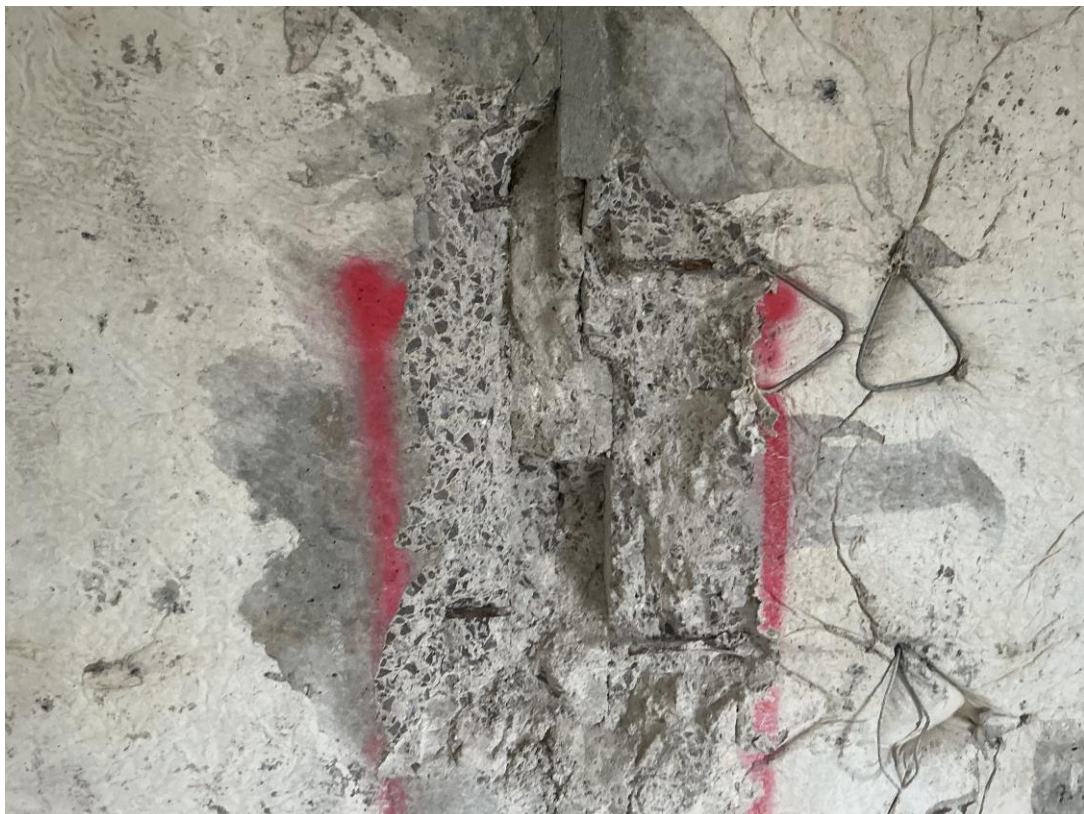
- Intrusive investigations proved the diameter and spacing indicated on the two scans completed prior. Investigation at the panel joints also shows no reinforcement between panels highlighted by the GPR scan.

Figure 16 – John Cozens precast panel joint and exposed reinforcement with blockwork ties left in position from casting and not pulled out for use.

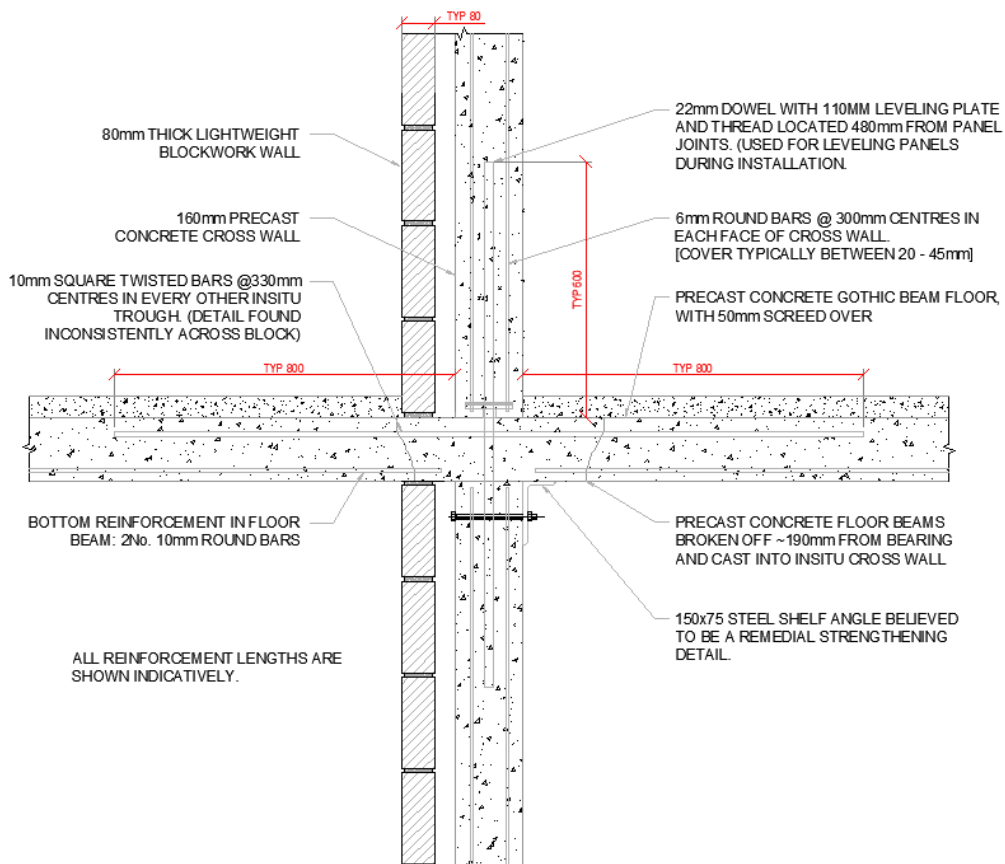
Figure 19 – Cross wall / floor slab joint

The tops of the floor beams were noted to have been broken off at their ends and had been incorporated into casting of the walls, likely to ensure a degree of homogeneity and to allow ties to be created between the elements.

The reinforcement within the wall panels does not appear to be continuous from panel to the next, being a precast concrete panel system, vertical ties should have been provided between the two precast panels in the form of cast in situ dowel bars. Vertical ties were not observed during the investigations suggesting no vertical tie is provided. A 22mm diameter dowel extending 600mm, is located in the centre of each panel 19" from the panel joints with a 110mm diameter levelling plate to help locate the panels during installation. The levelling plate has a thread on the bottom allowing for vertical adjustment of the panels. The levelling plate and dowel appear to have been left un-grouted and as such does not provide any vertical continuity between the two panels.

Record drawings suggest that horizontal ties should have been provided in every trough between the gothic beams, the horizontal ties found were found to be inconsistently installed across the block. In the locations where the spacing exceeds 600mm c/c the assumption for this assessment is that the tie is insufficient to resist disproportionate collapse.

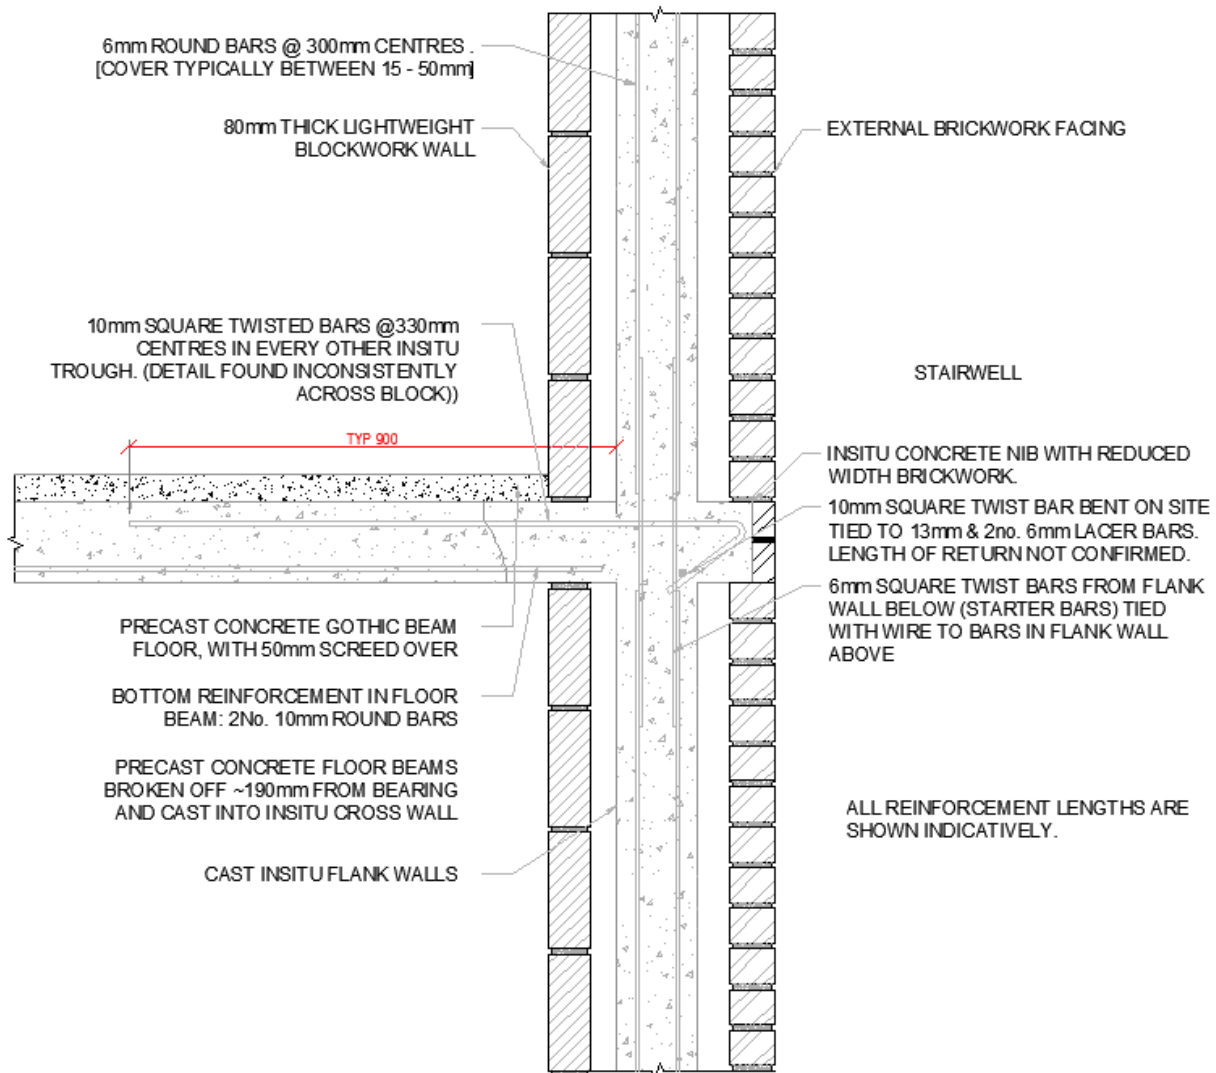
Figure 20 – Typical In-situ flank wall to floor slab joint

The investigations into the flank walls show that one flank wall is in-situ reinforced concrete and the other is precast as highlighted in Figures 18. The flank walls were found to blockwork inner leaf to the inside face of the flank wall, likely as a previous remedial action.

The investigation into the in-situ flank wall / floor slab joint suggested the existence of horizontal tie provision with 10mm square twisted bars provided in every other insitu trough being bent down into the wall panel. The bars were found on the back side of the wall and shown to tie to 2no. 6mm and 1no. 13mm longitudinal bar.

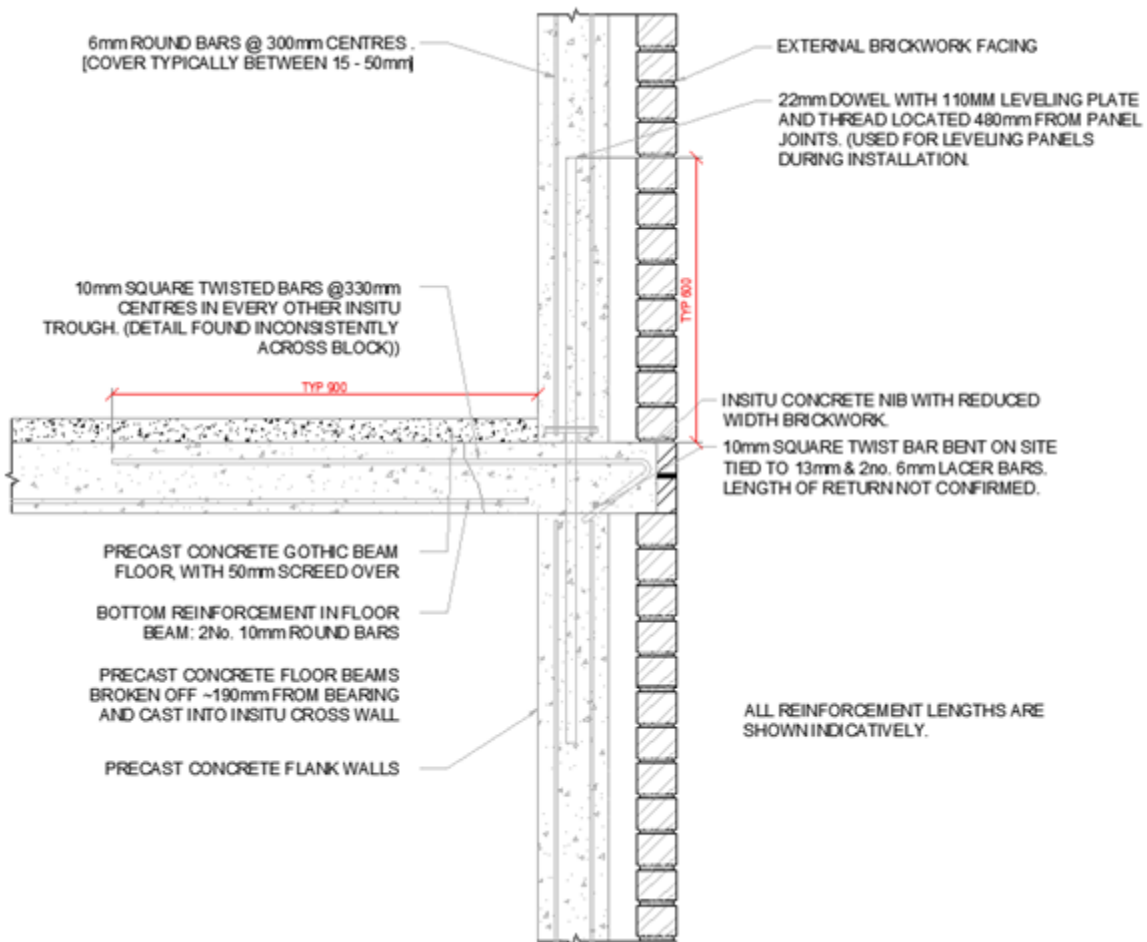
Figure 21 - Precast concrete flank wall/ floor slab joint

The investigation into the precast flank wall / floor slab joint suggested the existence of horizontal tie provision with 10mm square twisted bars are provided at varying centres and it was found that these bars bend down and return into the insitu stich between precast panels, linking around wall reinforcement and an additional 13mm lacer bar to provide an effective tie.

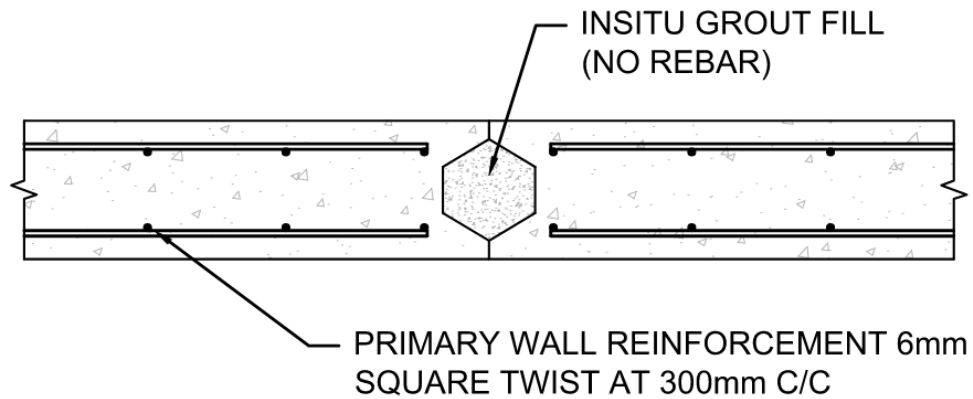
Figure 23 - Joint detail between cross wall panels as identified on site and in record drawings.

The existing John Cozens drawings indicate that no reinforcement was intended for the panel joints with only an insitu stich between panels. This detail was identified on site, with a grouted pocket between panels and no overlapping reinforcement – as shown in Figure 22 below.

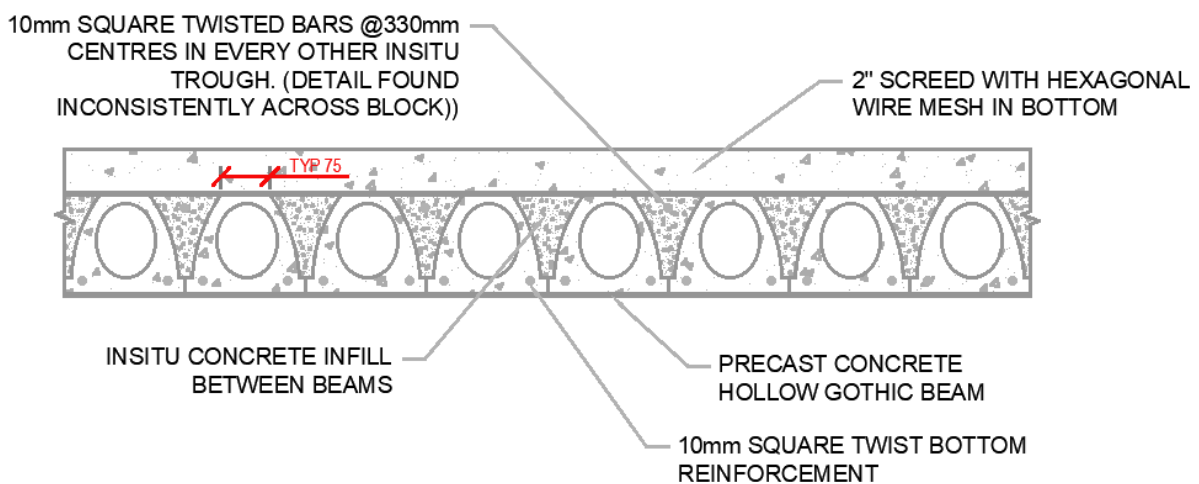
Figure 24 – Typical Gothic beam floor to wall joint construction detail.

In the four flats surveyed it was found that there was horizontal tie bars inserted into an average of every other grouted trough between the concrete beams at approximately 330mm c/c differing from the intent show on the existing drawing information. This was found to be inconsistent across the building with some areas having ties at in every trough, but others with ties missing for 5 troughs in a row. In the event of an internal gas explosion, it is likely that the tie bars would act sufficiently to resist disproportionate collapse, providing a tie force of 38.2kN/bar helping to resist a load of 20kN/bar based on a tie force requirement of 60kN/m. However, because of the inconsistency of installation found across the building, reliance on these tie bars cannot be made. Intrusive investigations revealed that in certain areas of John Cozens, no tie bars were located.

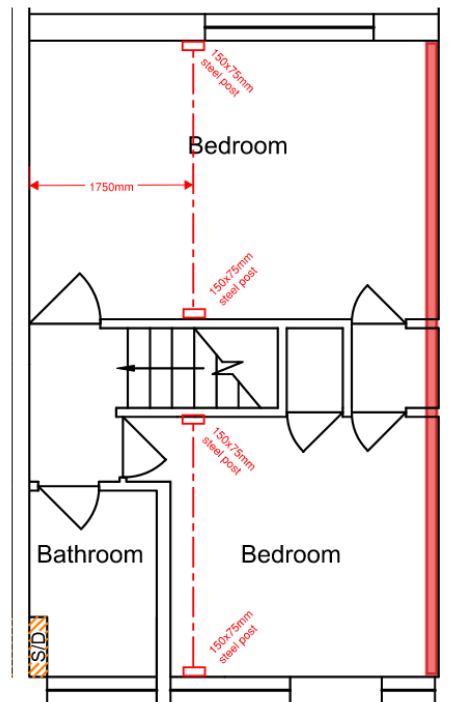
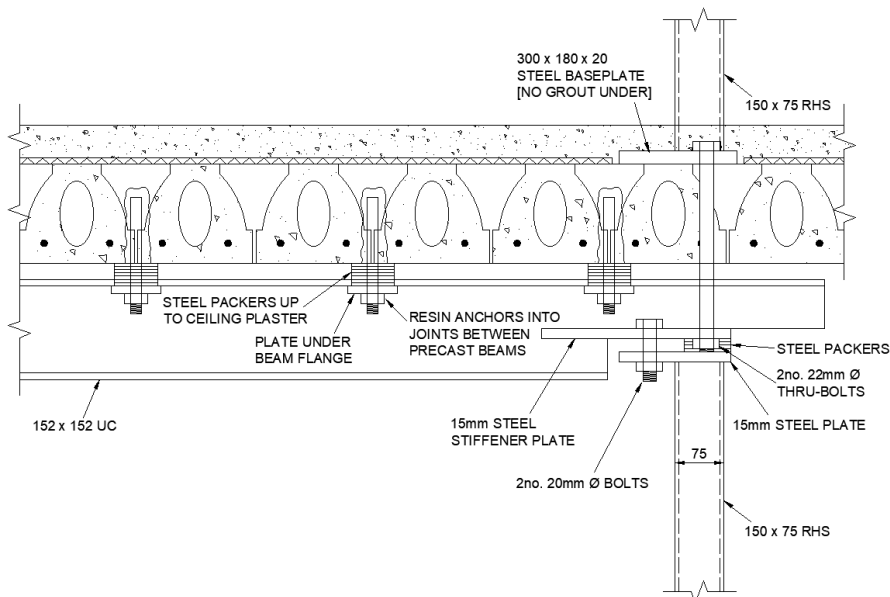
Following Ronan Point, John Cuzons had additional strengthening works completed with a combination of steel beams and columns to strengthen the floor slabs. Figure 25 shows the floor plan in flat 29 with the indicative locations of the strengthening works highlighted. It can be seen from the dimensions taken on site that the installed works have divided the span of the floor slab in half (approximately). Figure 25 and Figure 26 shows the details observed of the remedial strengthening works.

The remedial strengthening is fixed into the soffit of the existing slab at regular centres, these fixings help the slab when exposed to the overburden pressure in an uplift load case. Each beam has 16 fixing, 8 per side at 330mm c/c. Based on the total number of fixings, it was calculated that the fixings will need a capacity of circa 3.5kN. Additional pull load tests were completed on the fixings to confirm the capacity, the results are shown in section 5.6.

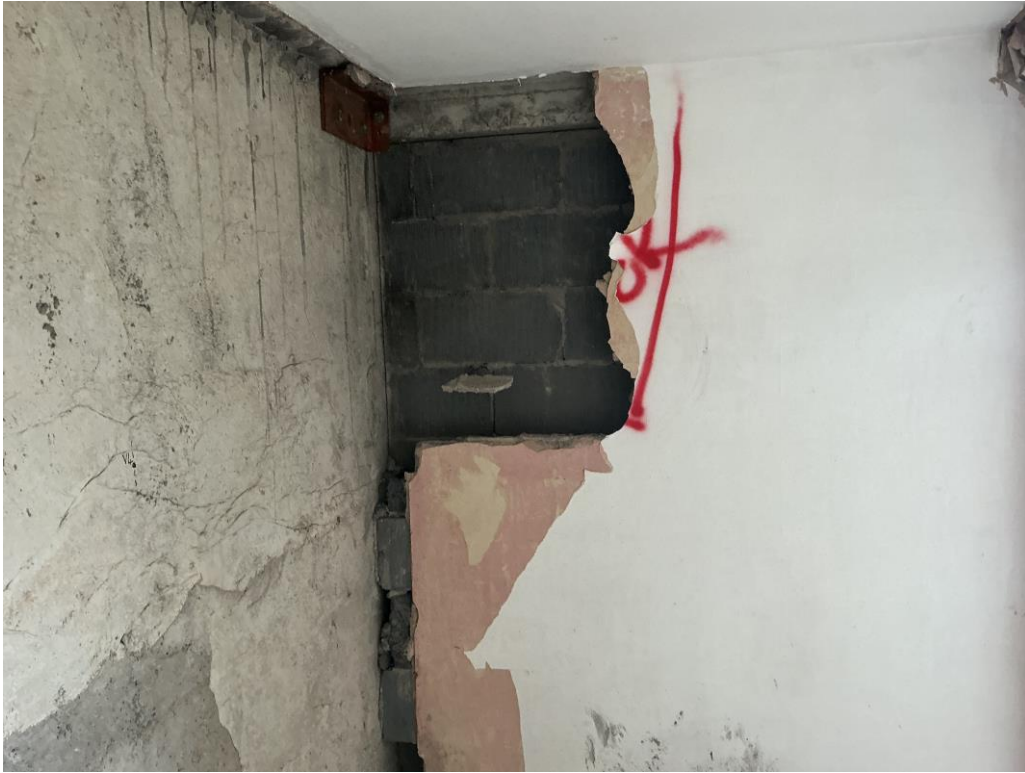
Figure 28 - Removed blockwork showing missing or unused wall tie

As indicated in Figure 27 wall ties across a cavity should generally be provided at 450mm vertical centres and 900mm horizontal centres, with additional ties provided around openings. In most instances one or two ties were found in the external wall panels and no additional wall ties were found around window and door openings. Additionally, there were limited ties between each masonry skin and the structural cross walls. It was noted that the cross walls had cast in wall ties, however most cases these had not been used when building the walls. The instructive investigations only allowed this to be reviewed in the inner skin of the cavity wall and therefore assessment of the outer skin cannot be made.

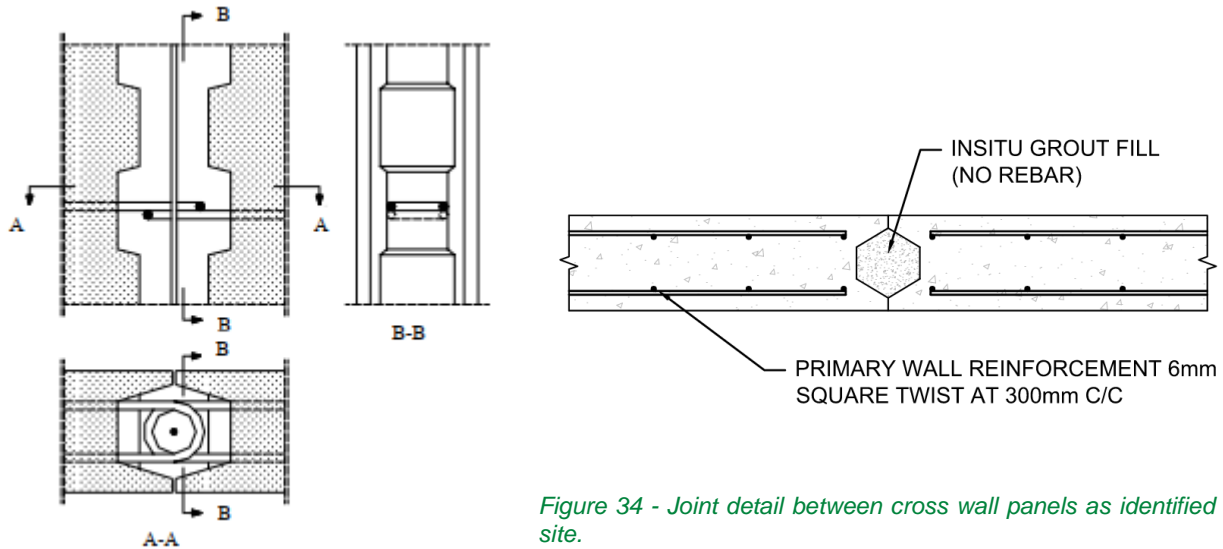
Figure 34 - Joint detail between cross wall panels as identified on site.

The vertical joints between abutting wall panels are in the form of a 'shear key' connection. It would be expected that this type of joint would contain reinforcement, similar to that shown in Figure 19 below, to prevent the joint from uncontrolled separation.
