**ST JUDES – LANGTON HOUSE  
STRUCTURAL ROBUSTNESS ASSESSMENT**

**BRISTOL CITY COUNCIL**  
January 2025

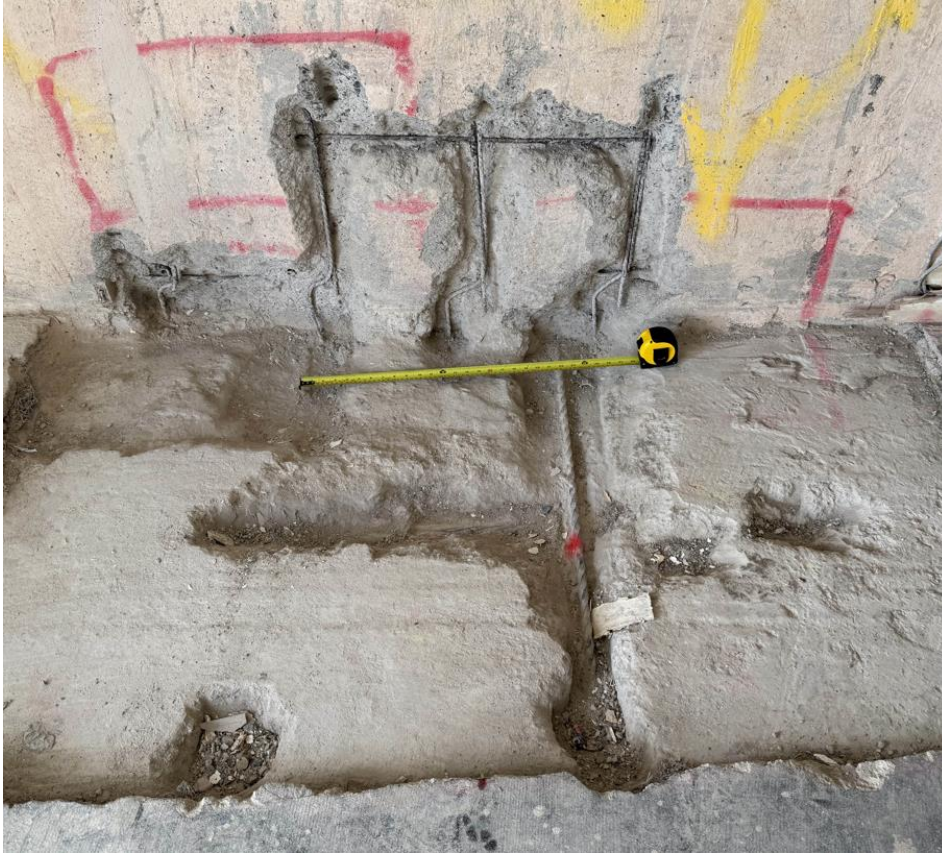
The block is a reinforced in-situ concrete panel construction with one way spanning concrete slabs supported on in-situ concrete cross walls. The wall panels had a 6mm reinforcement in both directions and the slab had 6mm bars in the bottom at 90mm c/c and 10mm bars in the top and across joints.

*Figure 8 - Floor to wall opening up works in Langton House*

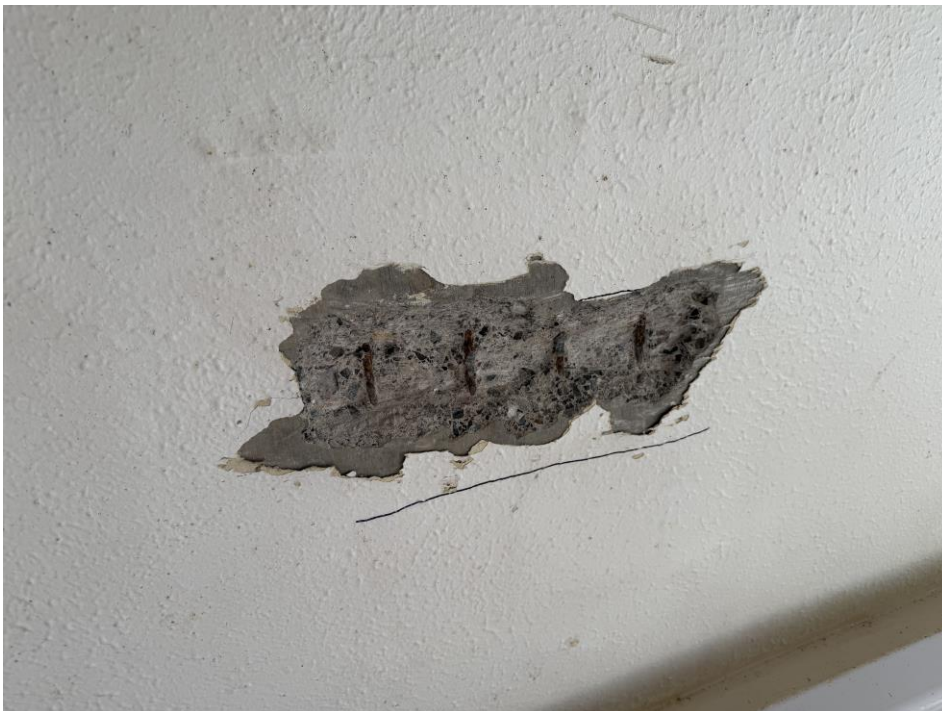
*Figure 9 - Exposure of soffit reinforcement in Langton House*

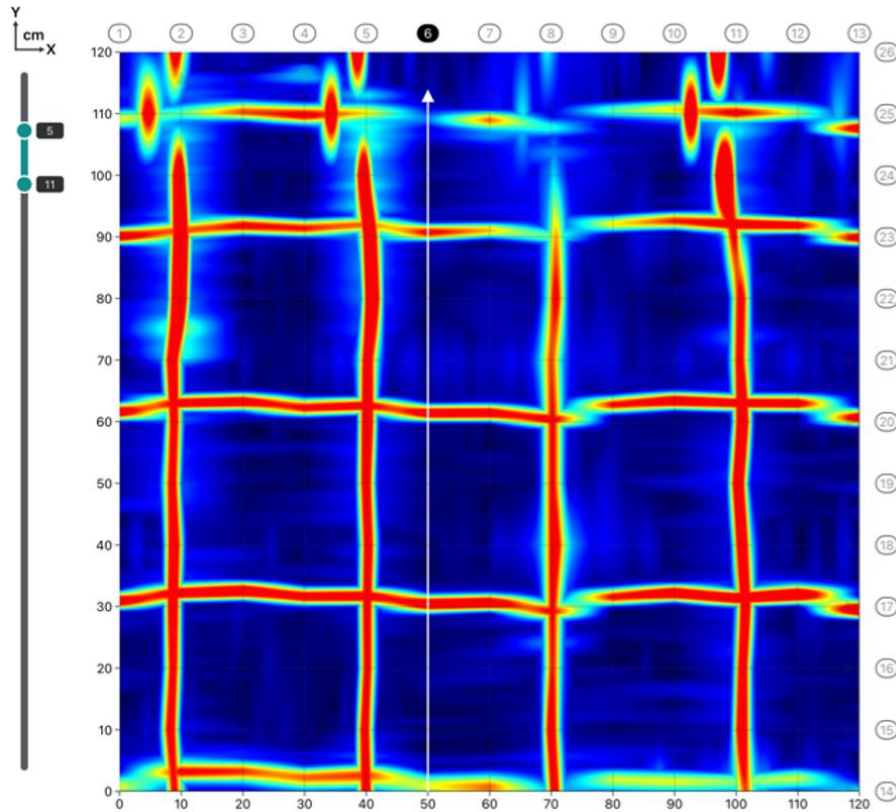
- Cross walls were shown through GPR scans to have 2 layers of reinforcement at 300mm c/c.

Figure 10 – Sample of GPR elevation scan results for a cross wall in Langton House

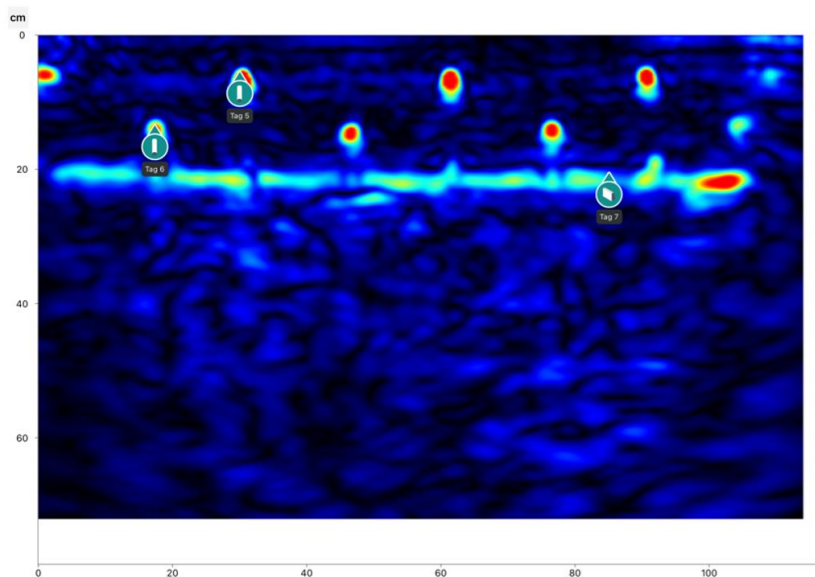
Figure 11 - Sample of GPR cross section scan results for a cross wall in Langton House

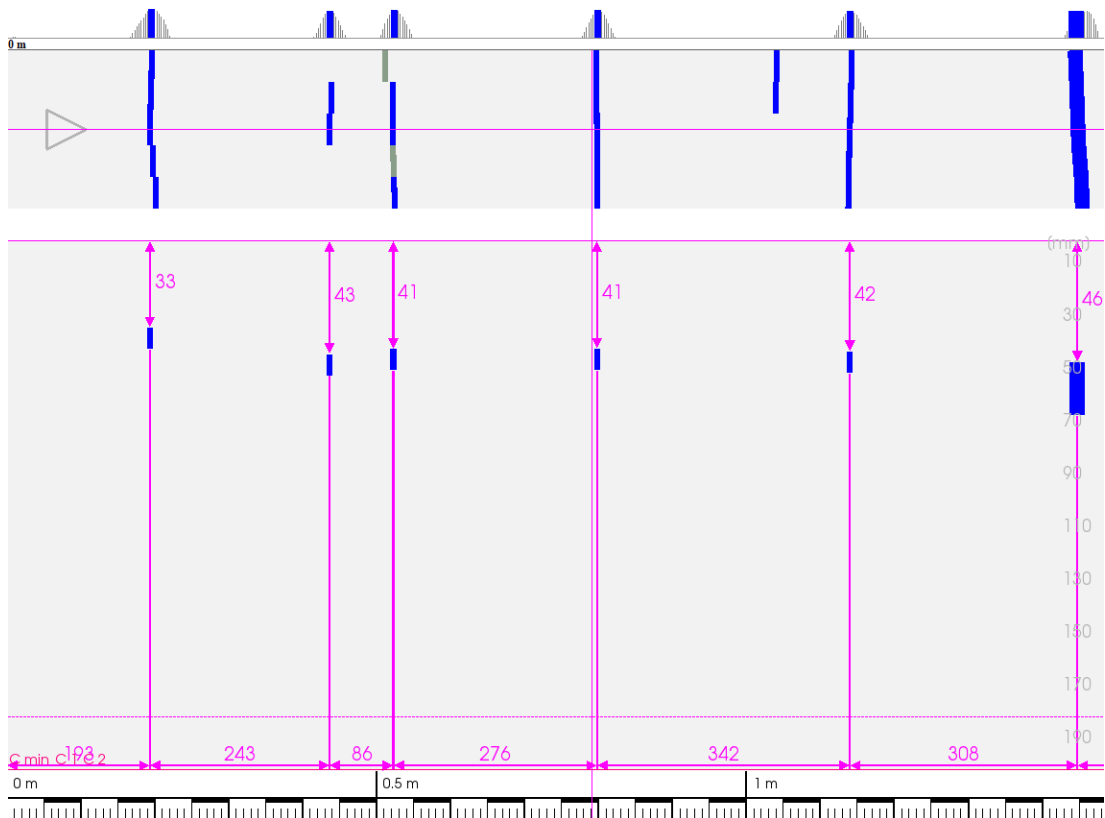
- Through Ferro scanning the diameter of the reinforcement was indicated to be 6mm with the spacing confirmed as 300mm c/c.

Figure 12 - Ferro scan of concrete cross wall showing reinforcement spacing and cover.

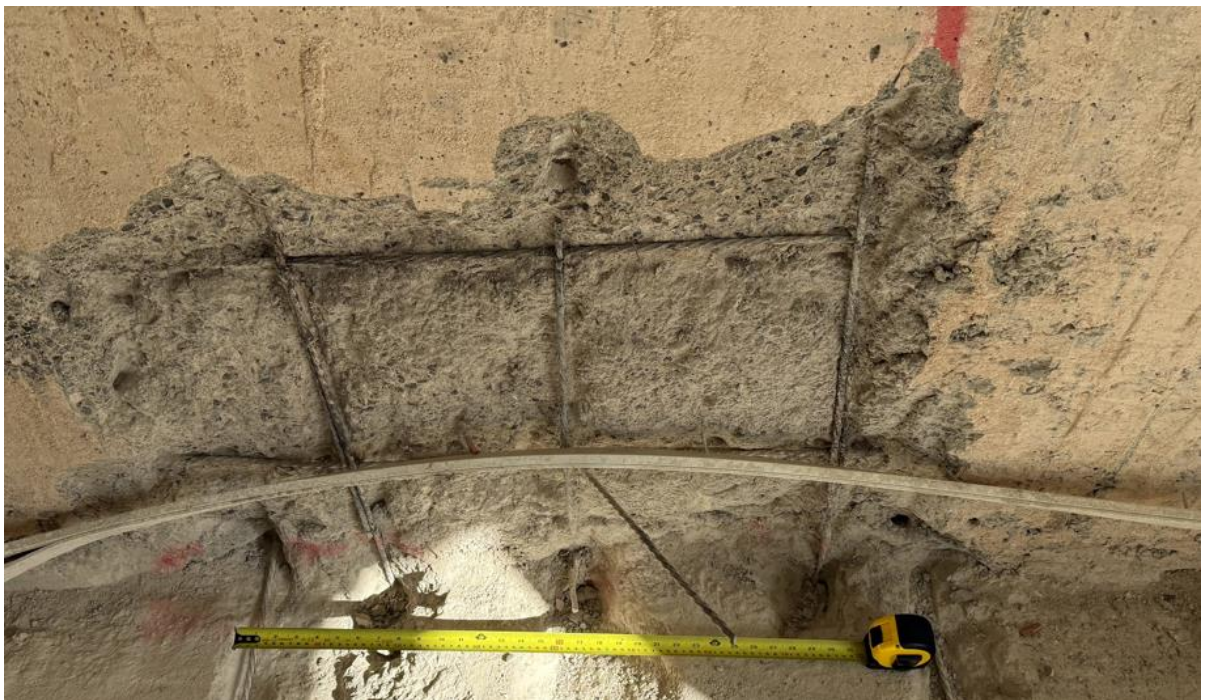
- Whilst the scanning of the reinforcement showed the spacing of the reinforcement to vary across the block from 250mm to 350mm, intrusive investigations showed the spacing to be between 300mm and 350mm with a bar diameter of 6mm. For analysis purposes an average of 300mm spacing has been used for the calculations.

Figure 13 – Langton House intrusive wall investigations

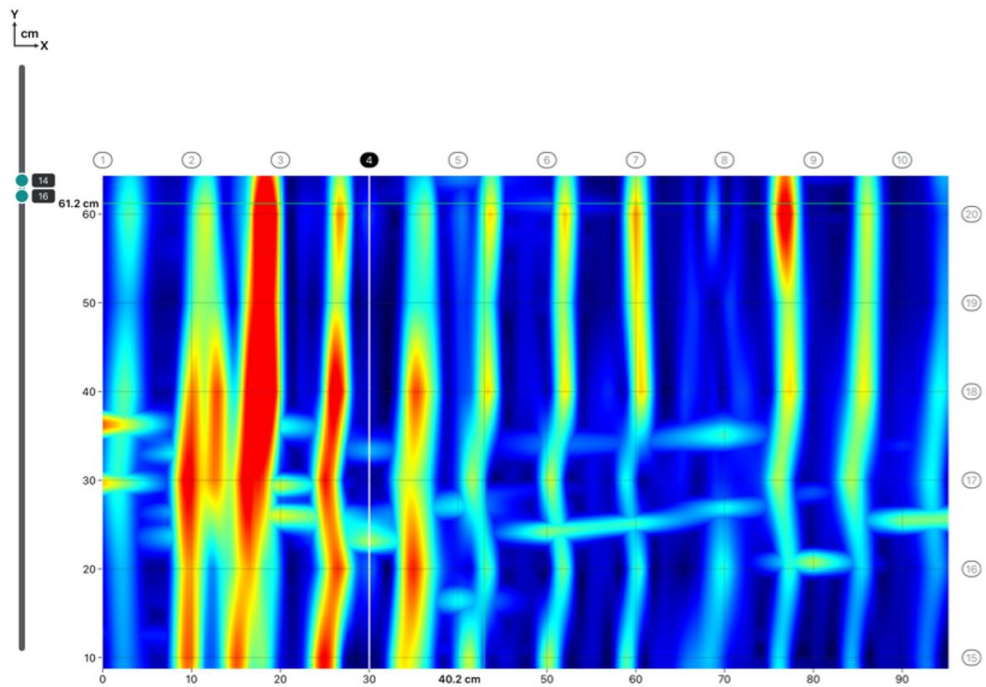
- GPR scans of the top and bottom of the slab shows 8mm reinforcement bars at 90mm c/c in the bottom and 12mm bars at 550mm c/c in the top. It was noted from verification of the scans that they often indicate larger bars than those installed. Therefore, from the scans it is assumed the bars in the bottom are 6mm and the bars in the top are 10mm.

Figure 14 - GPR scan of Langton House Soffit

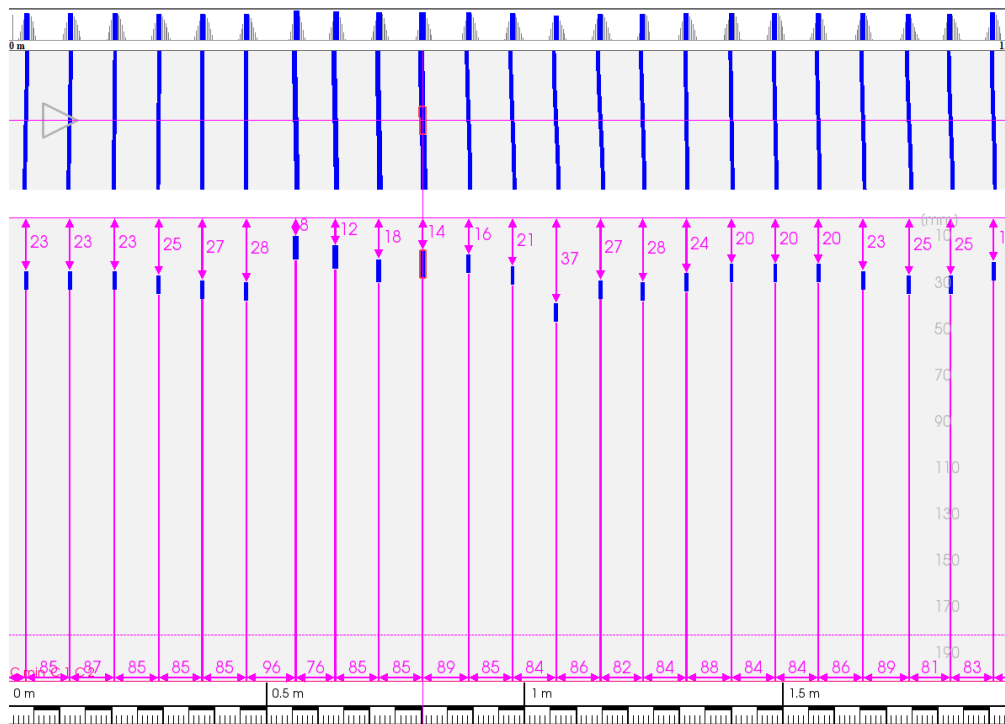
- The GPR scans correlate to the ferro scans completed and also give representation of the cover to the primary reinforcement.

Figure 15 - Ferro scan of Langton House soffit.

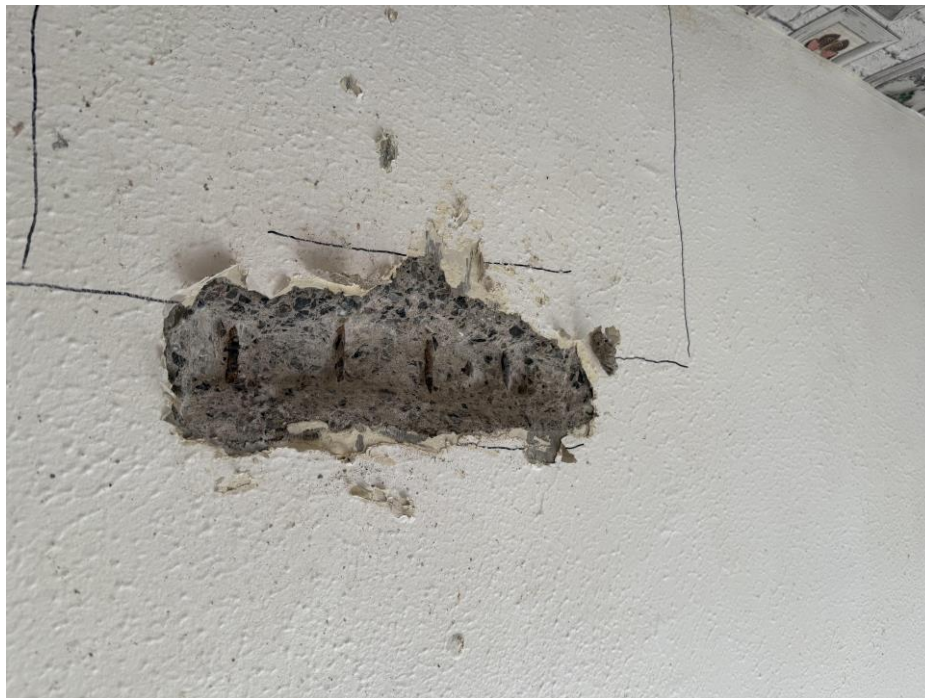
- The soffit of the flats in Langton House were partially broken out to reveal the cover, spacing and size of the primary reinforcement. Site measurements indicated the diameter was 6mm bars with the spacing recorded as 90mm – 100mm. With more data recovered from the GPR and Ferro scans the spacing of the reinforcement has been taken as 90mm.

Figure 16 - Site photo of soffit break-out in Langton House

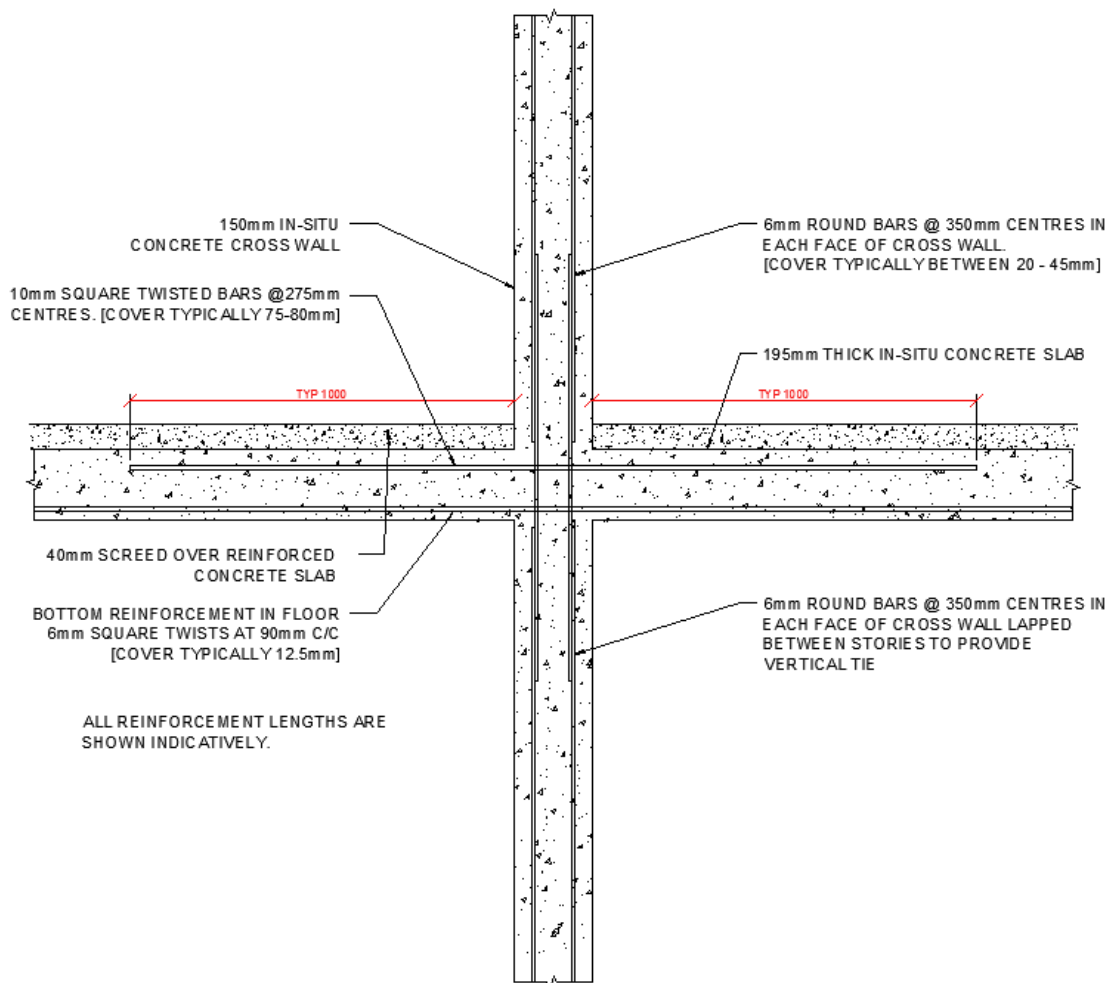
Figure 18 – Cross wall / floor slab joint.

The reinforcement within the wall panels appears to be continuous from one panel to the next with 6mm vertical bars lapped onto the primary wall reinforcement. The vertical wall reinforcement consists of two layers of 6mm square twist bars at 350mm c/c and cover ranging from 20-45mm. Horizontal ties are provided in the form of 10mm square twist bars at 275mm c/c in the top of the slab and the 6mm square twist bars in the bottom of the slab.

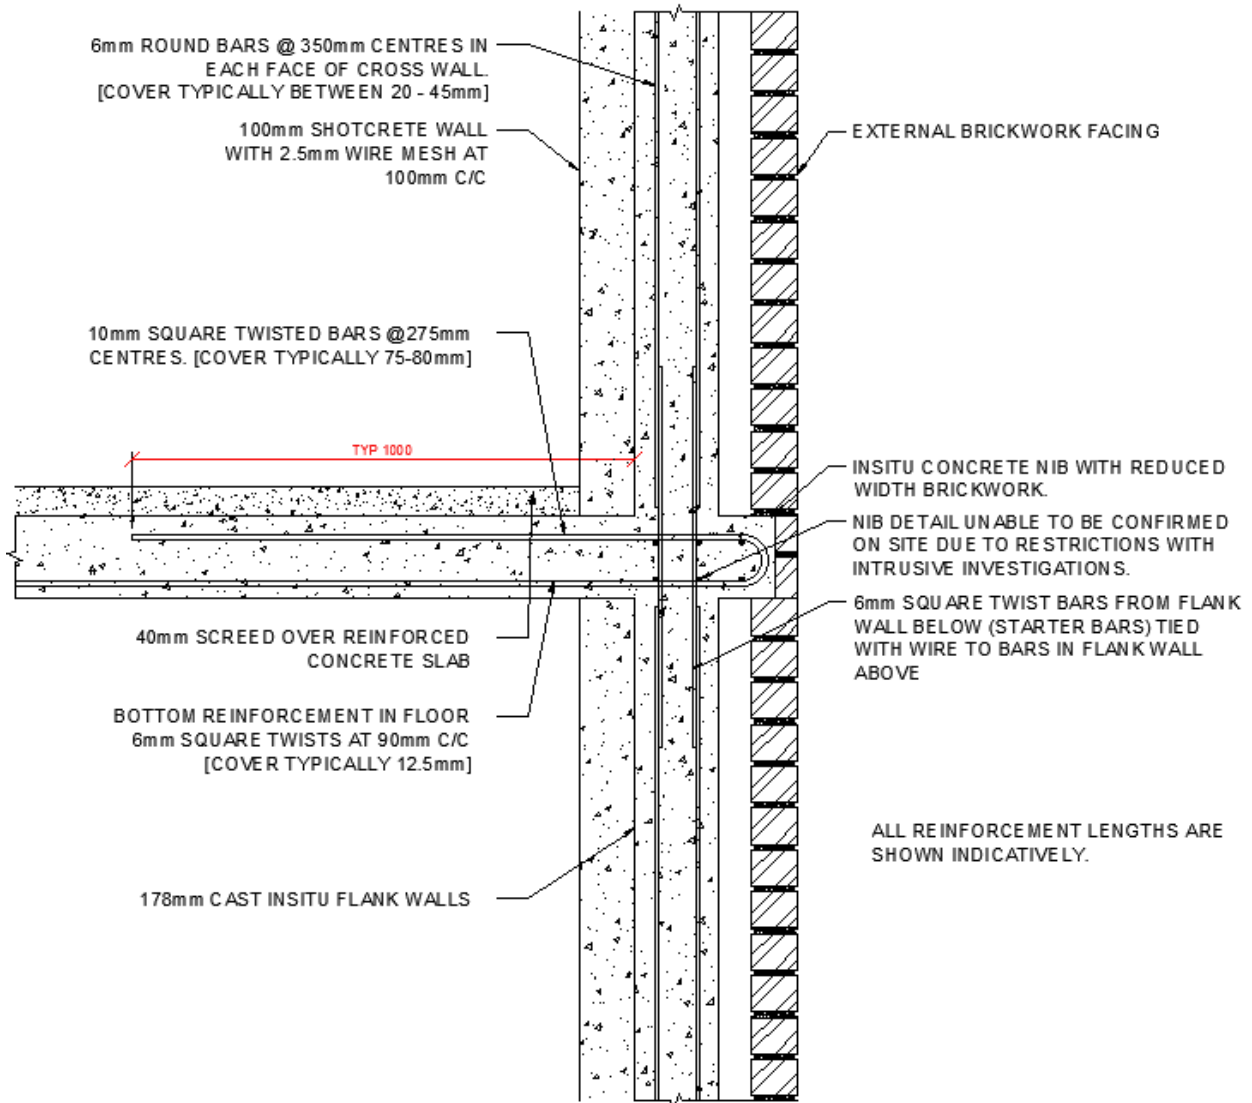
Figure 19 – Typical In-situ flank wall to floor slab joint.

The investigations into the flank walls show that the wall is in-situ reinforced concrete as highlighted in Figure 17 above. The flank walls were found to have a 100mm shotcrete liner with 2.5mm wire mesh reinforcement. These were assumed to be as a remedial measure with the attempt to provide a vertical tie in the building, however as the reinforcement does not lap correctly the detail is insufficient in providing the required tie.

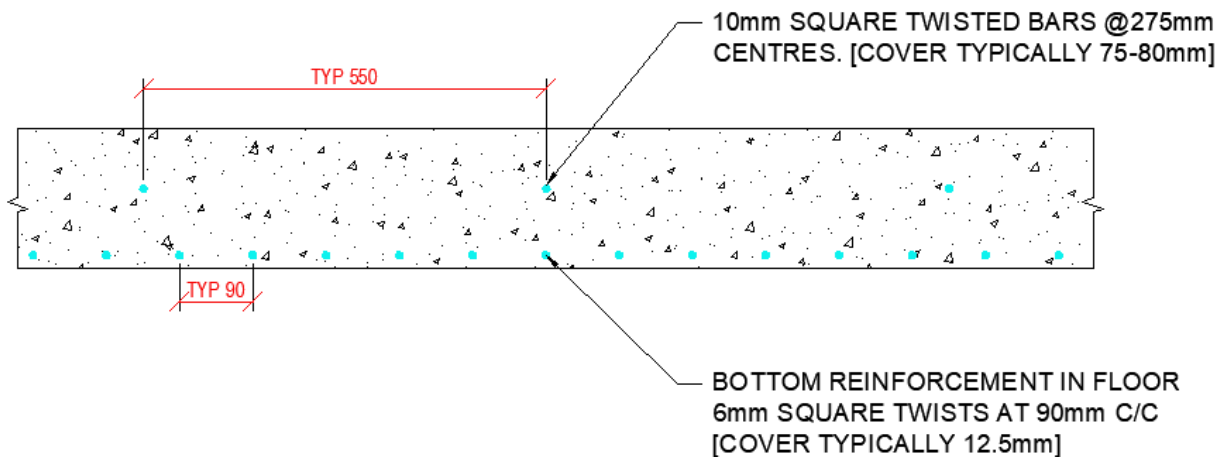
The floor slabs are constructed from 195mm thick reinforced concrete slab which have a non-structural 40mm screed over the top. The floor slab is constructed with 10mm ( $\frac{3}{8}$ " ) ribbed bars @ 275mm c/c located in the top of the slab providing a horizontal tie between slabs, 6mm ( $\frac{1}{4}$ " ) square twist bars at 90mm c/c are located in the bottom with 12.5mm cover typically.

In the three flats surveyed it was found that there were horizontal tie bars at approximately 275mm c/c. This was found to be consistent across the building. In the event of an internal gas explosion, it is likely that the tie bars would act sufficiently to resist disproportionate collapse, providing a tie force of 38.2kN/bar helping to resist a load of 20kN/bar based on a tie force requirement of 60kN/m.

Figure 20 – Typical Langton House floor construction detail.

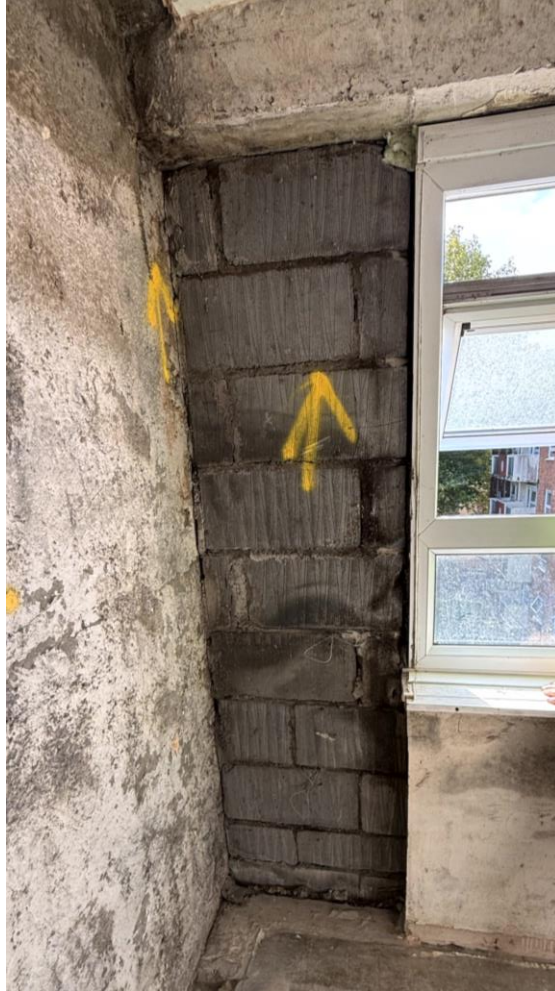
As indicated in Figure 19 wall ties across a cavity should generally be provided at 450mm vertical centres and 900mm horizontal centres, with additional ties provided around openings. In most instances one or two ties were found in the external wall panels and no additional wall ties were found around window and door openings. Additionally, there were limited ties between each of the masonry skins and the structural cross walls. The instructive investigations only allowed this to be reviewed in the inner skin of the cavity wall and therefore assessment of the outer skin cannot be made.

*Figure 22 - Removed blockwork showing missing or unused wall tie.*
