Conservation Area 9

# St Michael's Hill & Christmas Steps

Character Appraisal

October 2008

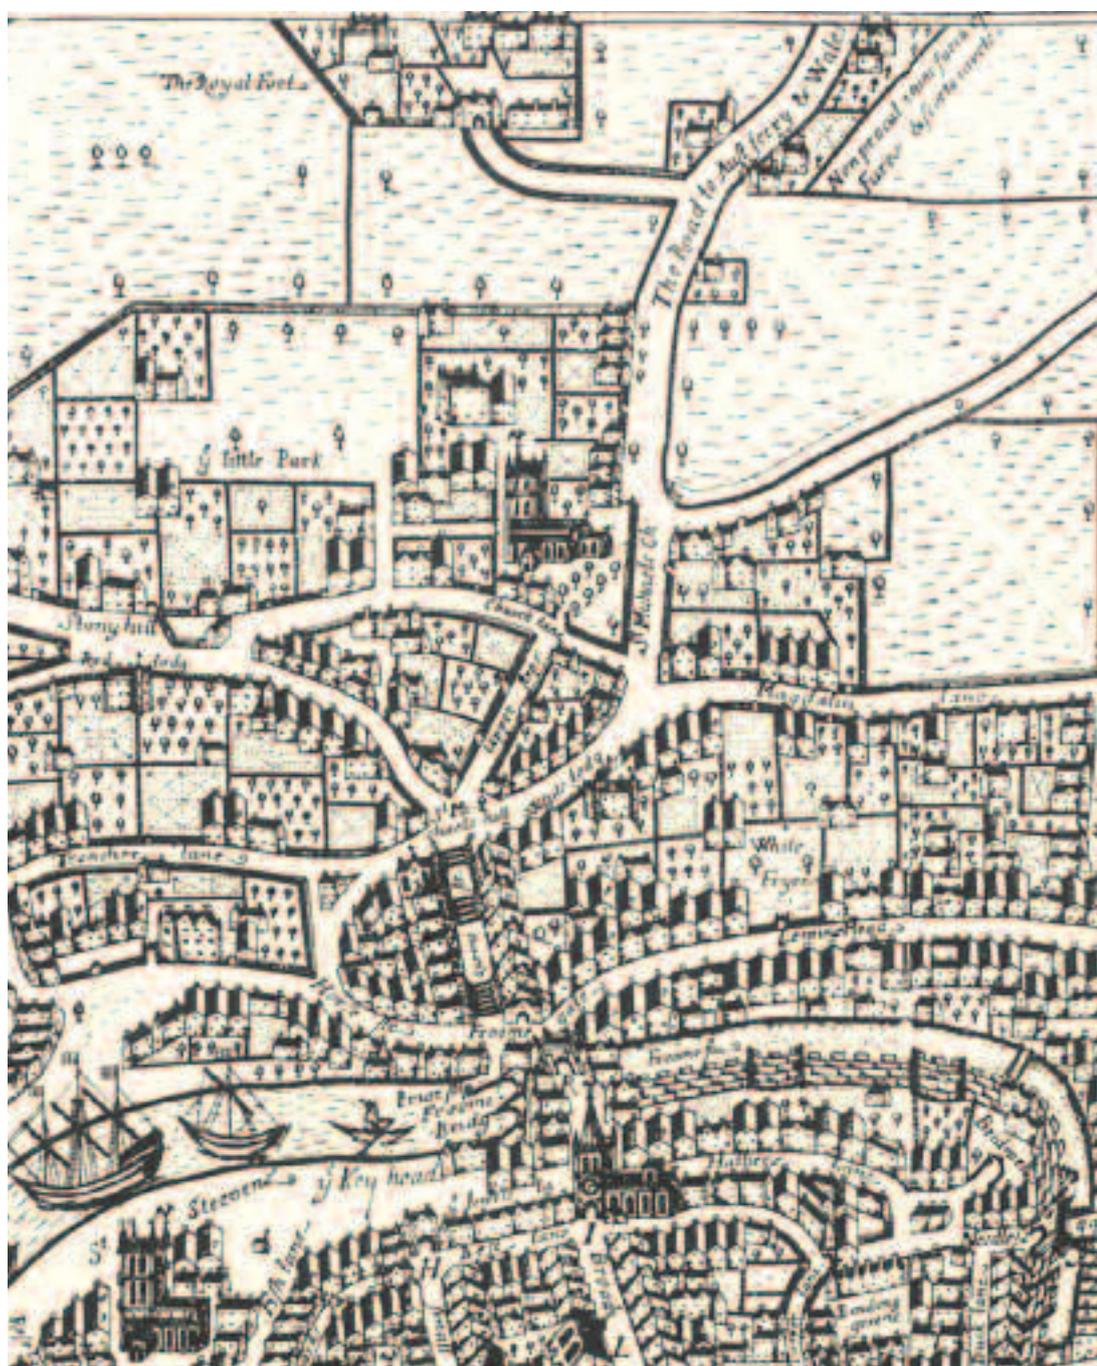
*Figure 1: Jacob Miller's Plan of Bristol, 1673 – shows the historic link between the south end of Queen Street (Christmas Steps) over the River Frome to the Old City. Development becomes less intensive north of St Michael's Church. Scattered plots exist along the Road to Aust Ferry (St Michael's Hill). These are the "summer houses" of Bristol's wealthiest inhabitants*

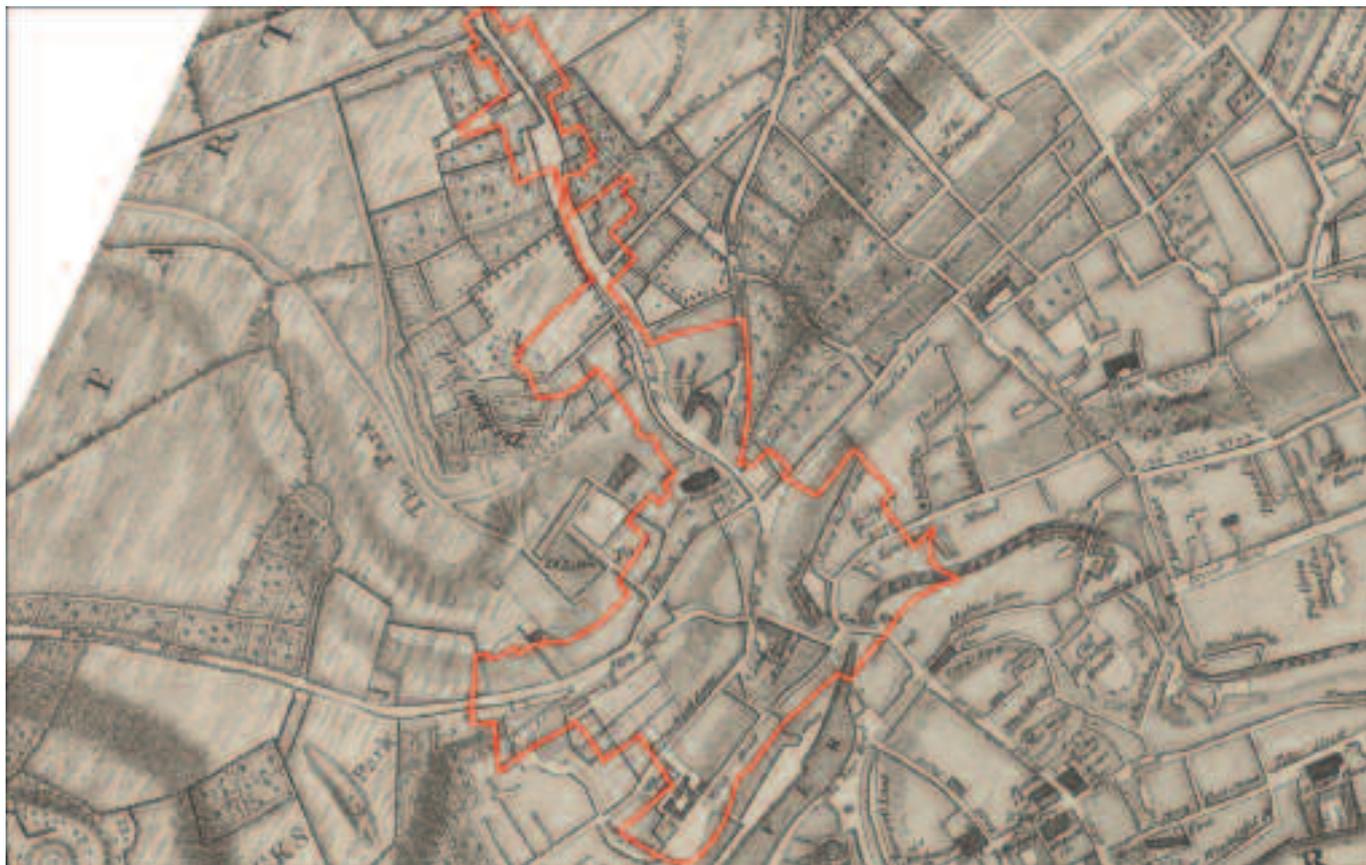
*Figure 2: John Roque's Map, 1746 – shows the increasing intensive development in the southern portion of the Conservation Area. The Colston's Almshouses have been laid out on the east side of St Michael's Hill and an increasing number of properties line the lower part of the Hill. The northern portion remains essentially rural, subdivided by small field plots and gardens. Johnny Ball Lane is clearly visible, running behind Lewins Mead to Maudlin Lane (Upper Maudlin Street)*

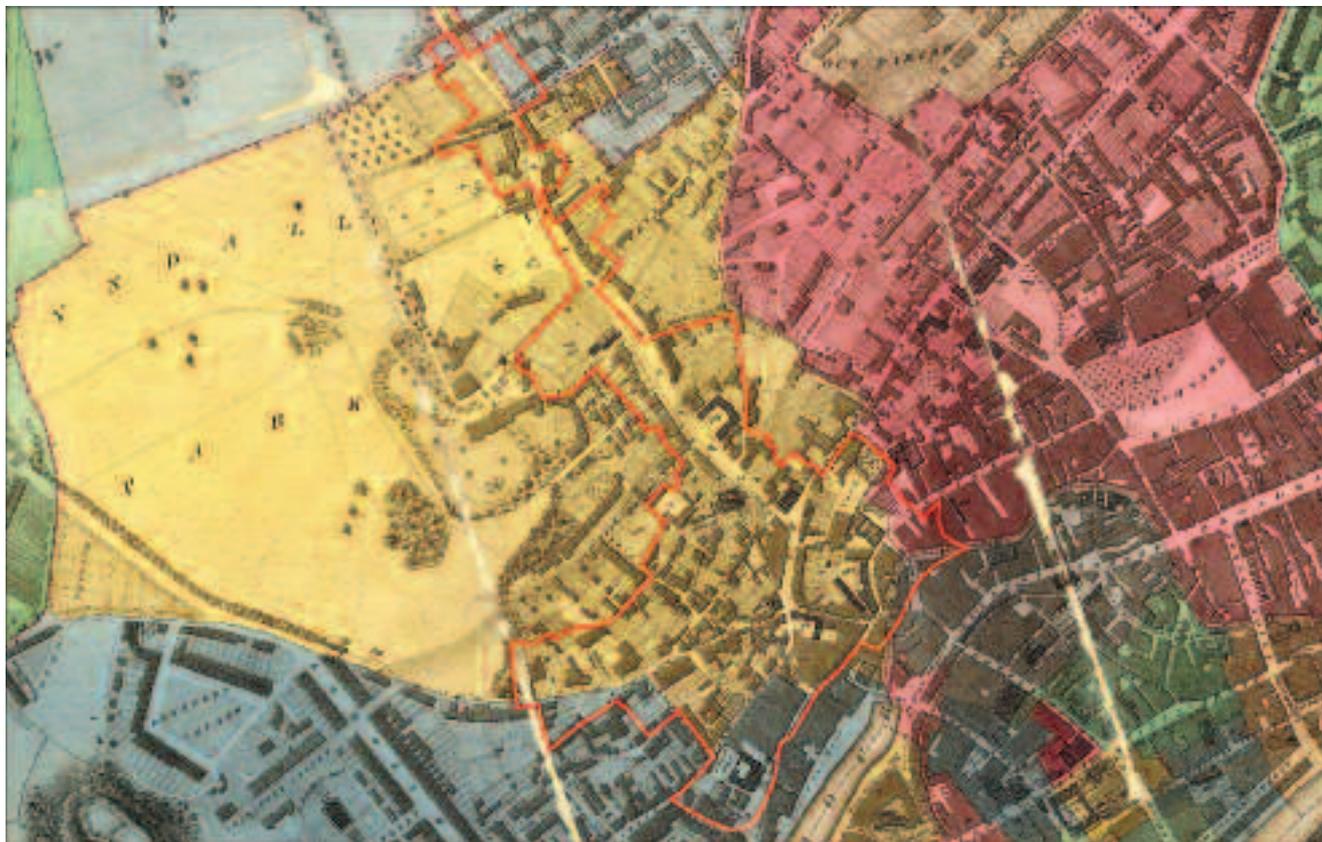
*Figure 4: Plumley & Ashmead's Plan, 1828 shows how intensively developed the lower portion of the Conservation Area was by the early 19th century. Ribbon development up St Michael's Hill has taken hold though this is far less intensive, being high-quality housing for the upper middle classes.*

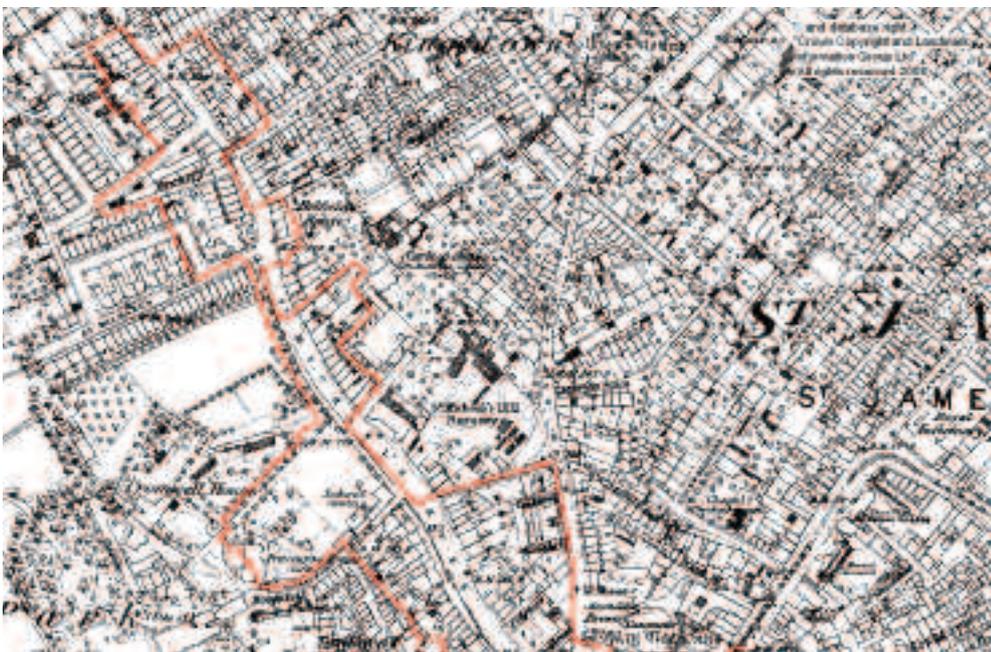
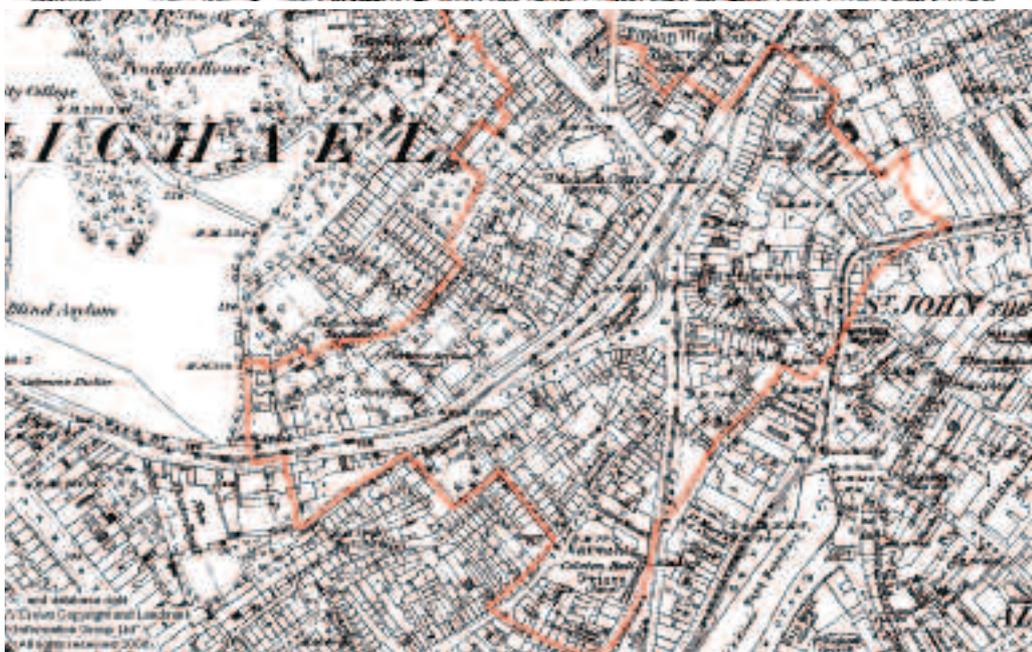
*Figures 5 & 6 : Ordnance Survey, First Edition, 1880 – the northern part of the Conservation Area has seen increasing development at the top of St Michael's Hill. The southern portion has been drastically re-configured with the introduction of Perry Road and Colston Street*

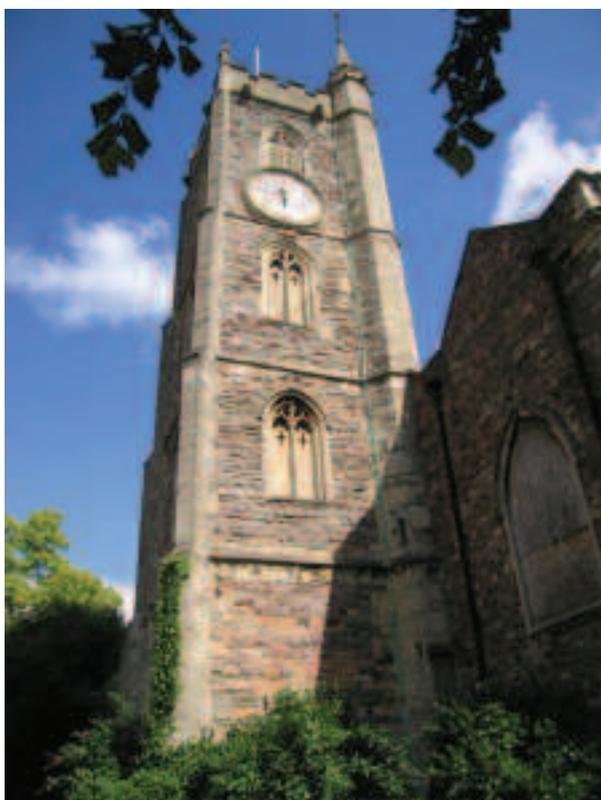
6.3.3 St Michael on the Mount is the most prominent feature in the Conservation Area, which sits on an elevated platform just above Perry Road. The distinctive medieval tower is visible in many local views. The Church is currently in a poor condition and features on the Bristol CC, English Heritage and Civic Society's Buildings at Risk Registers (see Negative Features, Section 8).

*Figure 10: St Michael on the Mount*

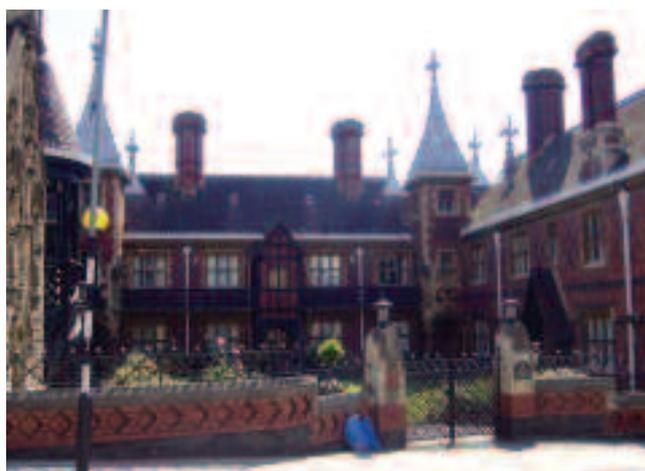
6.3.4 Foster's Almshouses, Colston Street is another significant landmark. The distinctive roof-form, punctuated by tall clustered chimneys, ornate diaper brick and tile-work and Gothic detail all contribute to the building's prominence.

*Figure 11: Foster's Almshouses, Colston Street*

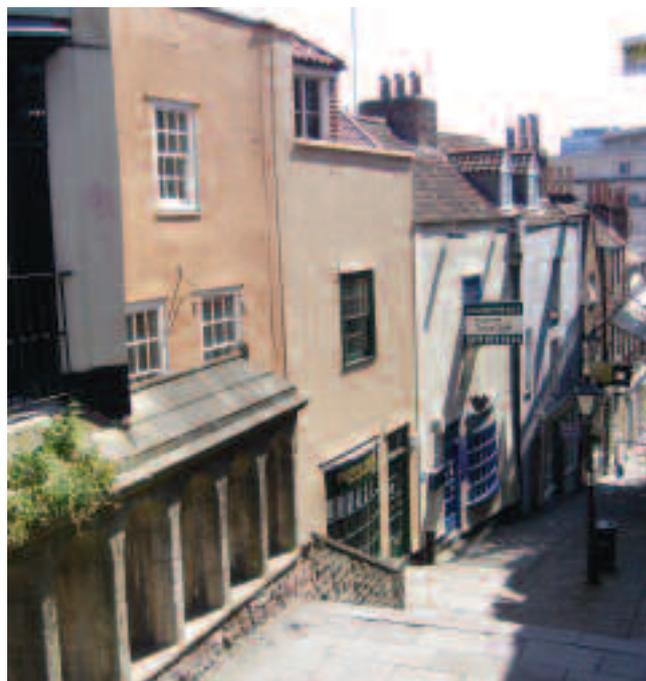
*Figure 12: Christmas Steps. The area south of Perry Road is characterised by a mixture of modest vernacular buildings.*

7.1.3 The area south of Perry Road is characterised by groups of tightly packed terraces, ranging from Victorian to 17th century timber-framed, most with active ground-floor uses. Despite the range between individual properties, overall harmony is achieved through a general consistency in scale and materials, and the preservation of traditional architectural details,

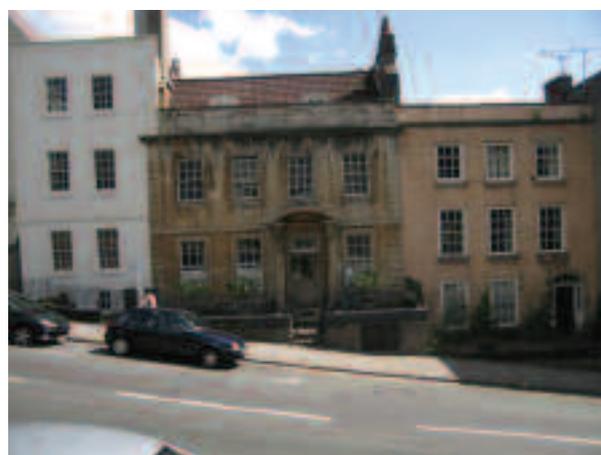
*Figure 13: St Michael's Hill properties are of high quality, reflecting the social status of their original inhabitants*

7.1.4 North of Perry Road, St Michael's Hill contains a range of fine Georgian townhouses that cling to the steep hillside as it rises towards Cotham. The substantially sized properties and quality of materials clearly reflects the social standing of the area's former residents, and the way in which the suburb grew as an out-of-City retreat offering a rural setting and panoramic views.

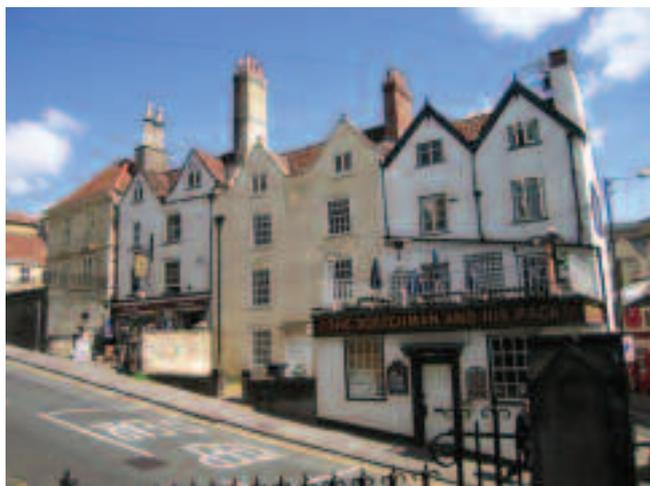
*Figure 17: Pre-Georgian buildings on the southeast side of St Michael's Hill*

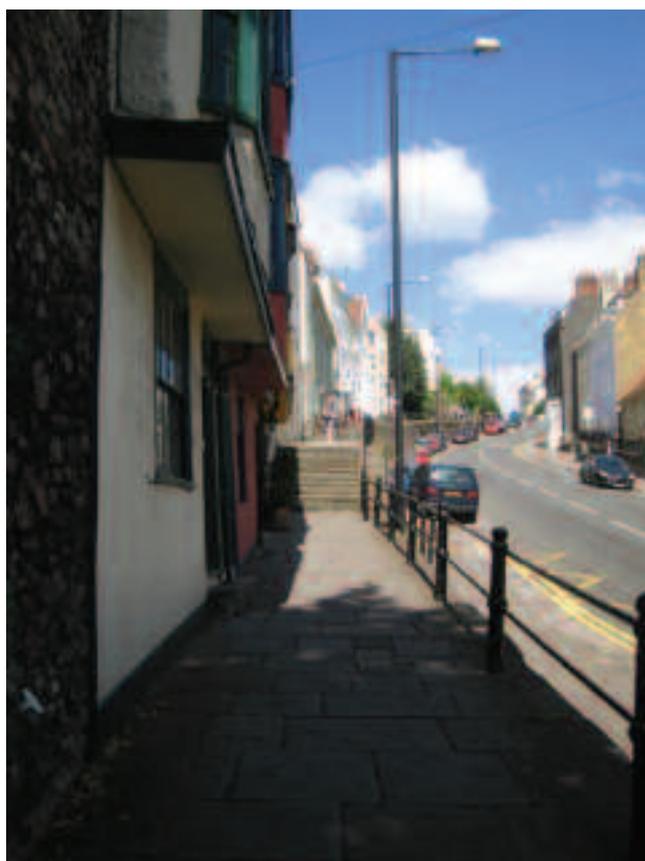
7.1.16 The West side of St Michael's Hill is raised on a rubble causeway and many other important townscape details run through the area. Boundary treatments are an extremely important feature and define a strong building line up the hill. Where buildings are demolished, their stone (Brandon Hill grit and Pennant) offers the possibility of re-use in buildings, boundary walls and paving.

*Figure 18: Rubble causeway on the west side of St Michael's Hill*

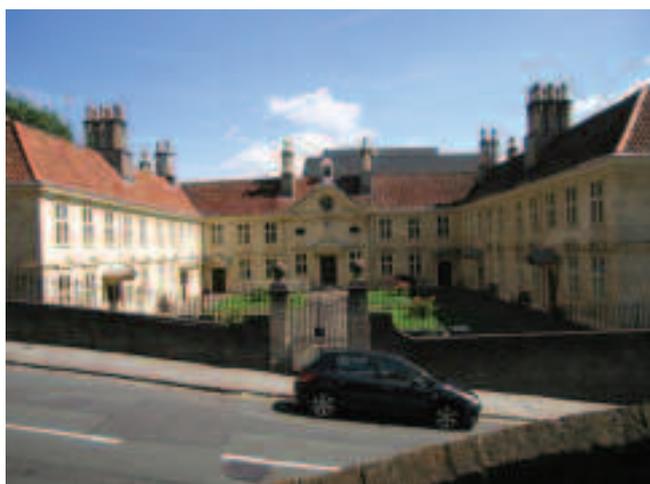
*Figure 19: Colston's Almshouses (Grade I Listed), St Michael's Hill*

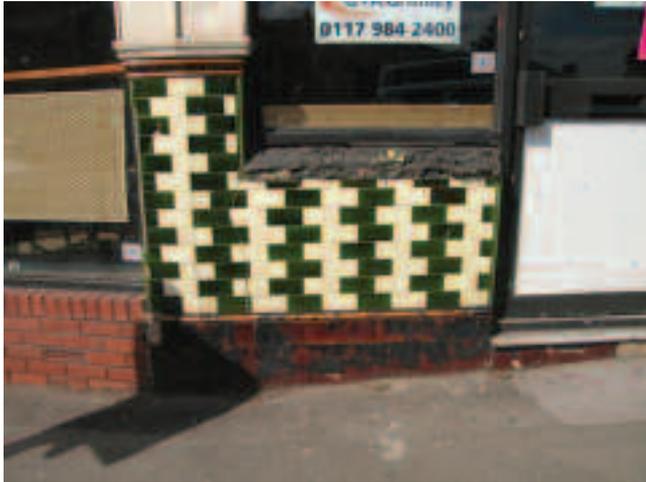
7.7.25 The volume of heavy traffic undermines the character of the area, conflicting with pedestrian movement and impacting on local trade. Some shopfronts are being poorly maintained or replaced; the Café Wall Illusion tiles (originally tiled as a butcher's shop, now an empty café) at no. 19-20 Perry Road, which inspired experiments in visual distortion by Professor Richard Gregory in the 1970s, are in a poor condition.

Figure 22: Café wall illusion tiles at no. 19-20 Perry Road

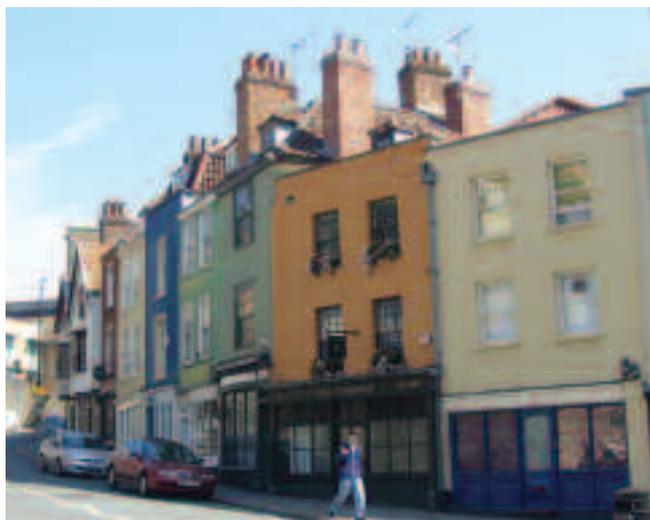
*Figure 23: Early vernacular buildings that round Colson Street from Christmas Steps*

7.7.28 Christmas Steps is one of the most important historic streets in Bristol, notable for its steep stepped form that dates from the Jacobean period. Buildings that round Colston Street and along Lower Park Row are some of the earliest in the Conservation Area, all timber-framed with a modest scale and vernacular character.

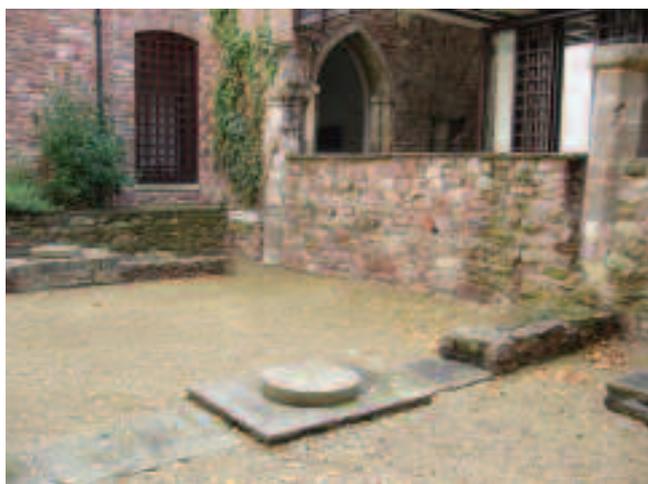
7.7.34 St Bartholomew's Court is a massive late 20th century office development that obscures the opening to the south of Christmas Steps. Tucked behind the offices is the site of the 13th century St Bartholomew's Hospital which is now a complex of small office units.

*Figure 27: Remnants of the former St Bartholomew's Hospital*

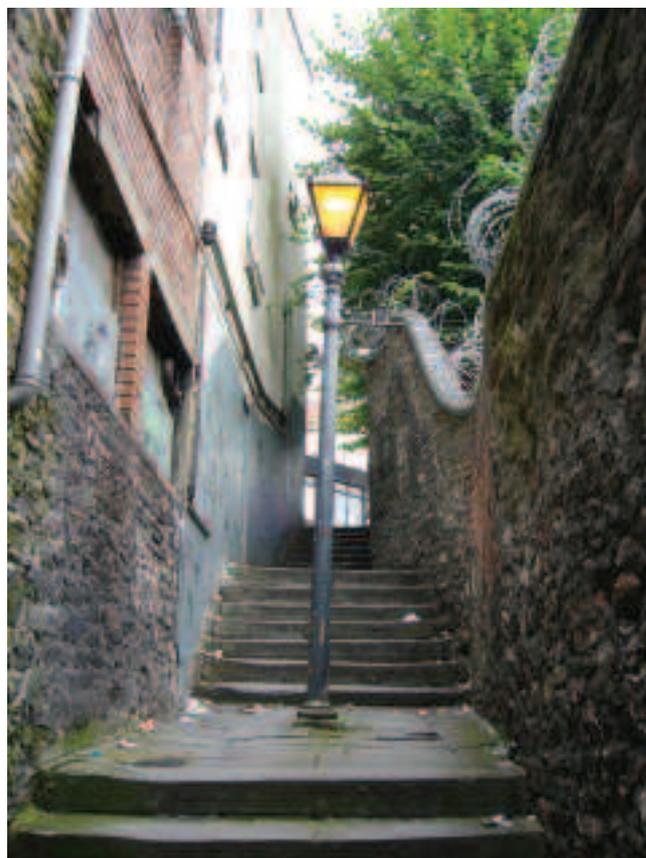
7.7.35 Host Street still reflects something of the maritime history that once shaped the area, owing to the small-scale warehouse type buildings, cast iron curb edges and Zed Alley that historically ran from the water up past

*Figure 28: Zed Alley leading from Colston Street to Host Street*

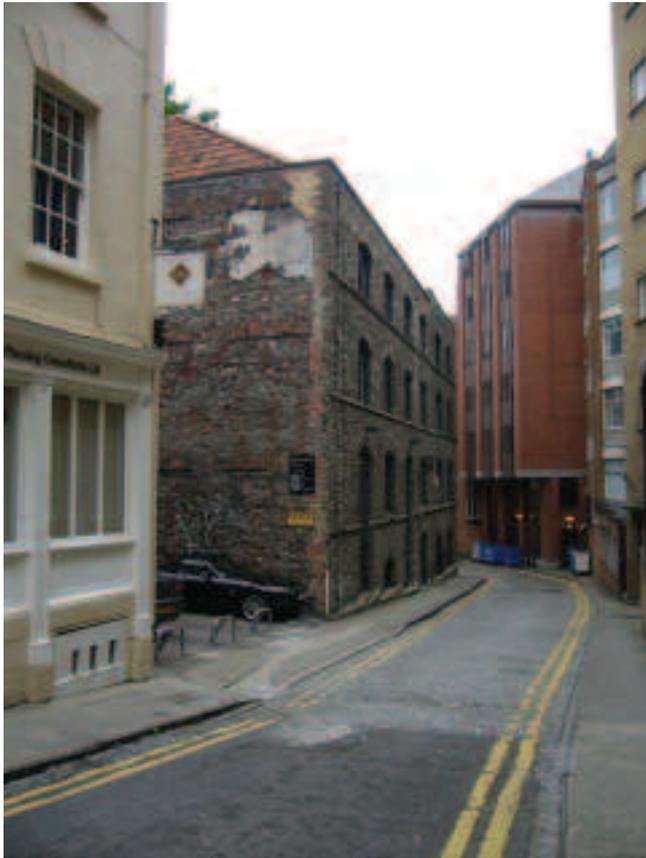
Figure 29: Host Street

7.7.37 Trenchard Street car-park looms over Trenchard Street and undermines the setting of the Conservation Area. Similarly, Colston Avenue buildings turn their back on Host Street and overshadow this historic route creating the sense of a forgotten back alley.

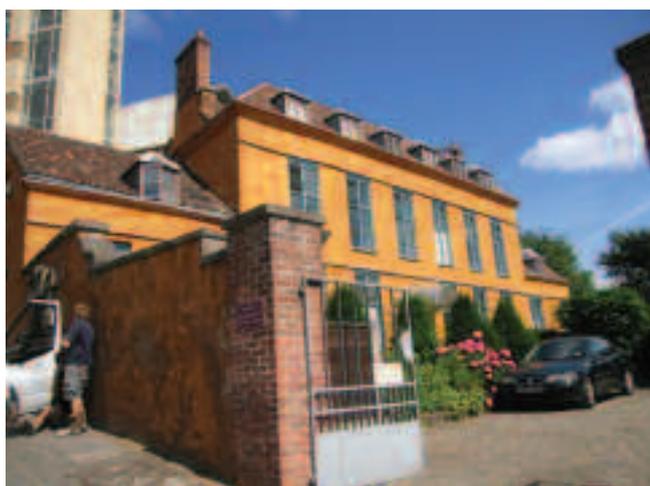
7.2.6 The earliest houses north of St Michael's Church reflect the higher status of this part of the Conservation Area. Properties are larger-scale, though 23 – 27 St Michael's Hill are timber framed, there is a higher quality in building materials and execution. Colston's Almshouse and the Manor House show a Classical symmetry that became more popular in the 18th century.

Figure 30: The Manor House, Park Lane

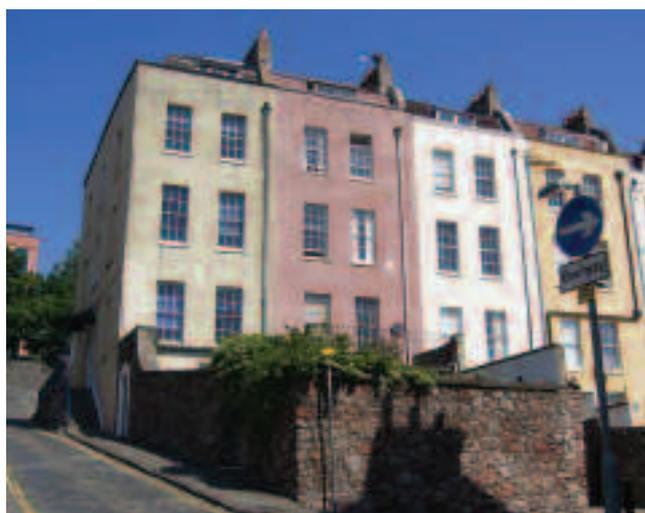
7.2.9 Decorative ironwork is a particular feature of Georgian buildings, seen in wrought iron area railings or occasionally in Regency balconies or entrances, for example at no. 1 Lower Park Row.

Figure 31: Nos. 1-4 Lower Park Row

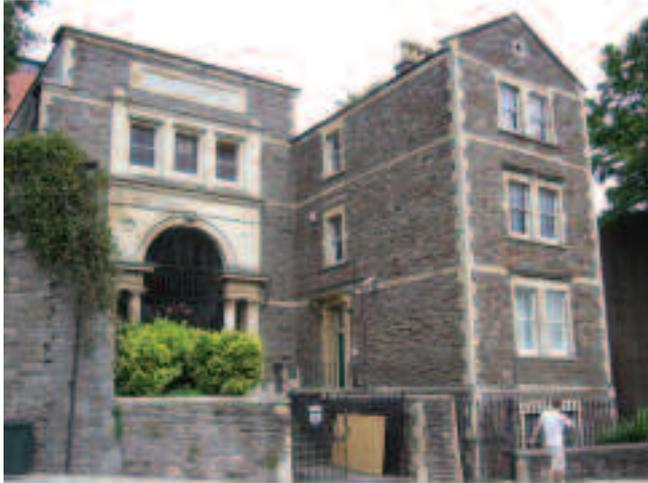
7.2.11 The Victorians also introduced a number of large-scale institutional and civic buildings into the Conservation Area, made possible by the massive road engineering that took place along Perry Road and Colston Street. Colston Hall, the re-built Foster's Almshouses, the Synagogue, St Michael on the Mount Primary School and the King David Hotel are all bold Victorian/Edwardian introductions.

Figure 32: Synagogue, Park Row

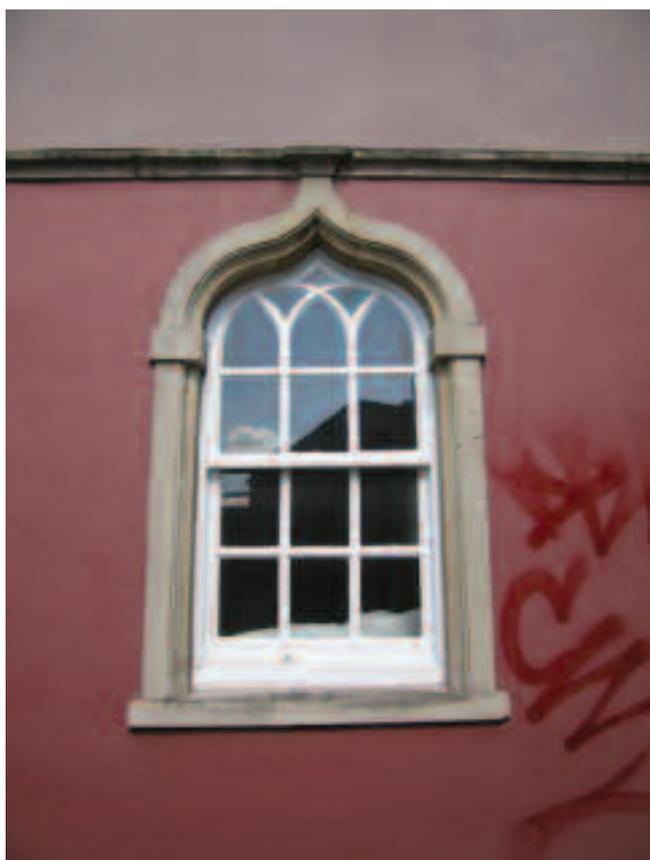
7.3.7 Typically, Georgian windows in St Michael's Hill & Christmas Steps are single glazed, double hung, timber sashes, recessed within the window reveal and painted white. Sashes are usually six-over-six, though there are variations to this pattern. Victorian windows are heavier, one-over-one timber sashes with moulded window horns (seen particularly at the north end of St Michael's Hill).

Figure 33: Unusual 'Gothic' window, the Old Rectory, Lower Park Lane

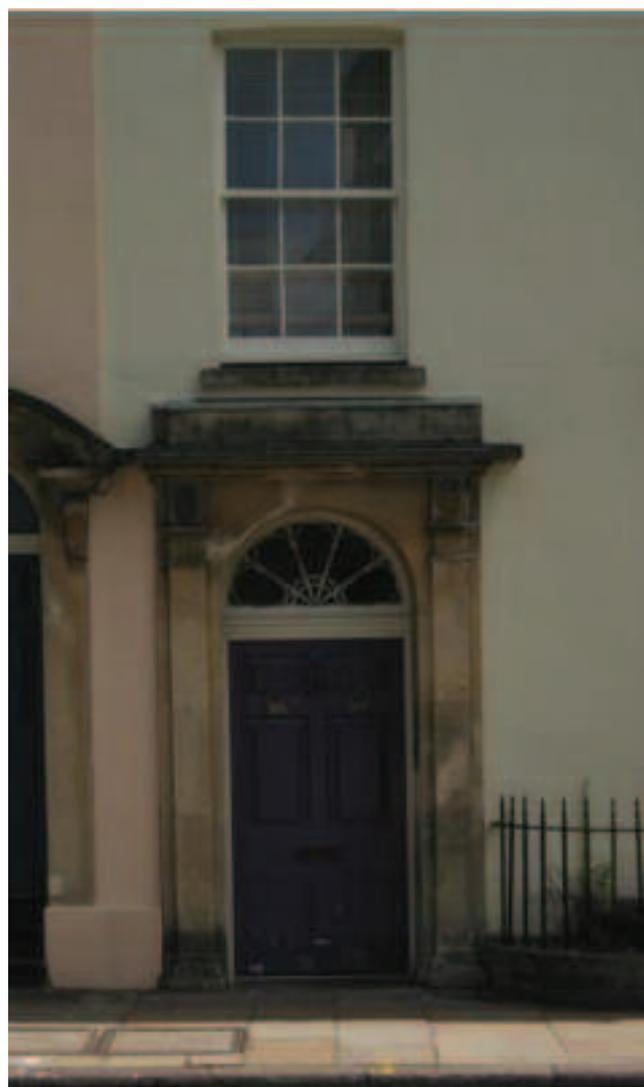
7.3.8 Doors and surrounds are the most elaborately detailed element of the facades. In St Michael's Hill & Christmas Steps there are a variety of original 6-panel doors with traditional door furniture. These have a variety of limestone Classical surrounds and some have elaborate shell-hoods, for example no. 67 St Michael's Hill.

Figure 34: No. 96 St Michael's Hill: Typical Georgian window and door details: six-over-six timber sash window; six panel door with decorative fanlight and Lime stone door surround

7.3.10 Regular maintenance and painting or traditional doors and windows is essential to ensure that problems of decay are not allowed to flourish. Other architectural details of special interest must be retained, and specialist advice sought on repair. (See Useful Information section.)

7.3.11 Where wholesale replacement is needed, the detail of doors and windows must match the originals in terms of glazing patterns and method of opening. Poor quality replacement doors and windows have a detrimental impact on the integrity of individual buildings, and the character of the conservation area as a whole (see Negative Features).

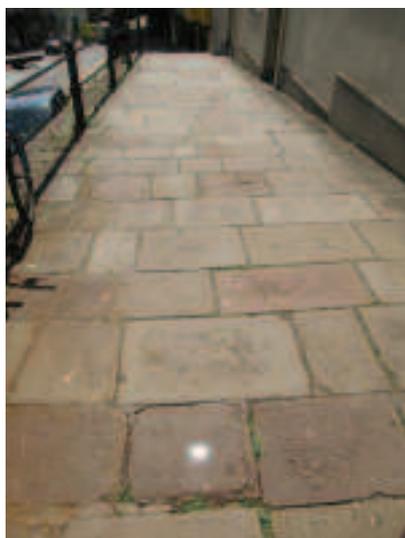
7.5.3 Traditional surface treatments such as setts and paving can be important elements in the townscape of an area. Paving, if well maintained and in high quality materials, contributes greatly to the character of an area, providing the backdrop to surrounding buildings. Their maintenance and retention is essential.

*Figure 35: Traditional Pennant stone paving along St Michael's Hill*

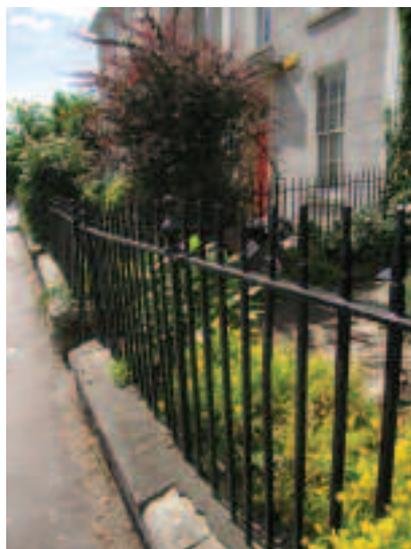
*Figure 36: Original wrought iron railings, St Michael's Hill*

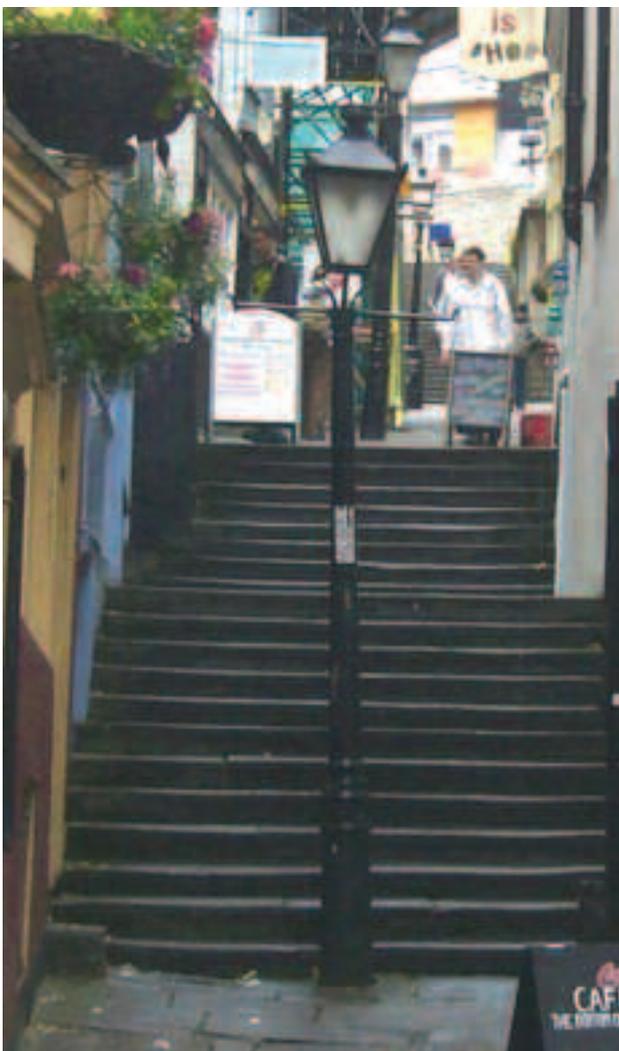
7.5.9 St Michael's Hill & Christmas Steps has a fascinating collection of historic street furniture, some of which is listed. Street furniture, including letter boxes, lamp standards, and other details, enlivens the street scene but also reflects the history of the area. Cast iron lamp posts, lanterns and iron support brackets made in Bristol foundries should be preserved in situ, where appropriate.

*Figure 37: Traditional lampstandards along Christmas Steps*

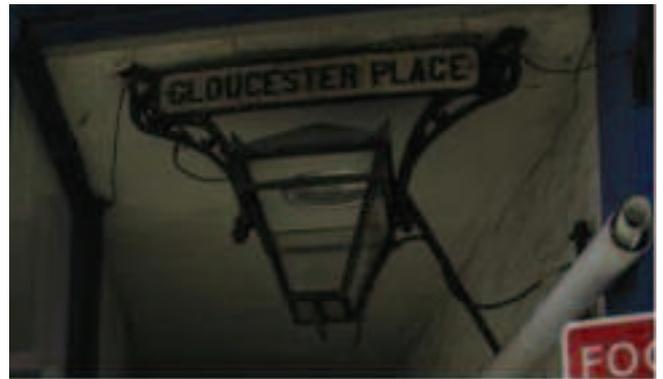
*Figure 38: Lantern and street sign to the little-known Gloucester Place, off St Michael's Hill*

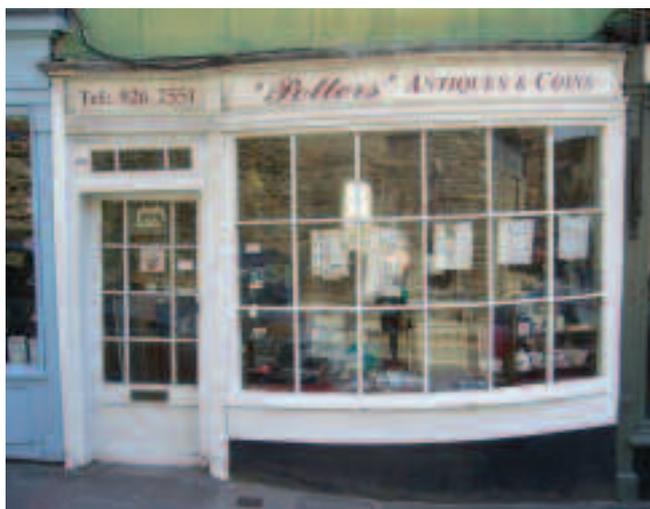
7.5.11 The St Michael's Hill & Christmas Steps Conservation Area has a fine collection of original and traditional shopfronts of various ages. The most interesting collection area in the lower portion, south of St Michael's Hill; though a cluster also exist at the northern extremity of the Conservation Area as well as those along Perry Road.

*Figure 39: Historic shopfront at no. 60 Colston Street*

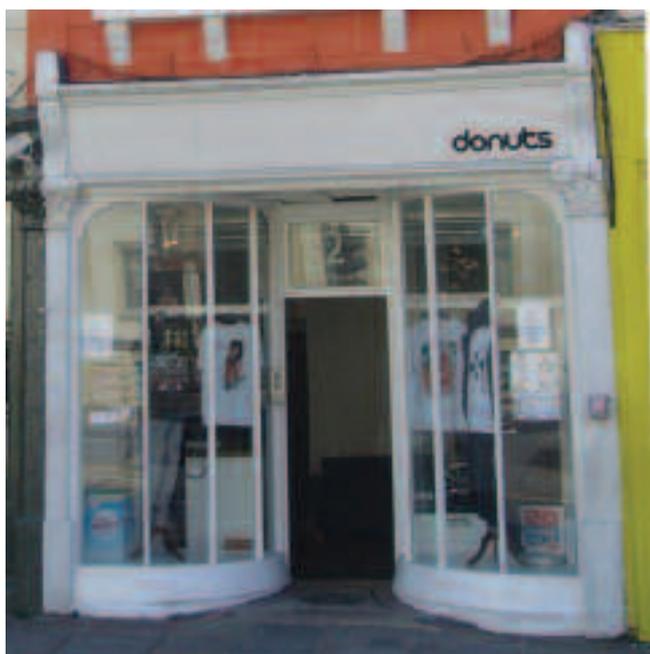
*Figure 40: Victorian shopfront at no. 2 Upper Maudlin Street*

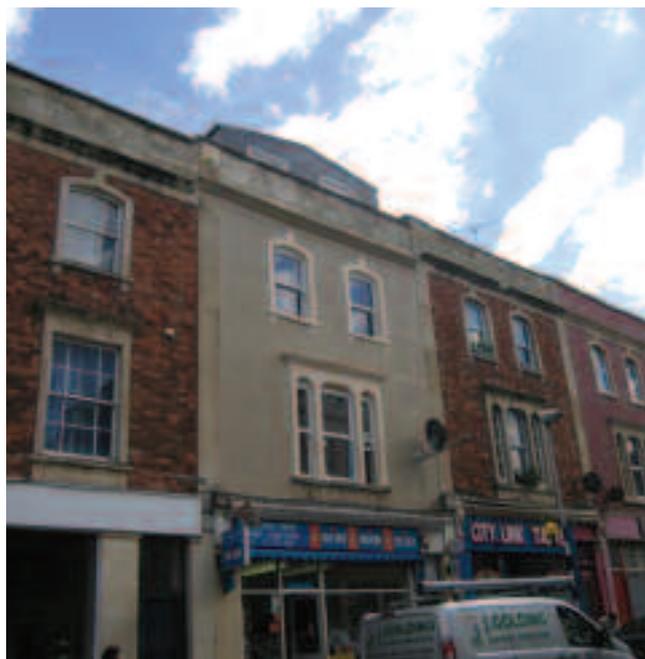
8.2 Unsympathetic alterations & loss of traditional architectural details – where poor quality replacement doors and windows or roof level extensions have been inserted these have had a significant and detrimental impact on the architectural integrity of individual buildings. (The character of the former King David Hotel has been severely compromised by the insertion of uPVC windows.) Roof-level extensions are particularly detrimental, especially when they interrupt the consistency of a group.

Figure 41: No. 148 St Michael's Hill, insensitive roof extension

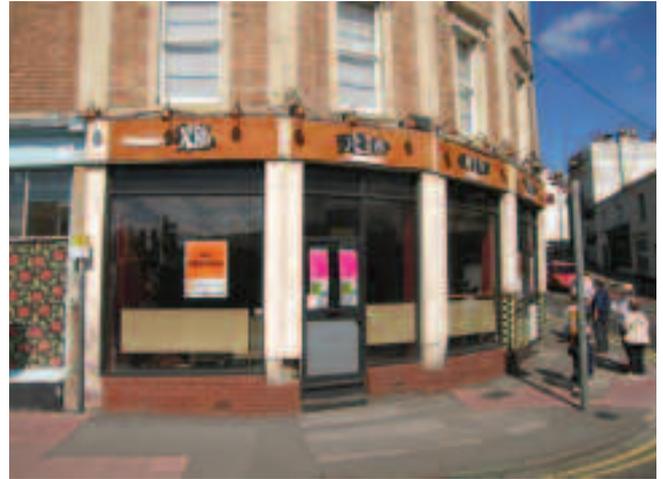
*Figure 43: Shopfront at no. 19 – 20 Perry Road is in a poor state of repair*

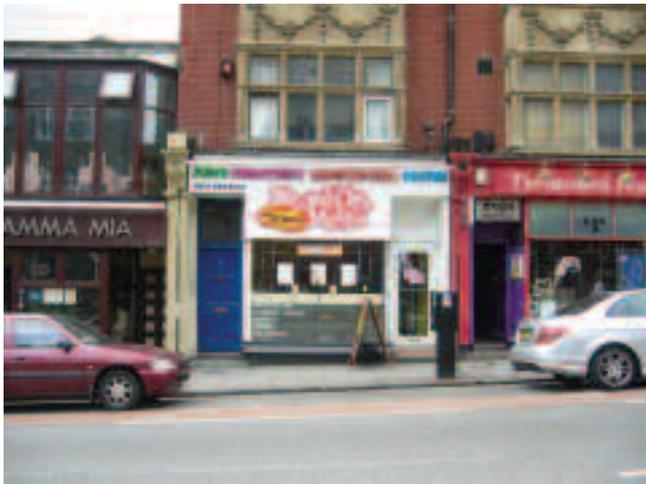
- 8.3 Unsympathetic infill and over-intensive developments – threaten to undermine the character and special interest of the area. Especially if they ignore predominant scale, materials, local architectural features and traditional building lines.
- 8.4 Shopfronts & Signage - Poor quality replacement shopfront, internally illuminated or over-size signage can have a dramatic effect on the quality of the street scene as well as being contrary to BCC design guidance. Grossly deepened fascia boards are a particular problem along Park Row, Perry Road and Upper Maudlin Street.

*Figure 42: Over-sized fascia board, Park Row*

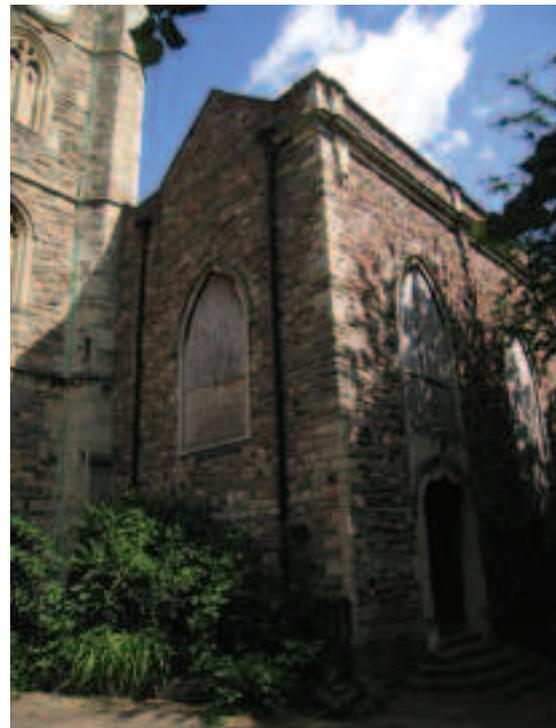
- 8.7 Buildings at Risk – St Michael's Church is currently redundant and has been vacant for over five years. Various discussions for appropriate re-use have failed and the building is rapidly deteriorating. The Church is currently on three 2008 At Risk Registers: English Heritage, Bristol City Council and The Civic Society.

*Figure 44: St Michael on the Mount, currently vacant and in a deteriorating condition*

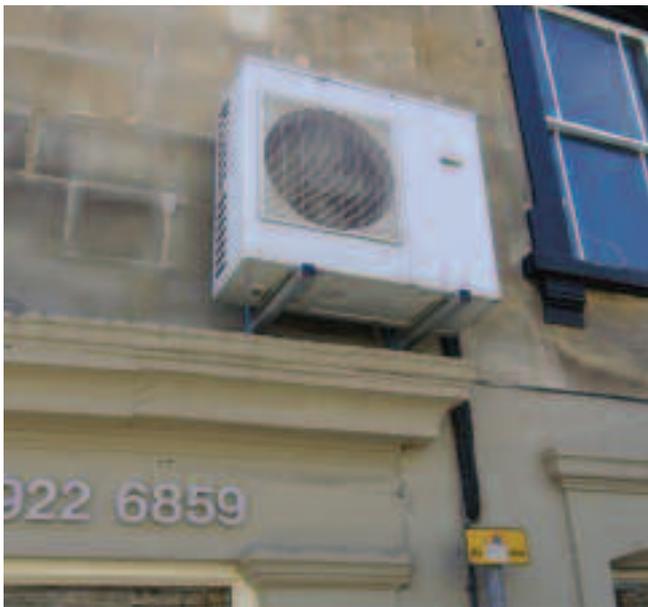
*Figure 45: Insensitively sited air conditioning unit, Lower Park Row*

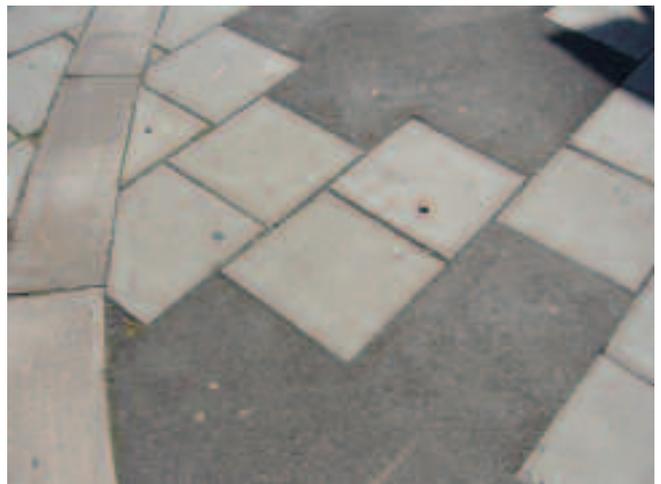
*Figure 46: Mix of street surfaces, Colston Street*

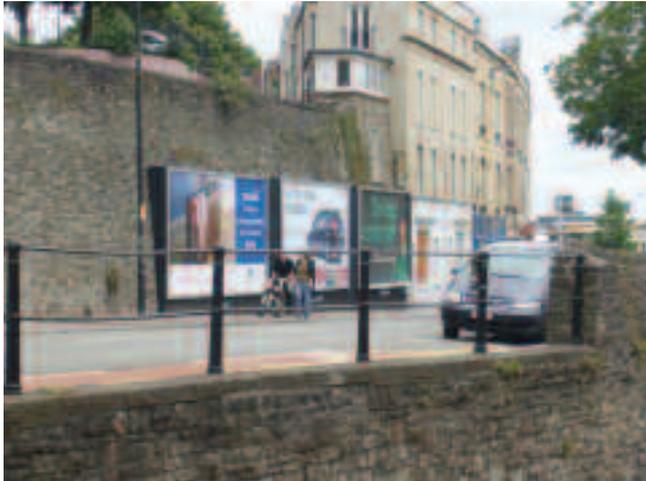
Figure 47: Advertising hoardings, Park Row

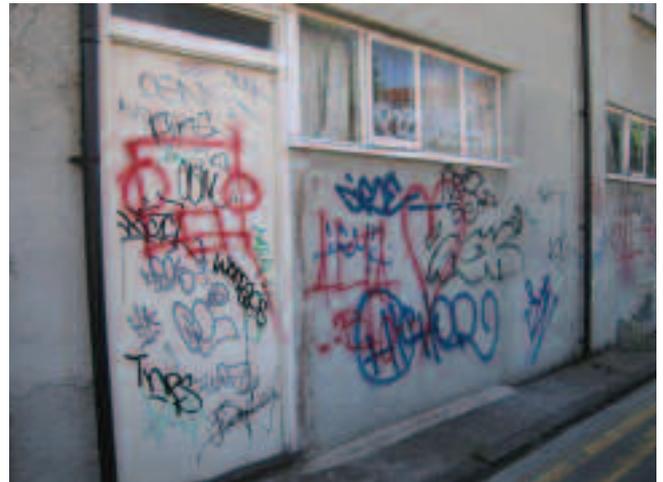
Figure 48: 'Tagging' along Lower Church Lane

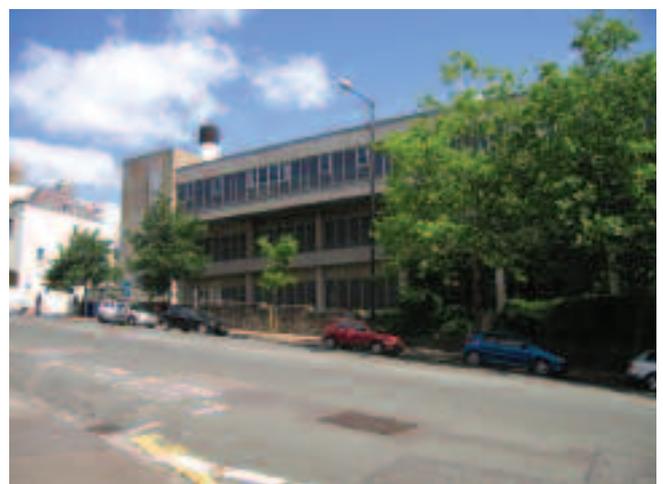
Figure 49: St Michael's Maternity Hospital on east side of St Michael's Hill blights the setting of the Conservation Area
