Conservation Area 19

Stokes Croft

Character Appraisal

October 2007

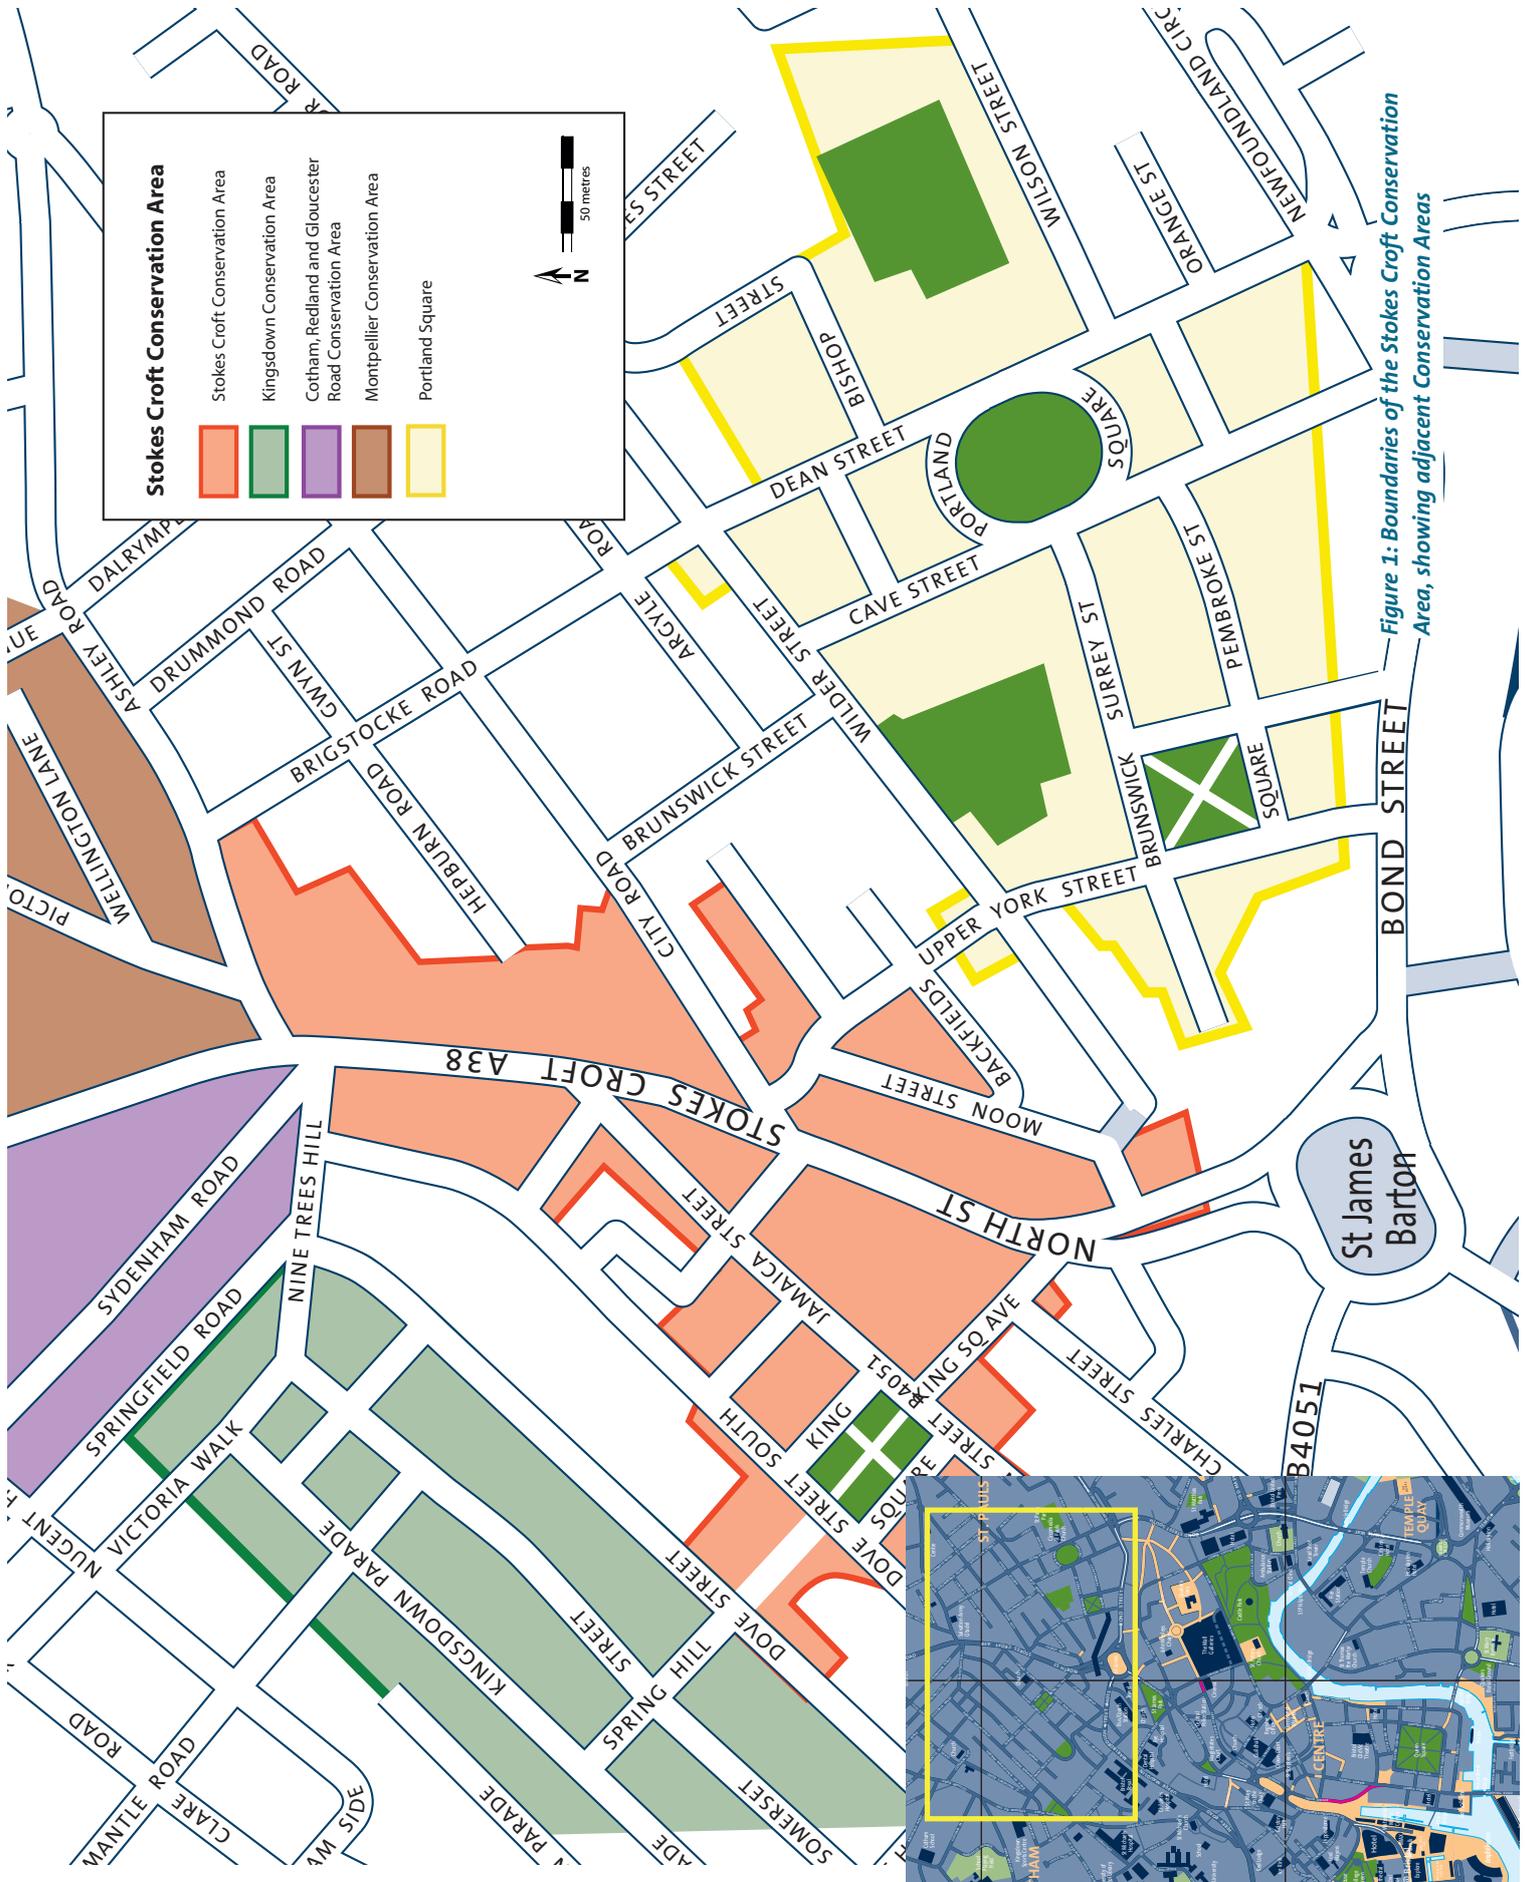
Figure 1: Boundaries of the Stokes Croft Conservation Area, showing adjacent Conservation Areas

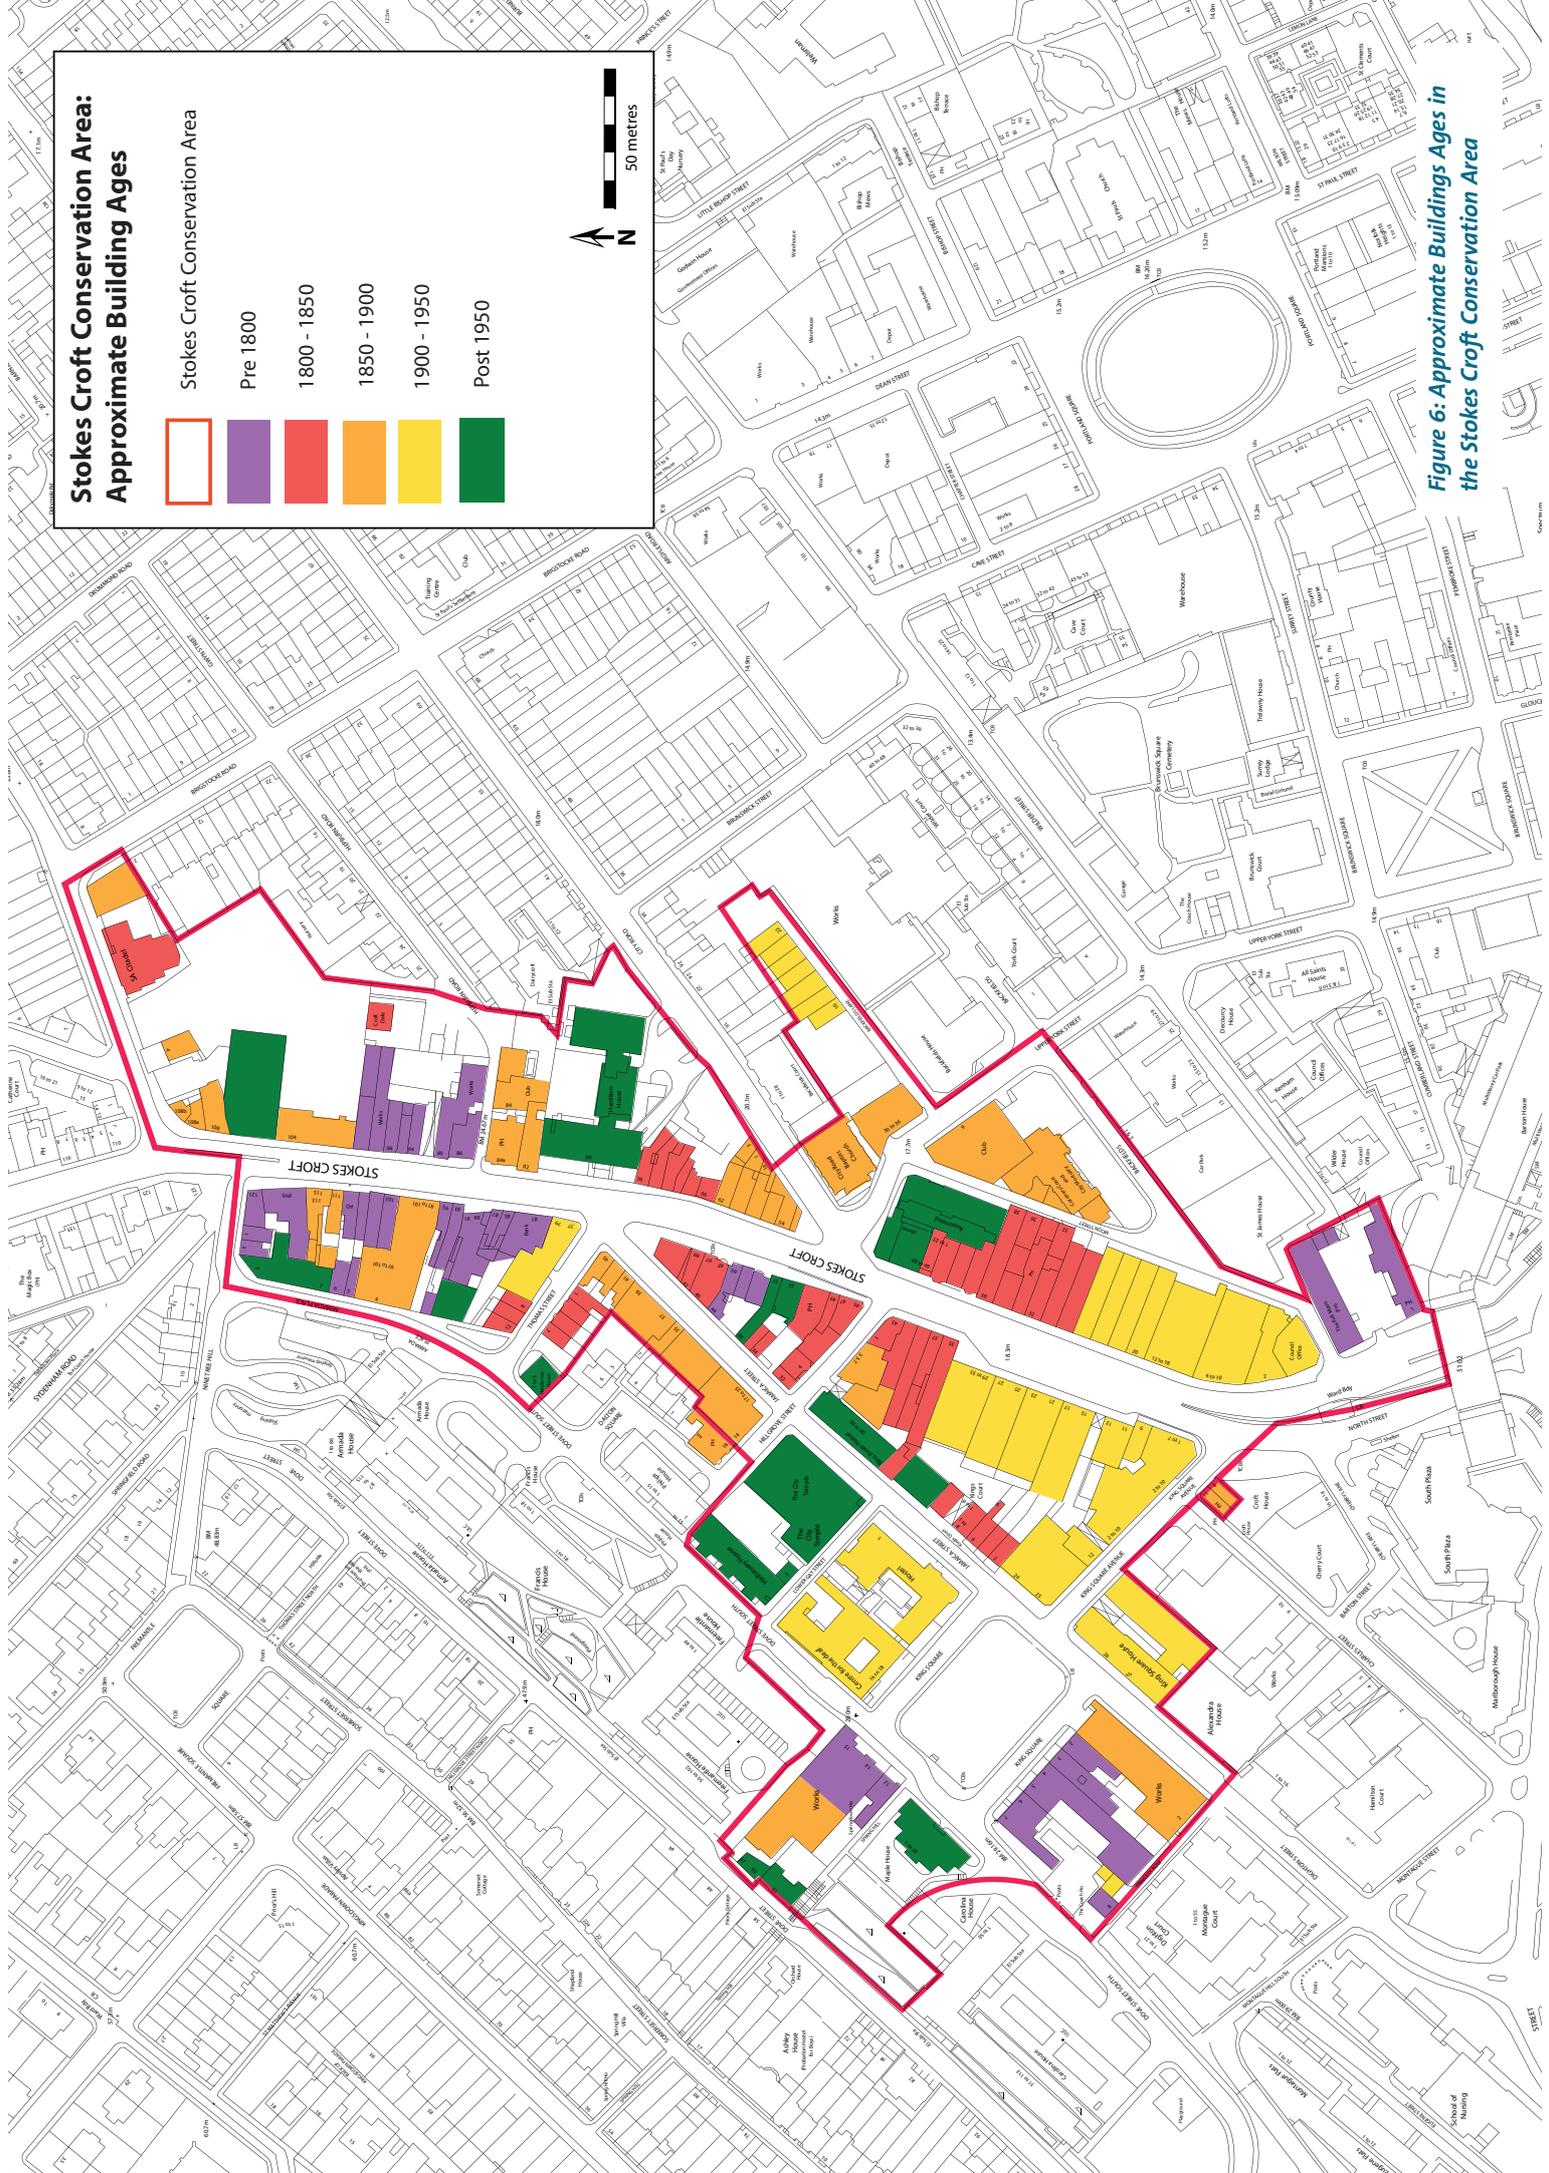
Figure 6: Approximate Building Ages in the Stokes Croft Conservation Area

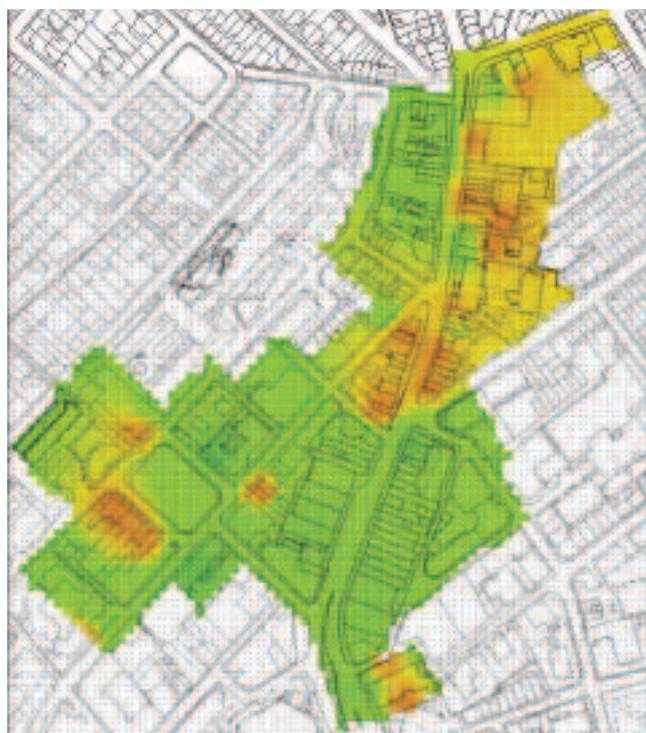
Figure 10: Map detailing the archaeology potential of the Stokes Croft Conservation Area

5.16 In most cases a detailed archaeological assessment will be needed in considering development proposals. The following illustration indicates the archaeological potential of the Stokes Croft area.

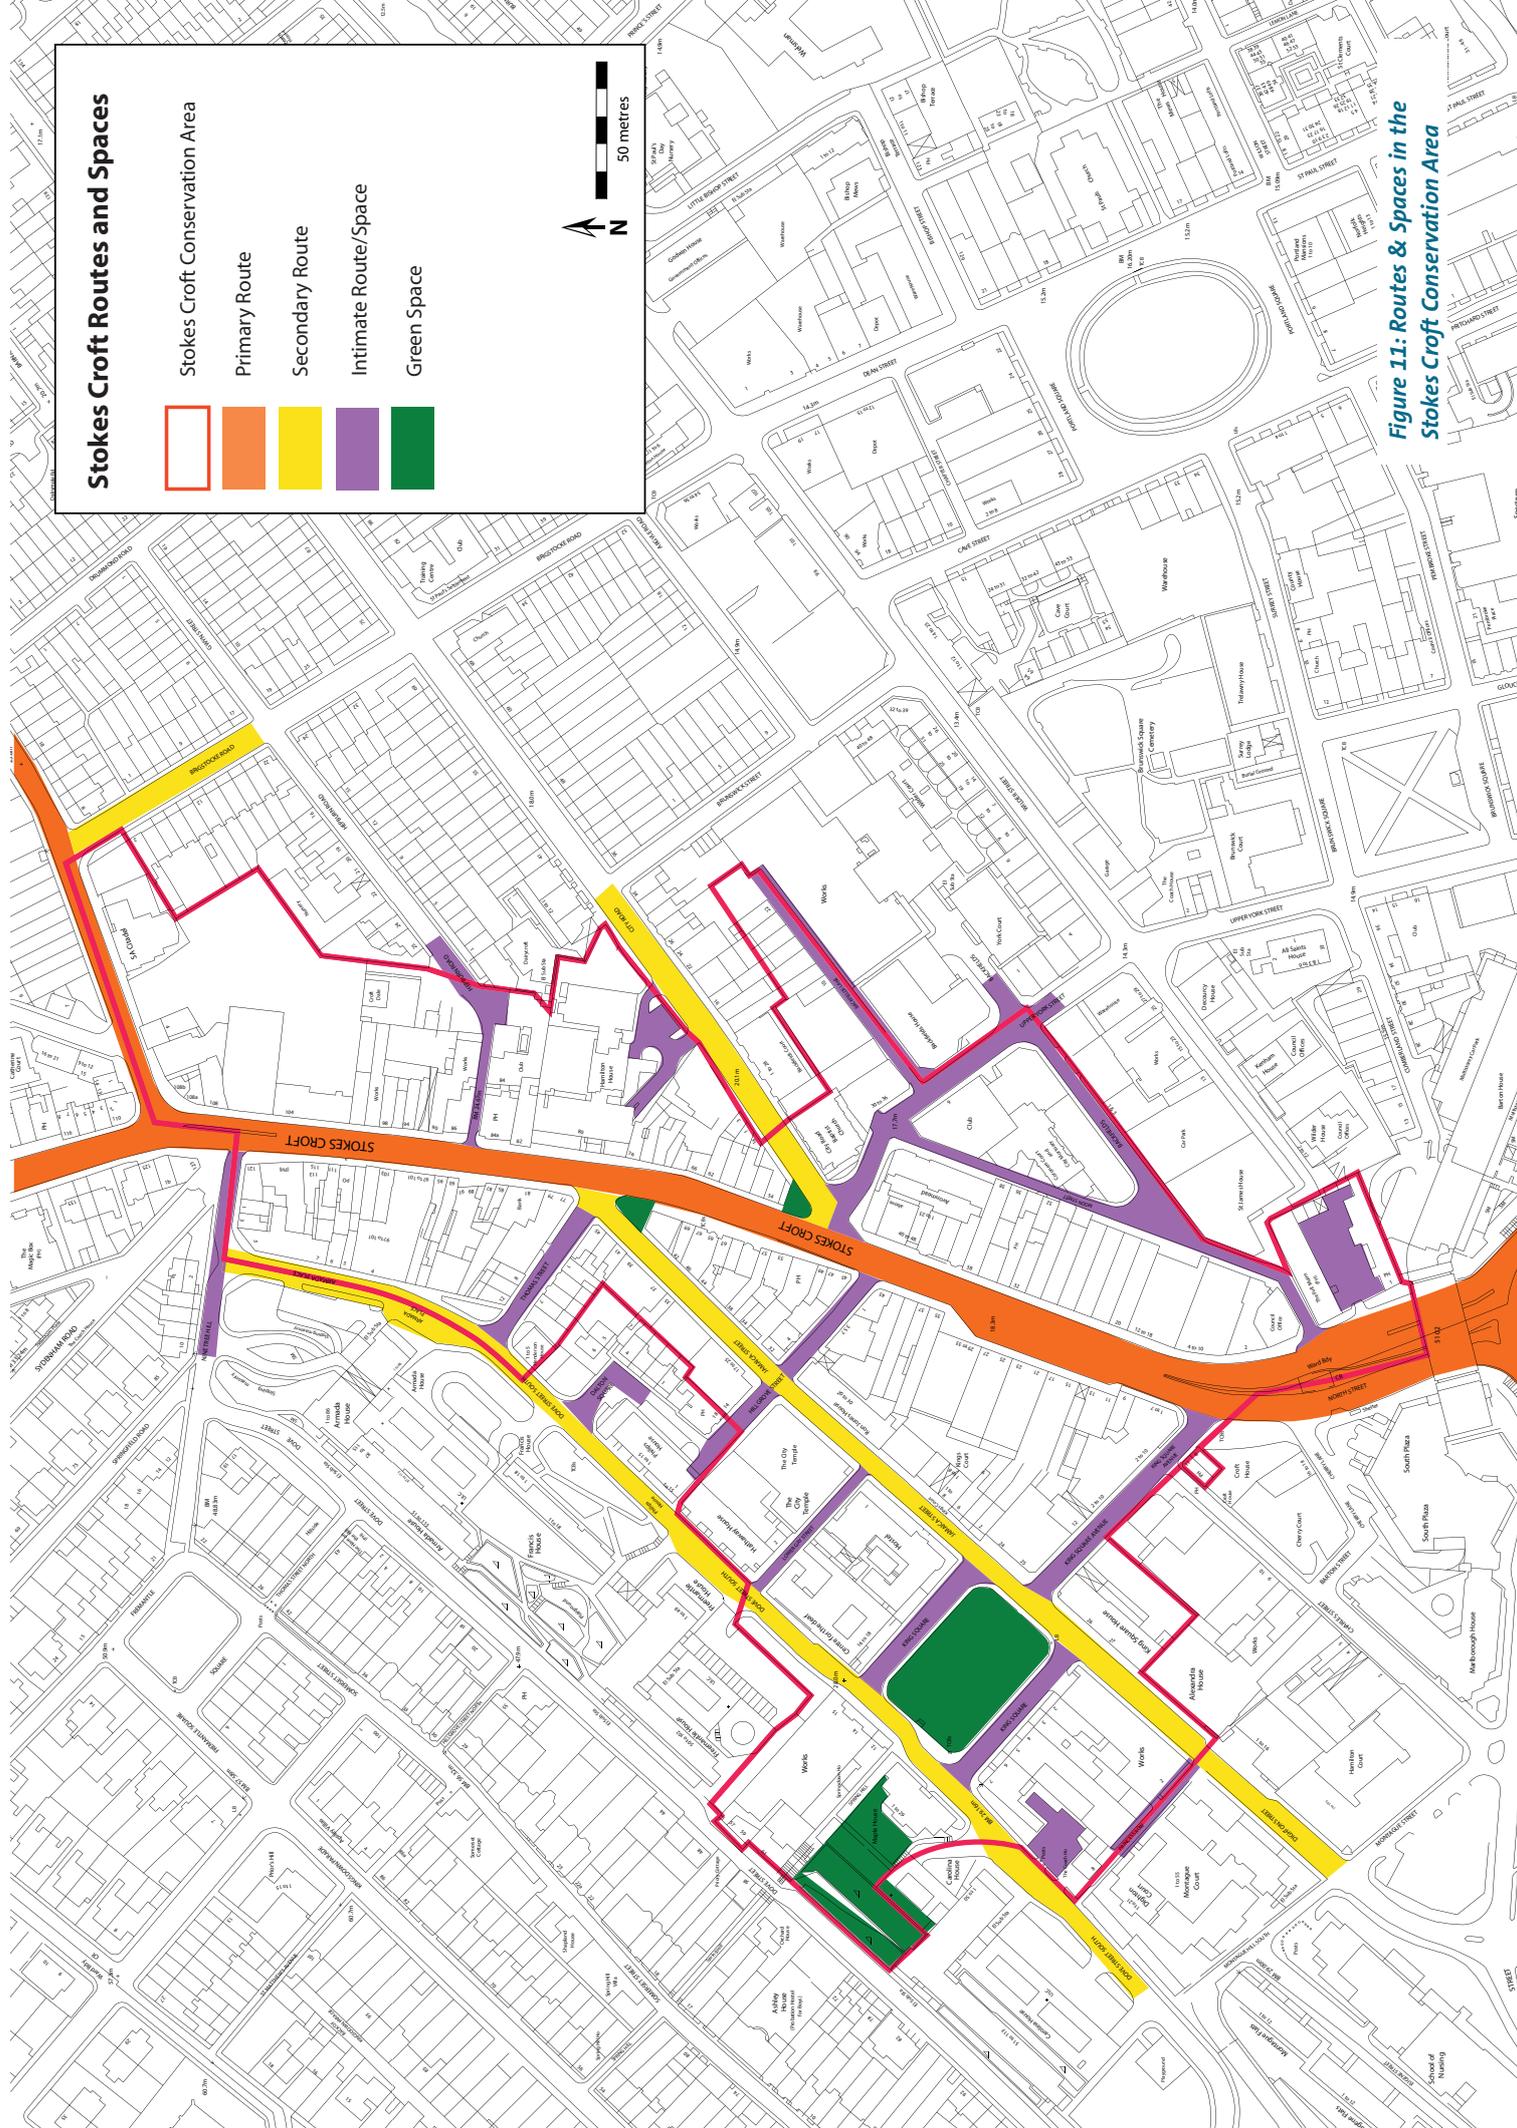
Figure 11: Routes & Spaces in the Stokes Croft Conservation Area

- 6.1.1 Stokes Croft is a major gateway into the City Centre from the northern parts of the Bristol and beyond, providing a through-route for both vehicles and pedestrians. Buildings along Stokes Croft generally front directly onto the pavement and occupy varying plot widths. After widespread bomb damage and a mid-20th century road widening scheme, buildings towards the southern end of Stokes Croft tend to be wider and sit further back on the west side.

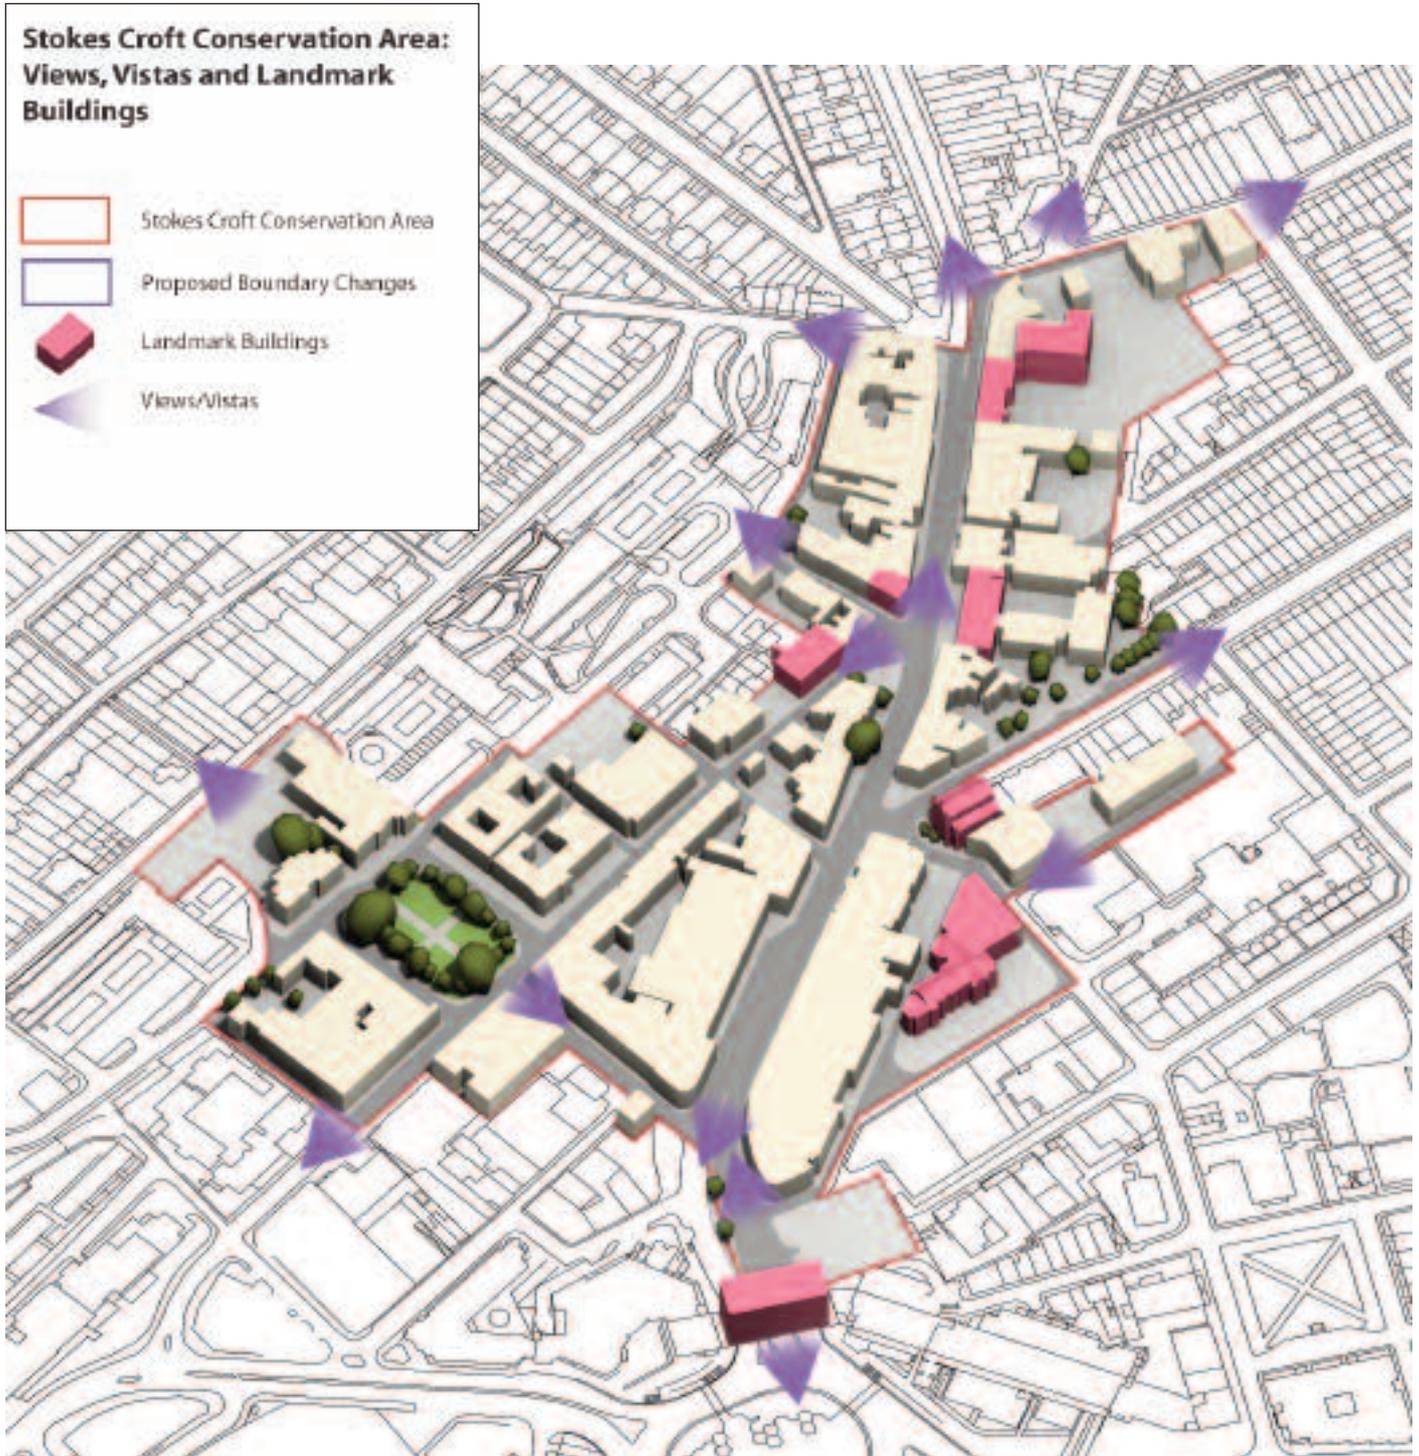
Figure 12: Views & Landmark Buildings in the Stokes Croft Conservation Area

- The Former Blundell’s Department Store, at nos. 77/79 Stokes Croft has a strong presence at the corner of Stokes Croft and Thomas Street.
- Finance House blocks views down Thomas Street. The extended plot width, materials and design are at odds with the rest of the Conservation Area. This building is also currently derelict.
- The former Coroners Court is the only Gothic style building surrounded by more industrial architecture. The presence of the building, originally a school, is emphasised by its setting within a large forecourt behind a high boundary wall.
- The former Malthouse (now Lakota Nightclub) is a local landmark due to its scale and prominent position on the corner of Moon Street and Backfields Lane.

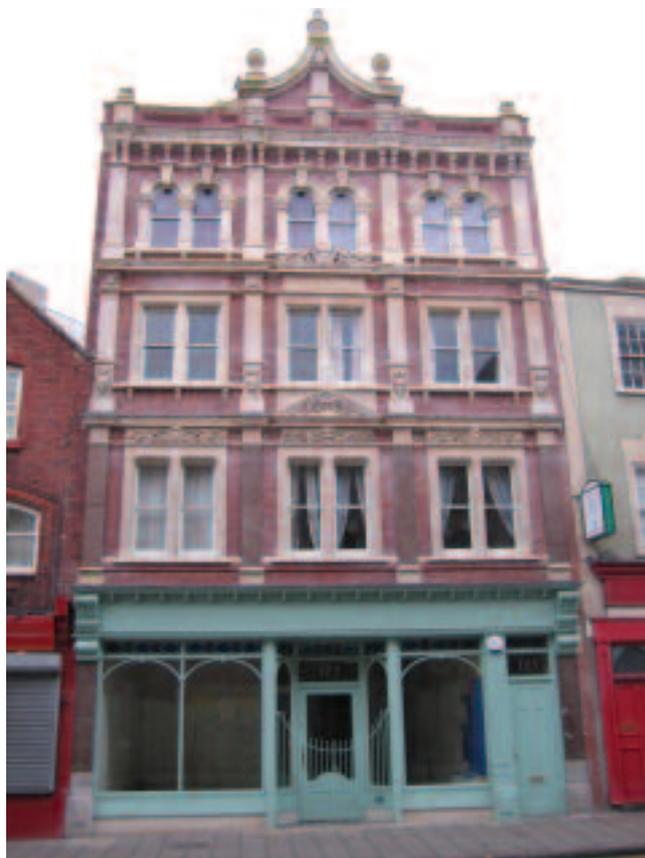
Figure 15: No. 113-115 Stokes Croft, example of a traditional building with shopfront at ground level and a vertical emphasis to the upper levels

7.2.3 Traditional developments tend to have a strong vertical rhythm, the narrow plot widths, with two to three floors above shopfronts at ground level. More recent additions have a more horizontal emphasis, and tend to occupy a number of traditional building plots. Glimpses of the rear elevations of properties reveal an ad hoc form of design, compared to the formality of the main frontages.

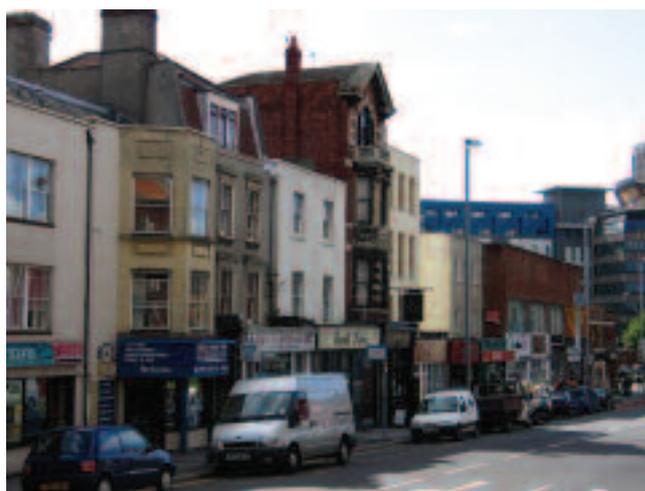
Figure 16: View down southeast side of Stokes Croft. Traditional buildings have narrower plot widths while 20th century buildings to the south are wider; '5102' ends views at the southern end

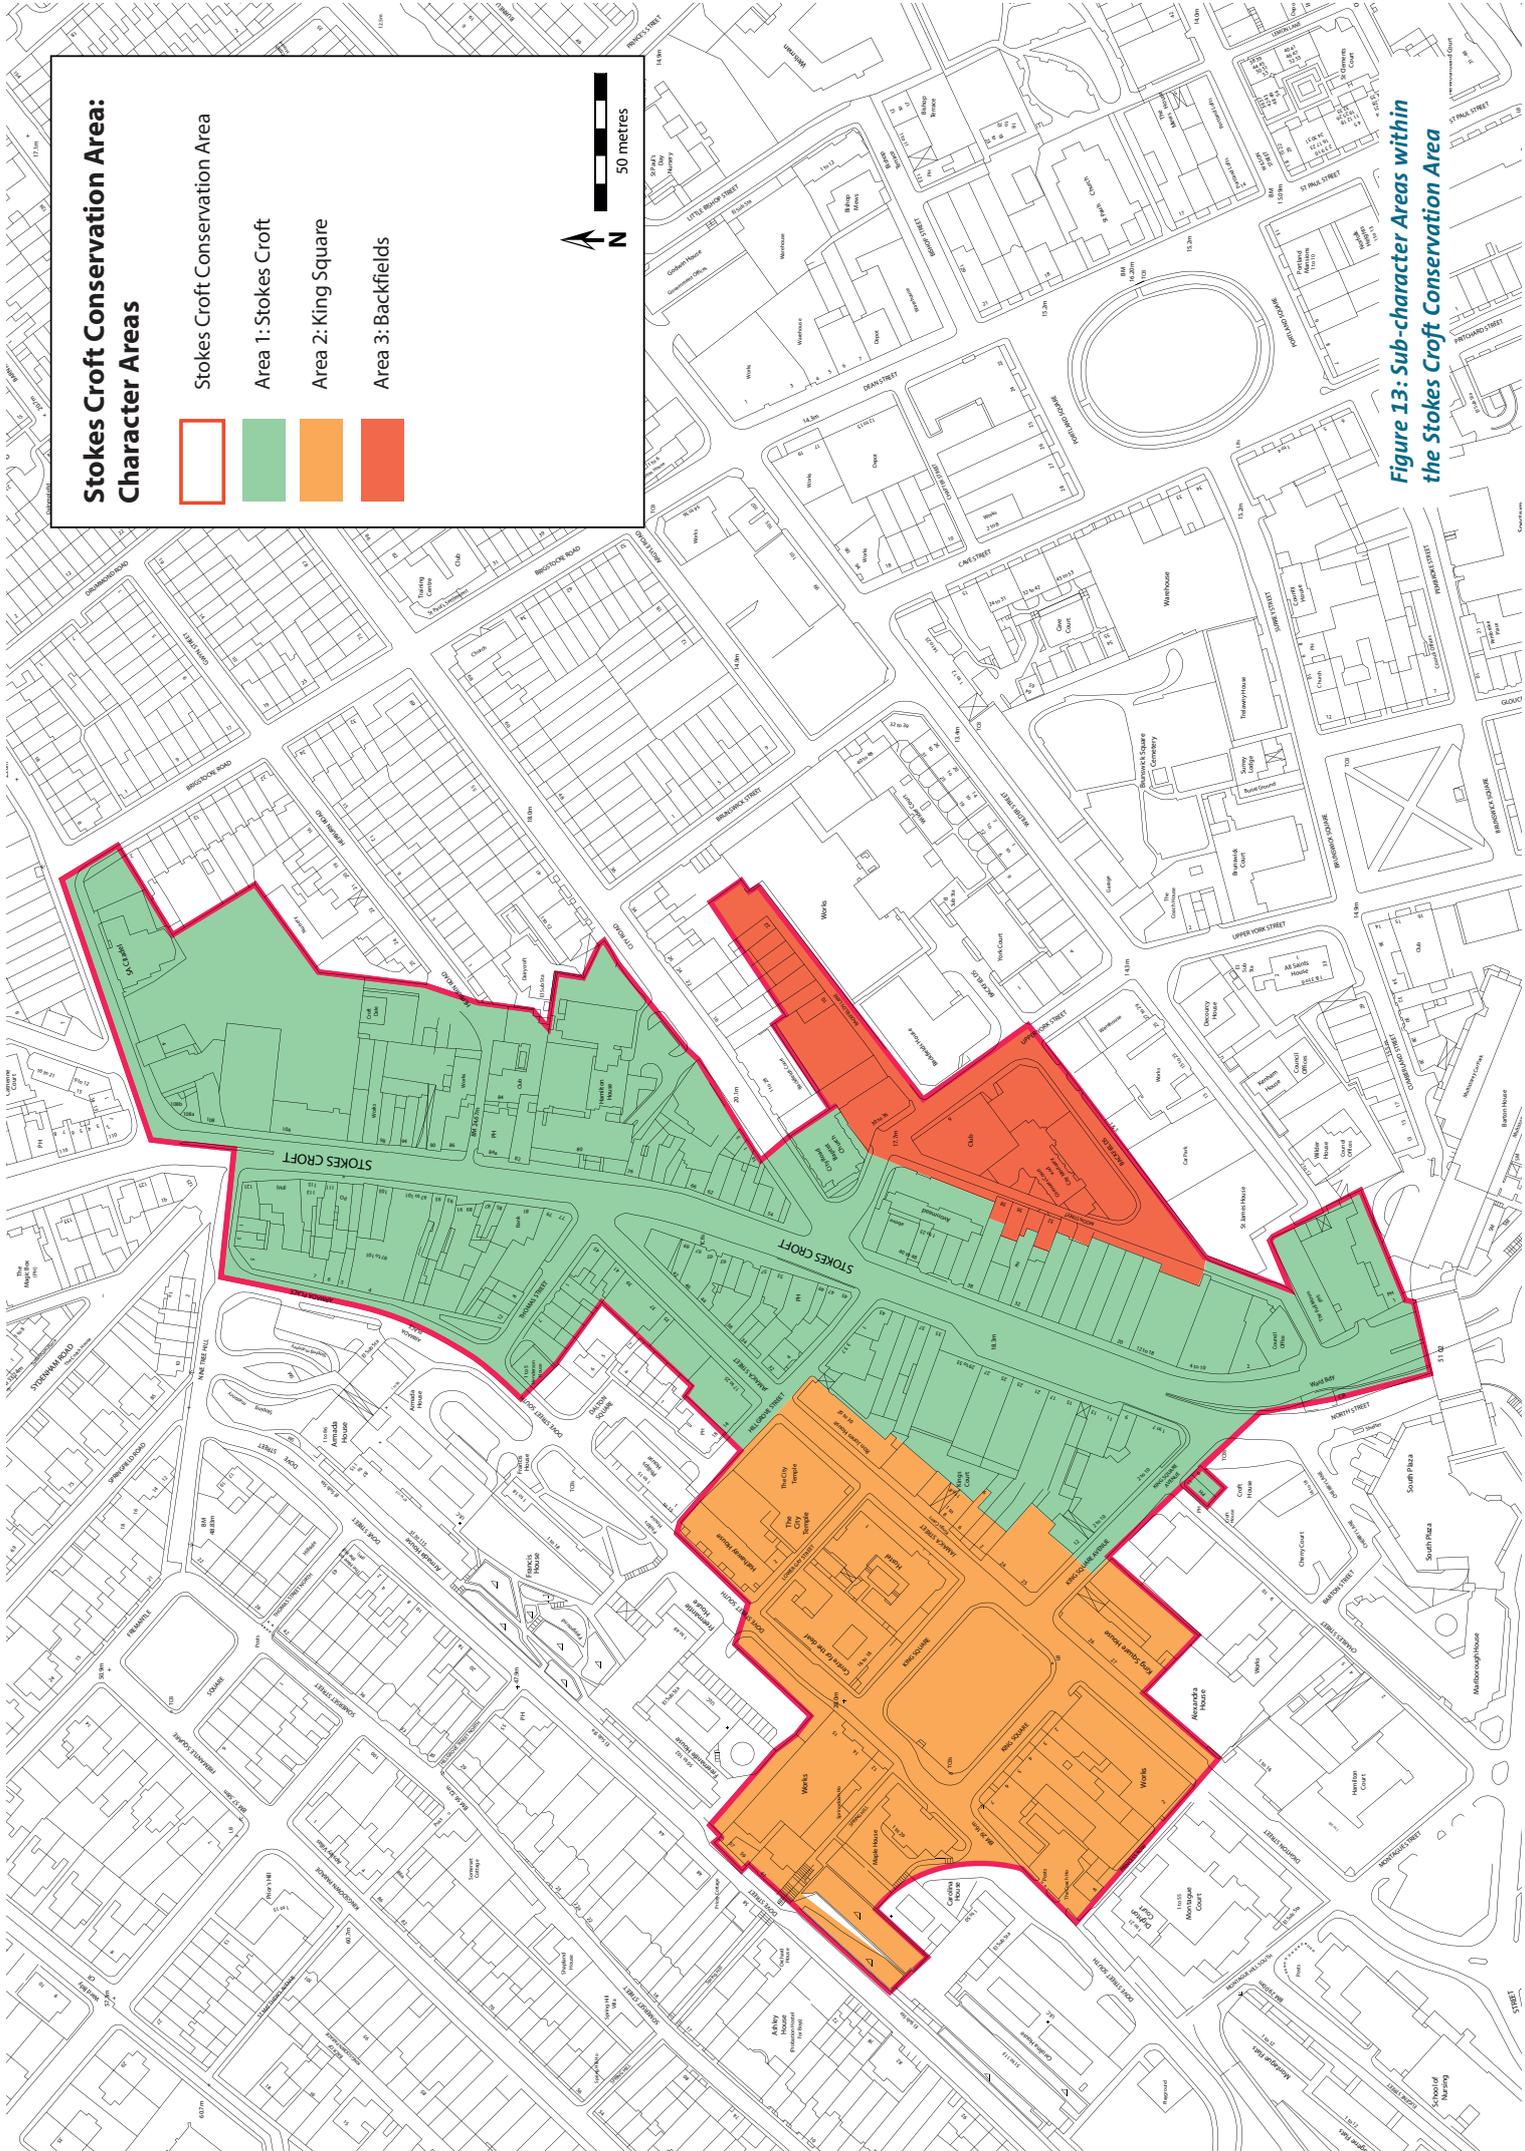
Figure 13: Sub-character Areas within the Stokes Croft Conservation Area

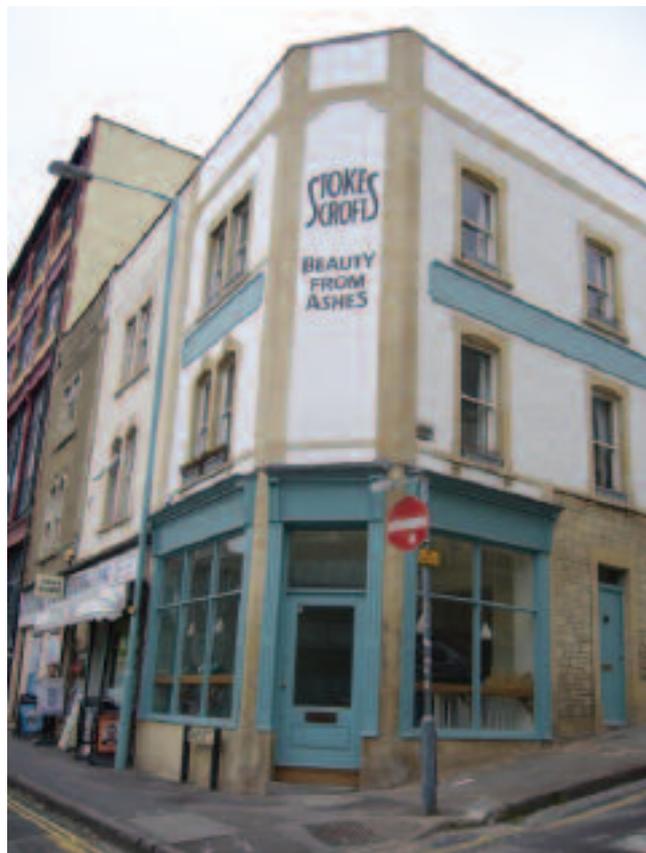
Figure 17: No. 45 Jamaica Street, a quality shopfront and sensitive renovation have recently been completed with positive effect. The simple painted signage on the upper elevation is also discreet but fitting contribution to the street scene

7.2.7 The area contains some traditional timber shopfronts, which make a significant contribution to the character of the area (see Townscape Detail section below). Poor quality shopfronts and signage still present a particular feature along Stokes Croft. A number of shopfronts in this character area have been recently reinstated or restored and now contribute to the quality of the environment.

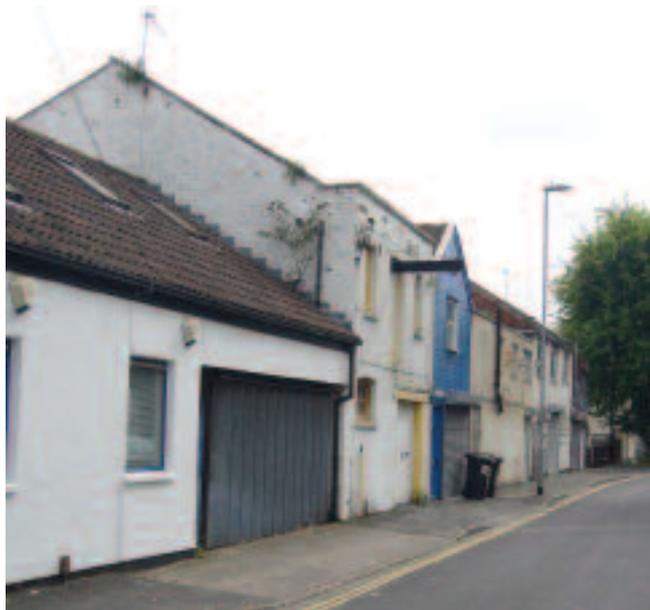
Figure 18: Former coach houses along Armada Place, which are currently vacant or used as workshops

7.2.8 The eastern side of Armada Place is included in this character area, which contains a group of former coach houses. These buildings have a utilitarian character, are just one or two storeys with simple pitched roofs and minimal architectural details. The form and character of these buildings, which vary in condition, reflect the informal spaces that historically existed behind the main street frontages.

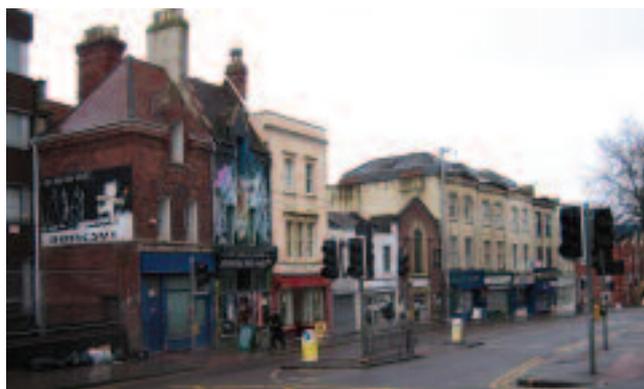
Figure 19: Banksy’s work on the side of no. 76 Stokes Croft, which has become a local landmark. Spray-painting that detracts from the quality of a building or damages brick or stone should be avoided.

7.2.11 A careful balance and appropriate management of spray-painted art works needs to be sought to prevent damage to historic surfaces such as brick and stone. One type of art should not overtly dominate the area with little respect for the character of the locality and the form and appearance of the building to which it is adhered.

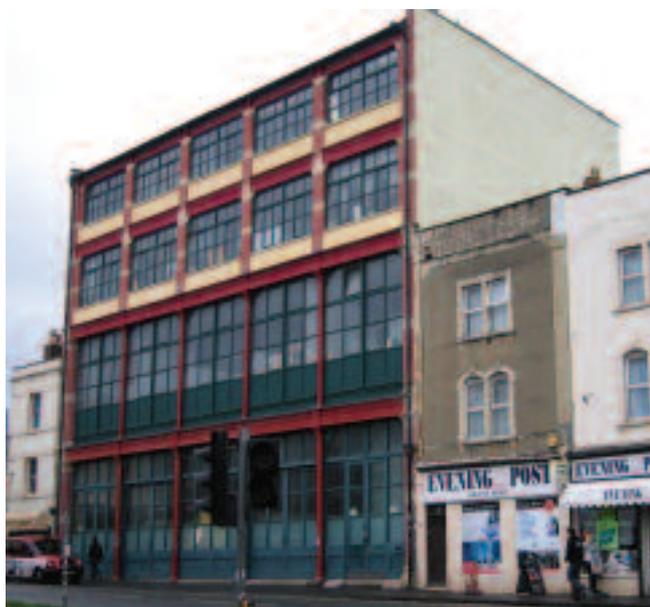
Figure 21: The Jamaica Street Studios at nos. 37-39 Jamaica Street, formerly a carriage works.

7.2.14 Jamaica Street Studios at nos. 37-39 Jamaica Street is a former carriage works and an early example of iron-framed construction. The double-height lower sections are iron-framed and fully glazed while the upper floors are in red brick with Bath stone bands. The building has been successfully restored through grant funding and is now occupied by local artists' studios.

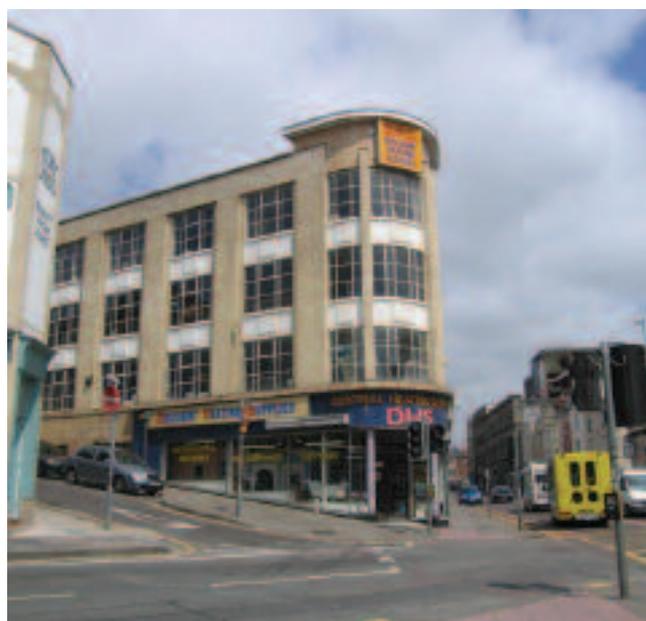
Figure 22: Former Blundell's Department Store, the prominent corner position makes it a local landmark

7.2.15 The former Blundell's Department Store at nos. 77-79 Stokes Croft by WH Watkins was constructed in the mid-20th century. The building has strong presence at the corner of Stokes Croft and Thomas Street and acts as a local landmark. The building is notable for its restrained design and upper storey glazing; unfortunately the ground floor shopfront and signage detract from the overall quality of the architecture.

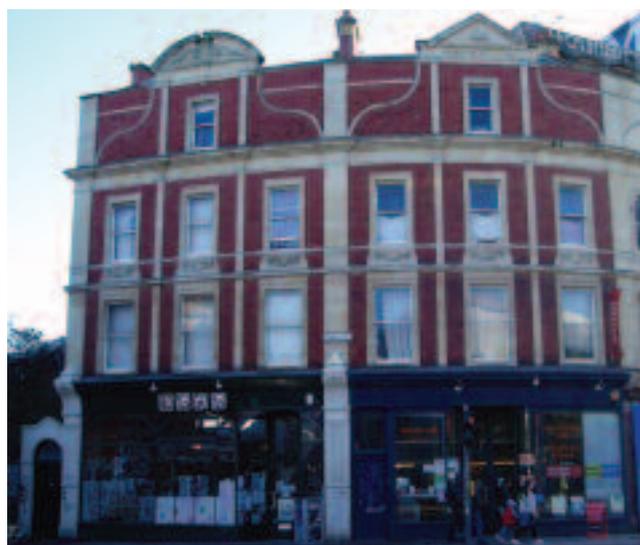
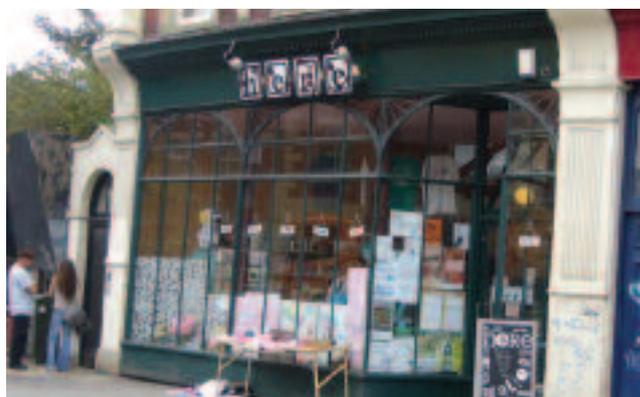
Figure 25 and 26: Tuckett's Buildings, which have attractive shopfronts at ground level

7.2.20 Tuckett's Buildings are a group of three late 19th century buildings that round the corner from Stokes Croft into Ashley Road. The left hand and central buildings are constructed of red brick with Bath stone dressings, while the right hand elevation is entirely stone-faced. There are attractive timber shopfronts at ground level, which retain much of their original character.

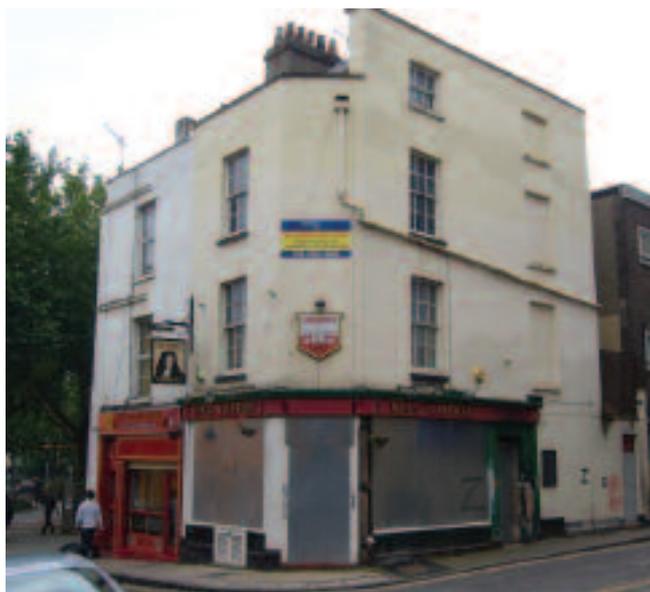
Figure 27: Nos. 9 & 11 King Square Avenue. These are currently in a poor condition though have retained some original architectural details and are worthy of Conservation Area protection to avoid their future redevelopment

7.2.21 Nos. 9 and 11 King Square Avenue were previously omitted from the Conservation Area. Currently vacant and in need of sensitive renovation, these buildings make a positive contribution to the character of the locality and retain a number of traditional architectural features and so have been included in Character Area 1.

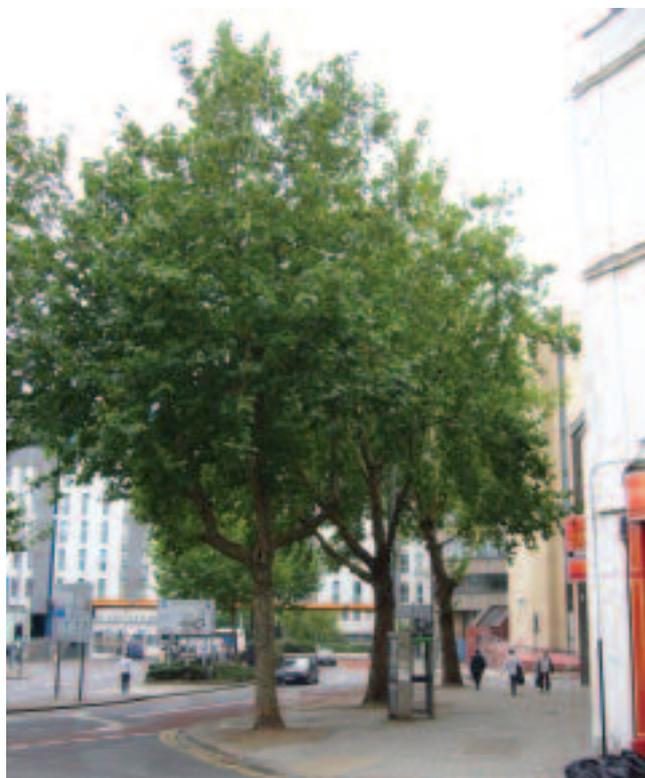
Figure 28: Street trees located towards the southern end of Stokes Croft. The planting of more street trees is would greatly enhance the local environment

7.2.23 There are few street trees within Area 1, those that exist help to soften the urban landscape, and make a positive contribution to the area. The protection of existing trees and planting of new ones, where practical, would greatly enhance the area.

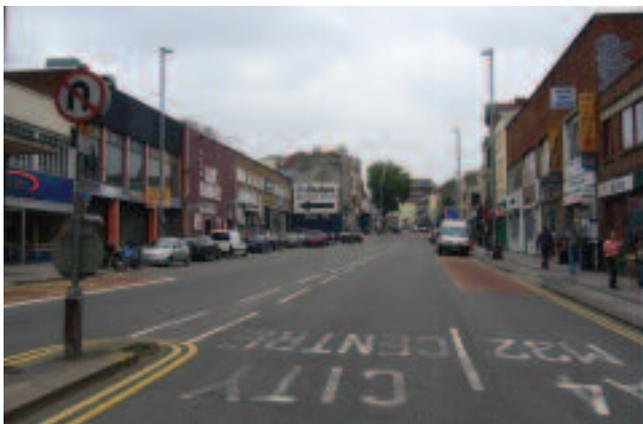
Figure 29: Southern end of Stokes Croft where the street becomes overly wide and hinders ease of pedestrian movement.

7.2.25 Pedestrian movement is a particular issue along Stokes Croft and there are poor mechanisms in place to aid navigation around the area. At the southern end of the street, the overly wide carriage way hinders pedestrian movement across the street. Towards the northern end of Stokes Croft, problems of the narrow pavements are increased by the proximity of fast and heavy traffic. Amenity and safety could greatly improve if pedestrian crossing points, pavement widths and traffic control were re-considered.

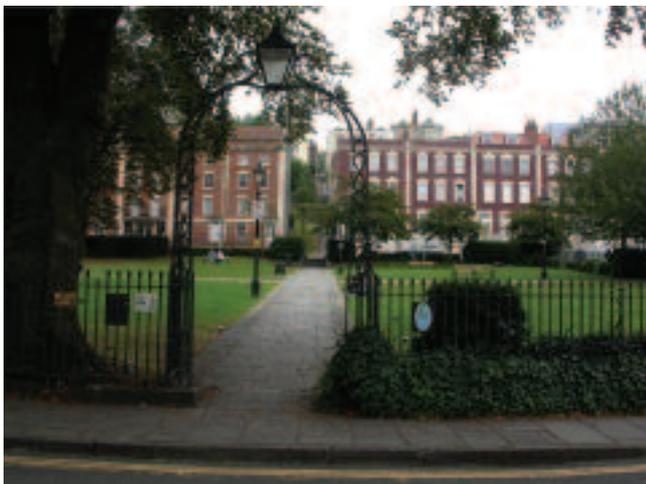
Figure 31: View across King Square to terraces on the northwest side. Those to the left are later 20th century and successfully respect the scale, materials and proportions of the original buildings to the right.

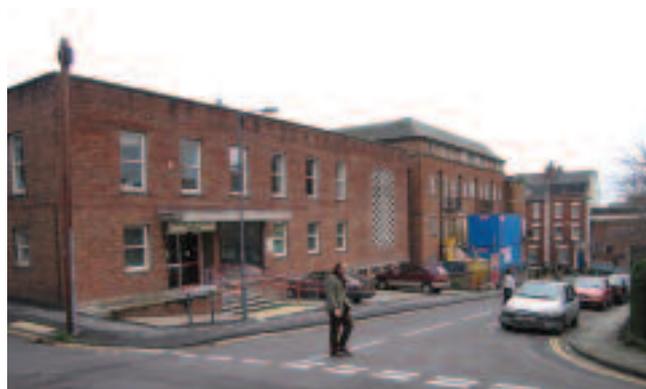
Figure 34: Although the Deaf Centre on the NE side uses red brick and respects the traditional building heights the horizontal emphasis and overall massing means it detracts from the character of the Square

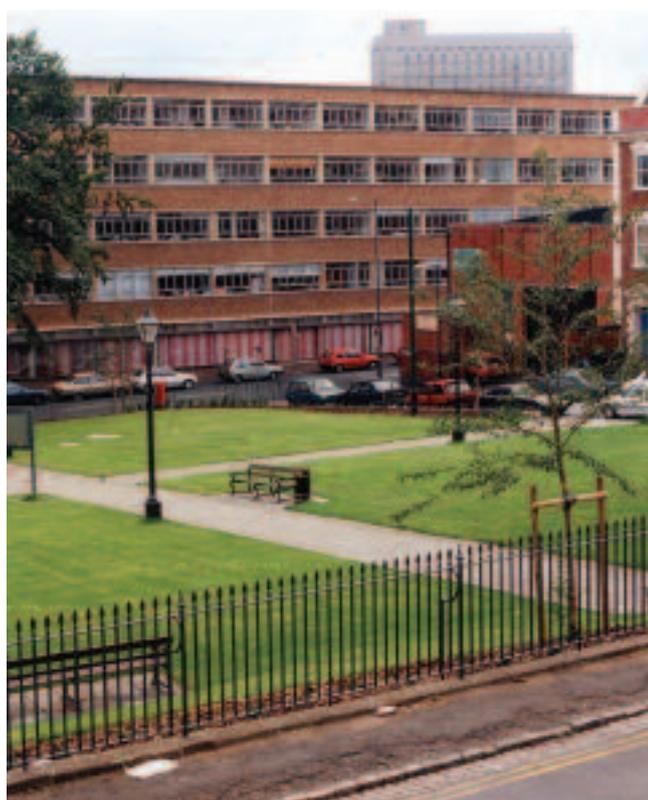
Figure 33: The substantial block on the SE side of the Square is out of character with the listed terraces nearby, notably due to its bulk and horizontal fenestration
