Conservation Area 19

Stokes Croft

Character Appraisal

October 2007

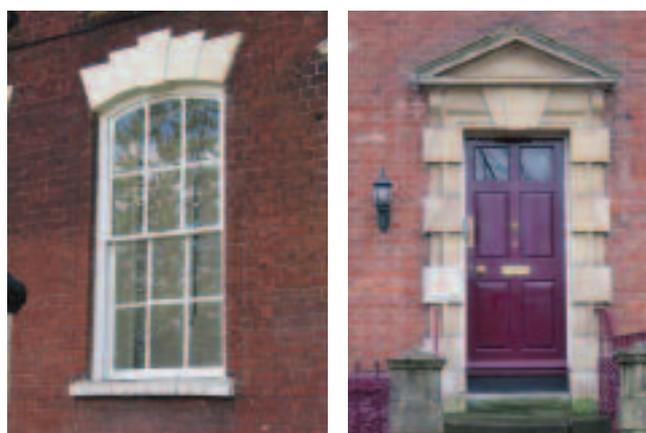
Figure 35: Traditional timber 6-over-6 sash window, with Bath stone header

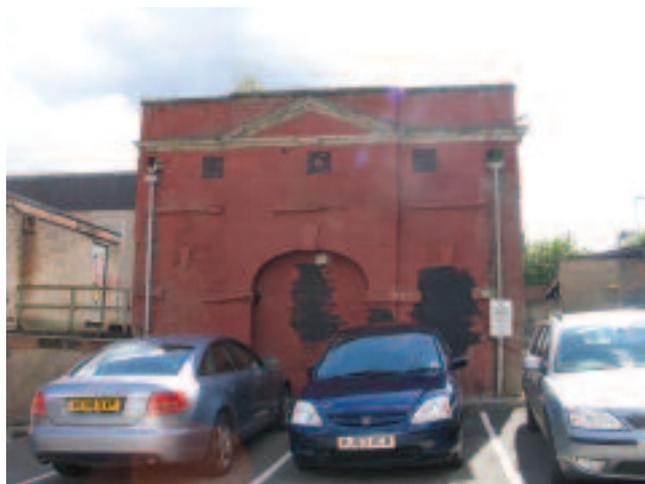
Figure 38: c. 1760 coach house behind King Square. The building is in currently derelict and in a poor state of repair.

7.2.37 Situated behind King Square, off Dove Street, is a small listed coach house building that dates from the Square's original development in the mid 18th century. The redbrick coach house, with stone details and pedimented parapet is in a poor state and stands derelict and forgotten. This building however is an important remnant of the service courts that are found behind the more formal terraces.

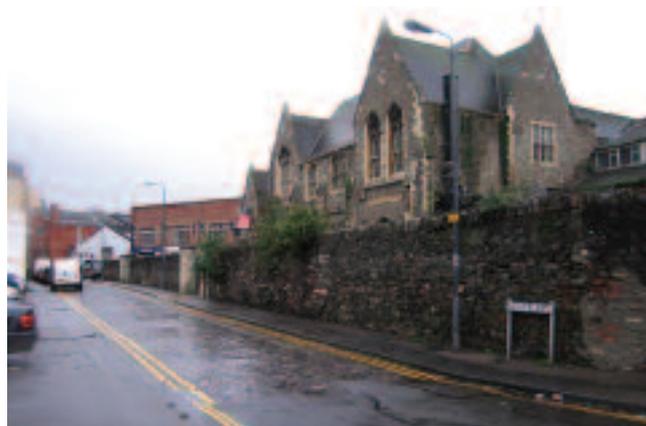
Figure 41: Former Coroners Court. The high Pennant stone boundary wall reflects the building's former use as a school and should be retained

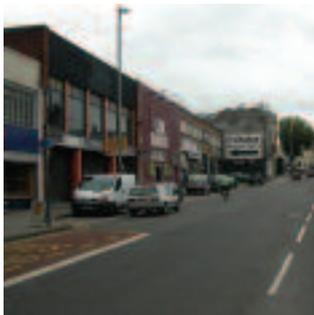
Figures 44 & 45: view northwards along Stokes Croft, showing how a poor quality streetscape can appear more acceptable when viewed through a framework of trees

7.3.1 Stokes Croft Conservation Area is predominantly characterised by a dense urban form, with buildings that address the street and little relief provided by street trees or green spaces. Where they matured, street trees make a vital contrast to the otherwise hard environment. New tree planting within the streetscape would present a real opportunity to enhance the character and appearance of the Conservation Area and improve the quality of the environment.

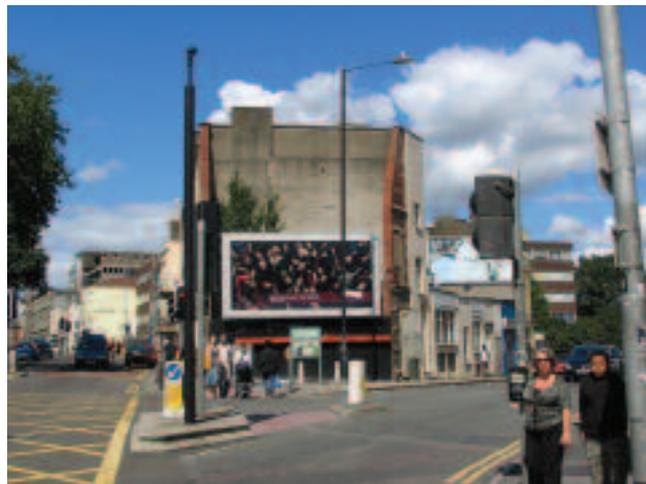
Figure 46: Site at corner of City Road and Stokes Croft that represents an opportunity for enhancement as a landscaped space within the Conservation Area.

7.3.3 The plot of land at the junction of Jamaica Street, Stokes Croft and Thomas Street (known as Turbo Island) and other spaces provide some relief from the dominant built form and add to the character of the Conservation Area. Some of these sites also present opportunities for enhancement and improvement through considered well-designed landscaping.

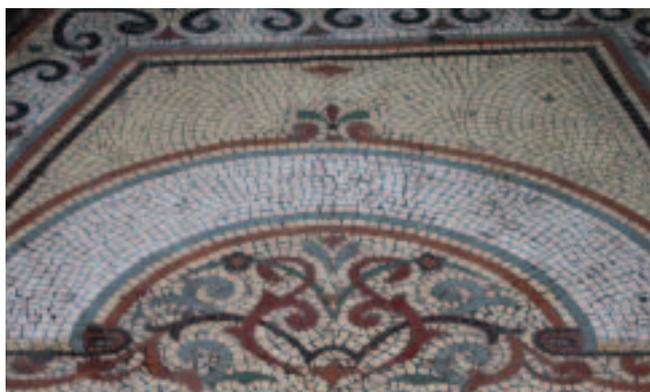
Figure 47: Traditional mosaic threshold to Stokes Croft shop

7.4.2 The majority of main routes through the Conservation Area are covered with tarmac, with footways typically in concrete slab paving. Pockets of historic surfaces are found in side streets, some of which include Pennant stone setts and kerbs, and some shop doorways retaining mosaic designs in their thresholds. Such traditional features greatly contribute to the special interest of the area and their removal should be strongly discouraged.

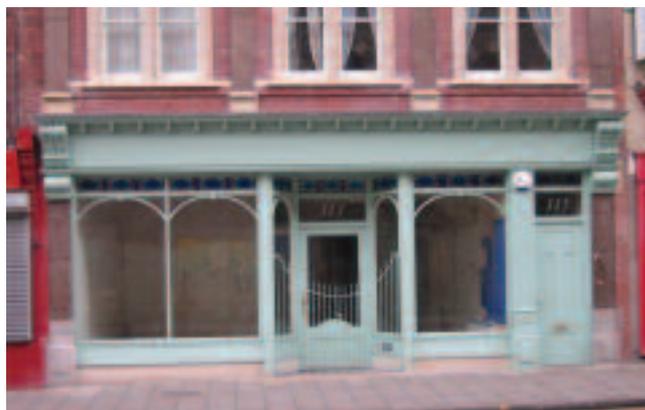
Figure 49: Traditional shopfront at no. 113 Stokes Croft which has been recently restored

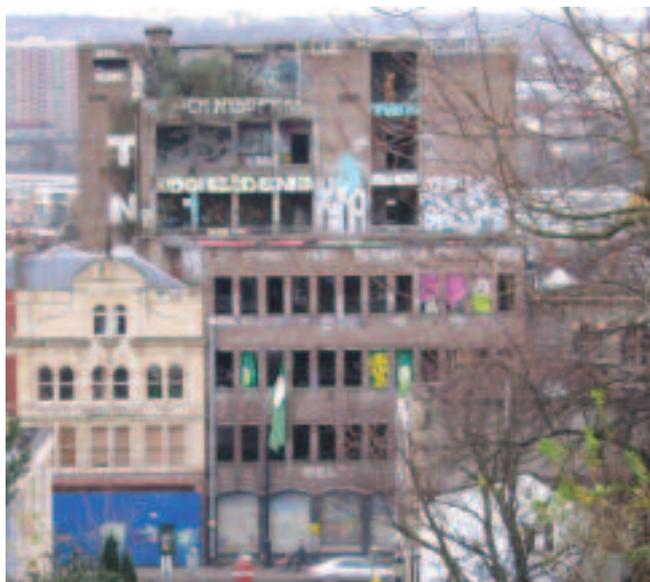
Figure 53: Westmoreland House

7.6.2 The number of disused or significantly run-down buildings is a particular issue, which is having a negative effect on the character and appearance on the Conservation Area. These buildings include:

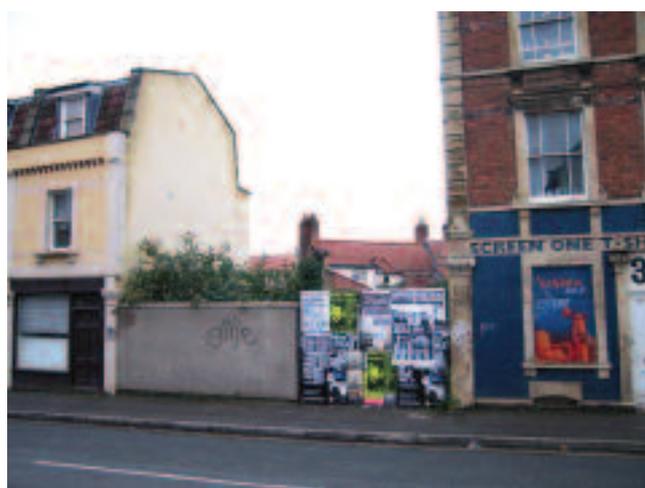
7.6.3 Gap sites also fail to make a positive contribution to the character of the locality; these aggravate the already neglected appearance of the Conservation Area and present an opportunity for appropriate redevelopment that enhances the conservation area and respect its character. Gap sites include:

Figure 55: Gap site between nos. 32 and 34 Jamaica Street

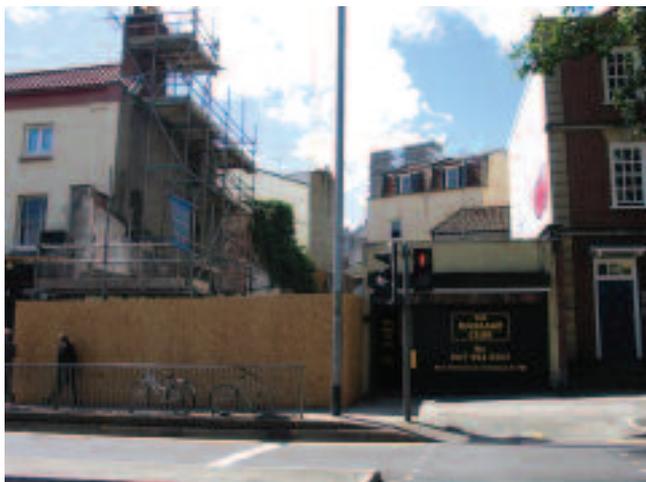
Figure 56: Land at no. 53 Stokes Croft

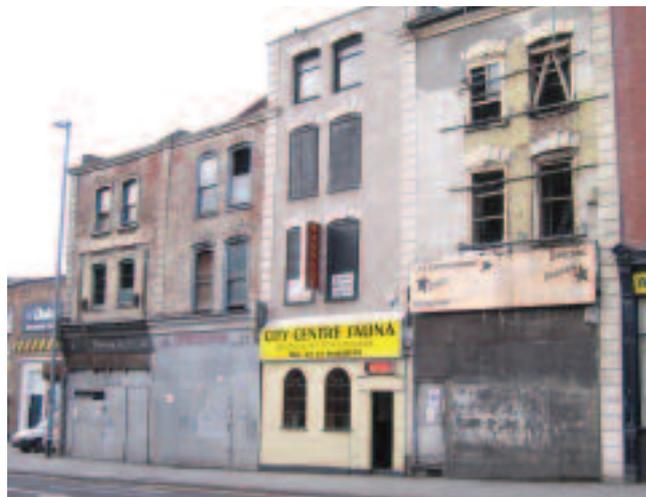
Figure 57: Buildings at Risk - nos. 35, 37 and 41 Stokes Croft

7.6.4 The Conservation Area also has a number of buildings that are identified on the Council's Buildings at Risk Register. In addition to buildings on the Council and English Heritage At Risk Registers, many more buildings have been poorly maintained and add to a sense of neglect in the area. In their current condition, these buildings fail to make a positive impact on the character and appearance of the area and contribute to its sense of neglect. Buildings At Risk include:

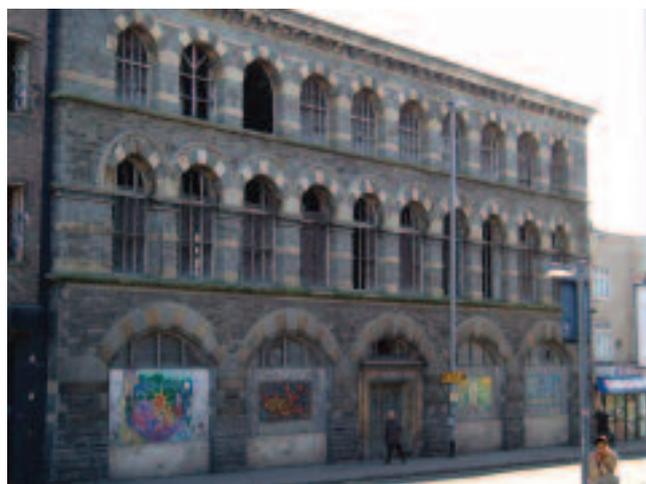
Figure 58: Former Perry's Carriage Works

5.13 In 1912, Perry sold to Anderson's Rubber Co. who occupied it until 1960. It was then taken over by the Regional Pools Company, since 1979 it has stood empty. During the 1960's the adjacent site no. 106 Stokes Croft was redeveloped with the building known as Westmoreland House, this too remains empty and awaits redevelopment.

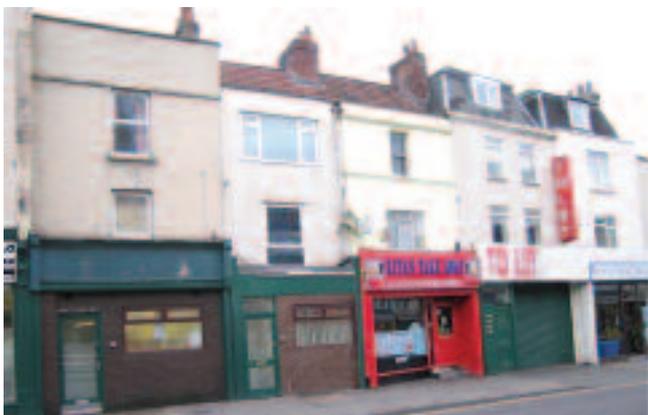
Figure 59: Nos. 90 – 98 Stokes Croft, the quality of these buildings has been seriously undermined by the insertion of poorly designed shopfronts and signage and low-grade uPVC windows

7.6.6 The gradual erosion of small-scale architectural details can have a significant negative impact on the character of an area. Windows and doors are frequently replaced with uPVC or non-traditional examples. Where they remain, traditional architectural details should be preserved and restored; and reinstatement of lost features sought where possible.

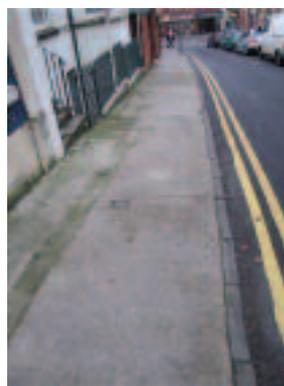
Figure 60: Mixed and varying quality street surfaces is gradually degrading the attractiveness of the street environment

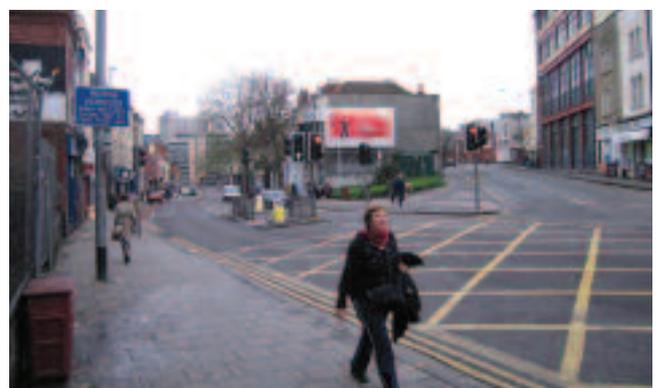
Figure 61: Yellow box junction at the Stokes Croft/Jamaica Street corner. There is also a proliferation of street furniture in this area
