BARTON HOUSE

STRUCTURAL ROBUSTNESS ASSESSMENT - PHASE 2

February 2024

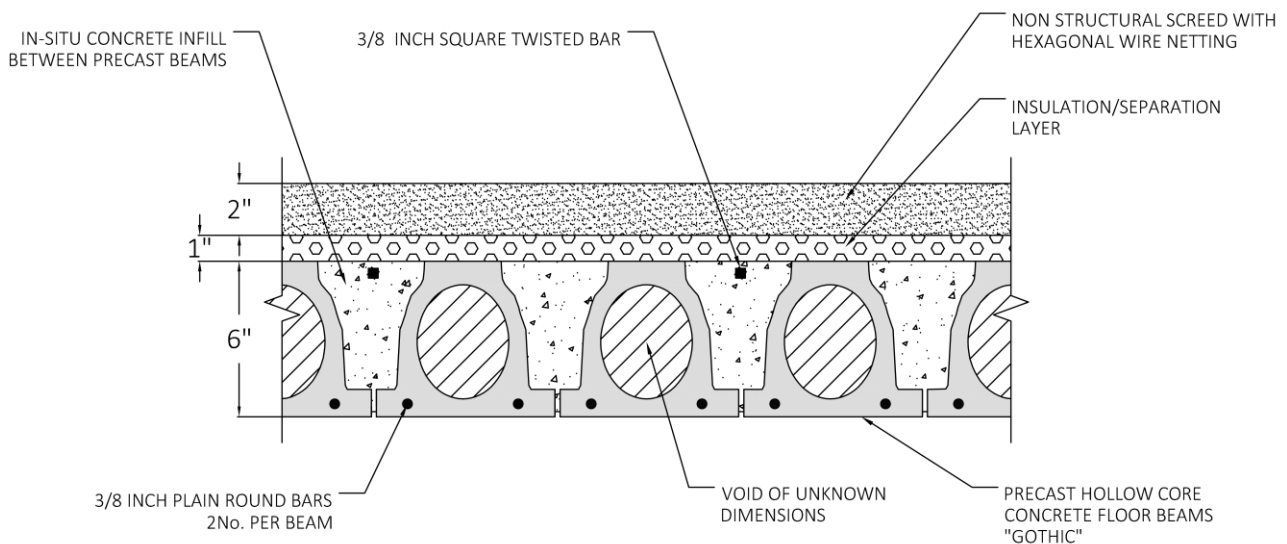
Figure 2: Representation of existing precast concrete slab makeup at tie locations

The first floor consists of a 12" ($\approx 304\text{mm}$) thick in-situ concrete slab and is conventionally reinforced. The slabs above (levels 2 to roof) are being constructed out of 6" ($\approx 152\text{mm}$) deep precast concrete hollow beams, described as "Gothic Beams", spanning between cross walls with a clear span of 13 feet ($\approx 3962\text{mm}$) wall to wall. Each precast beam has 2 bottom plain bars running along the beam's length protruding into the walls either side Figure 2. In order to form the slab, gaps between the beams are filled with in-situ concrete and topped with 25mm of insulation and 50mm thick screed nominally reinforced with hexagonal steel netting of no structural significance.

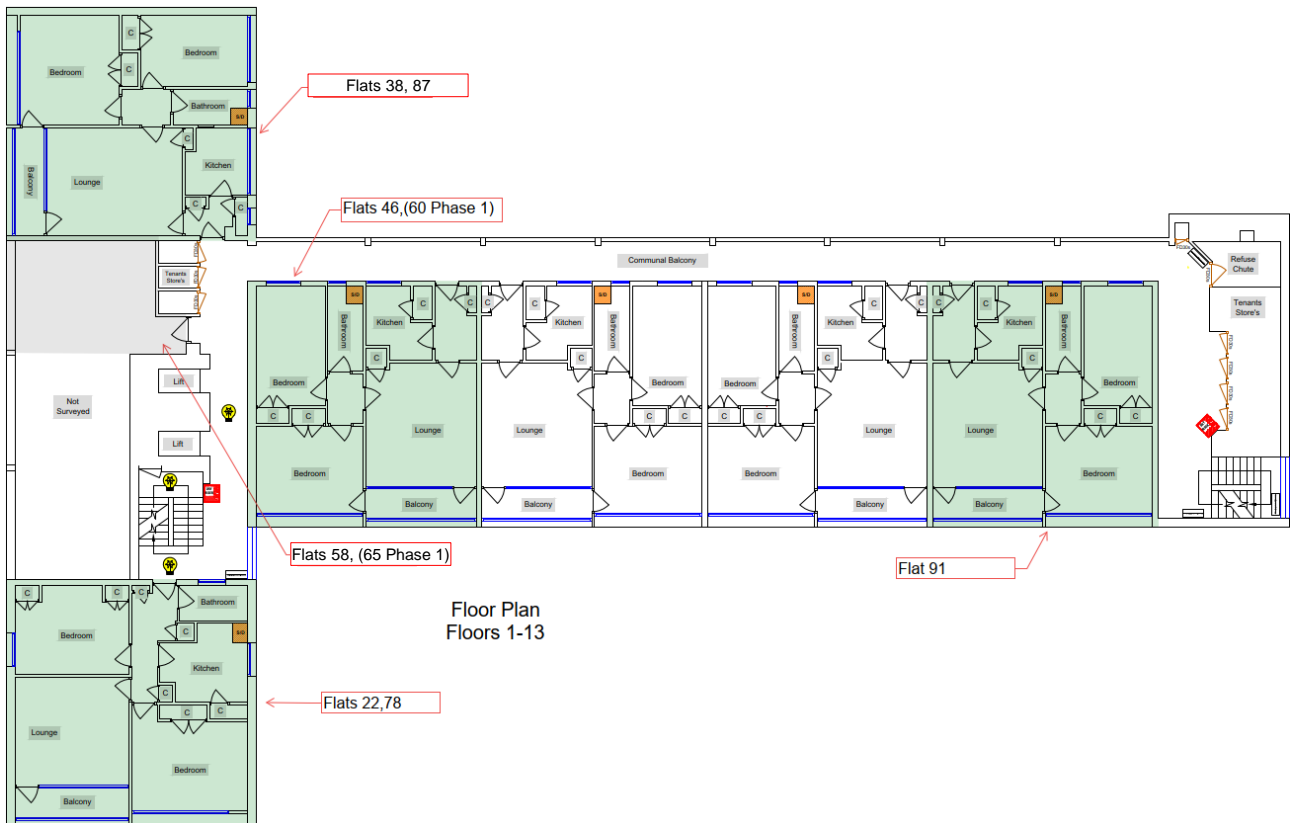
Figure 4: Typical plan view of Barton House, Phase 1 and 2 intrusive investigation locations.

Several flats were identified in order to carry out the intrusive investigations with the aim to cover most of the critical elements within the structure. Amongst these were the three flats accessed during the 2022 intrusive investigations, flats No. 60, 65 and 78. However, from these three, only flats No. 78 and 60 were made available for access during the second phase of investigations. Flat No. 78 was one of the flats where provision of ties was deemed to be questionable during phase 1. Additionally, flats No. 22, 38, 46, 58, 87 and 91 were accessed as can be seen in Figure 4 below. Combined with Phase 1, approximately 10% of the total number of flats were surveyed during both phases on different floor levels of the structure.

The survey was carried out in Flats 22, 46, 58, 78, 87 and 91. The location and results of this survey can be seen in Appendix B.

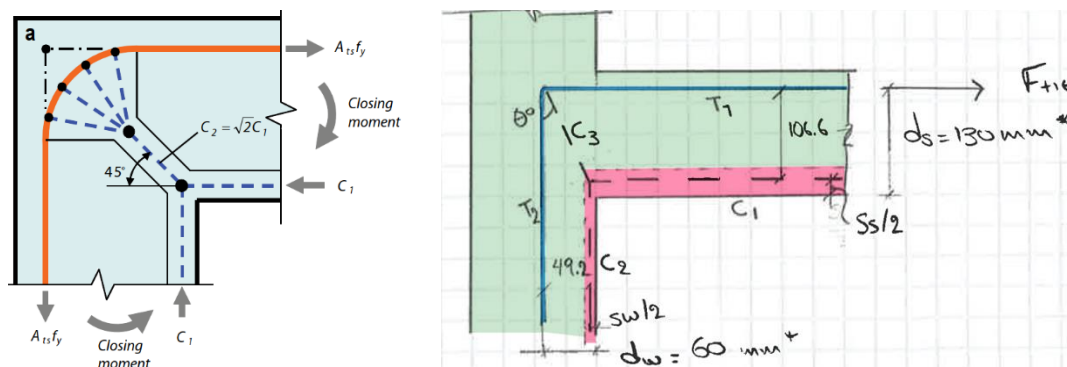
Figure 9: Strut-and-tie model of forces concept (left) [10], flank wall strut-and-tie analysis model of Barton House (right)

Although the majority of ties have been provided as intended, a workmanship error was consistently observed when exposing the flank wall horizontal ties (Scenario 1). The original design intent was for the horizontal ties to be lapped at the rear face of the wall (Figure 6 left). Doing so would have ensured that the force applied in the ties would be equal throughout the tie itself. However, the as built condition suggests that the horizontal ties were installed just at the back of the front face wall reinforcement (Figure 6 right) providing an embedment of approximately 60 mm. The location of the flank wall ties in relation to the front of the wall exacerbates the force experienced by the ties. The method to analyse such condition and its effects is described below.

There is little information in the codes about how to check the capacity of the concrete and the behaviour of the node of an L-shaped embedded bar. Following a review of design literature, the most appropriate way found to analyse such condition was presented in a 2008 paper by Gary J. Klein titled "Curved Bar Nodes" [10], the concept of which is shown in Figure 9 below. The concept behind the curved bar nodes is based on a strut and tie method. When two connecting elements are of equal geometry the force in the tie is uniform and equals to the force applied at the face of the support. When one of the two elements are of different geometry, the force between T_1 and T_2 is relevant to the lever arm correlation between C_1 and C_2 respectively as the Product $T_1 * d_s = T_2 * d_w$ and hence $T_2 = T_1 * d_s / d_w$. Since d_s is approximately 2.16 times greater than d_w the force exerted in the tie T_2 should be 2.16 times of T_1 . A more codified approach to this concept can be found in PD 6687-1:2010 figure B [11].

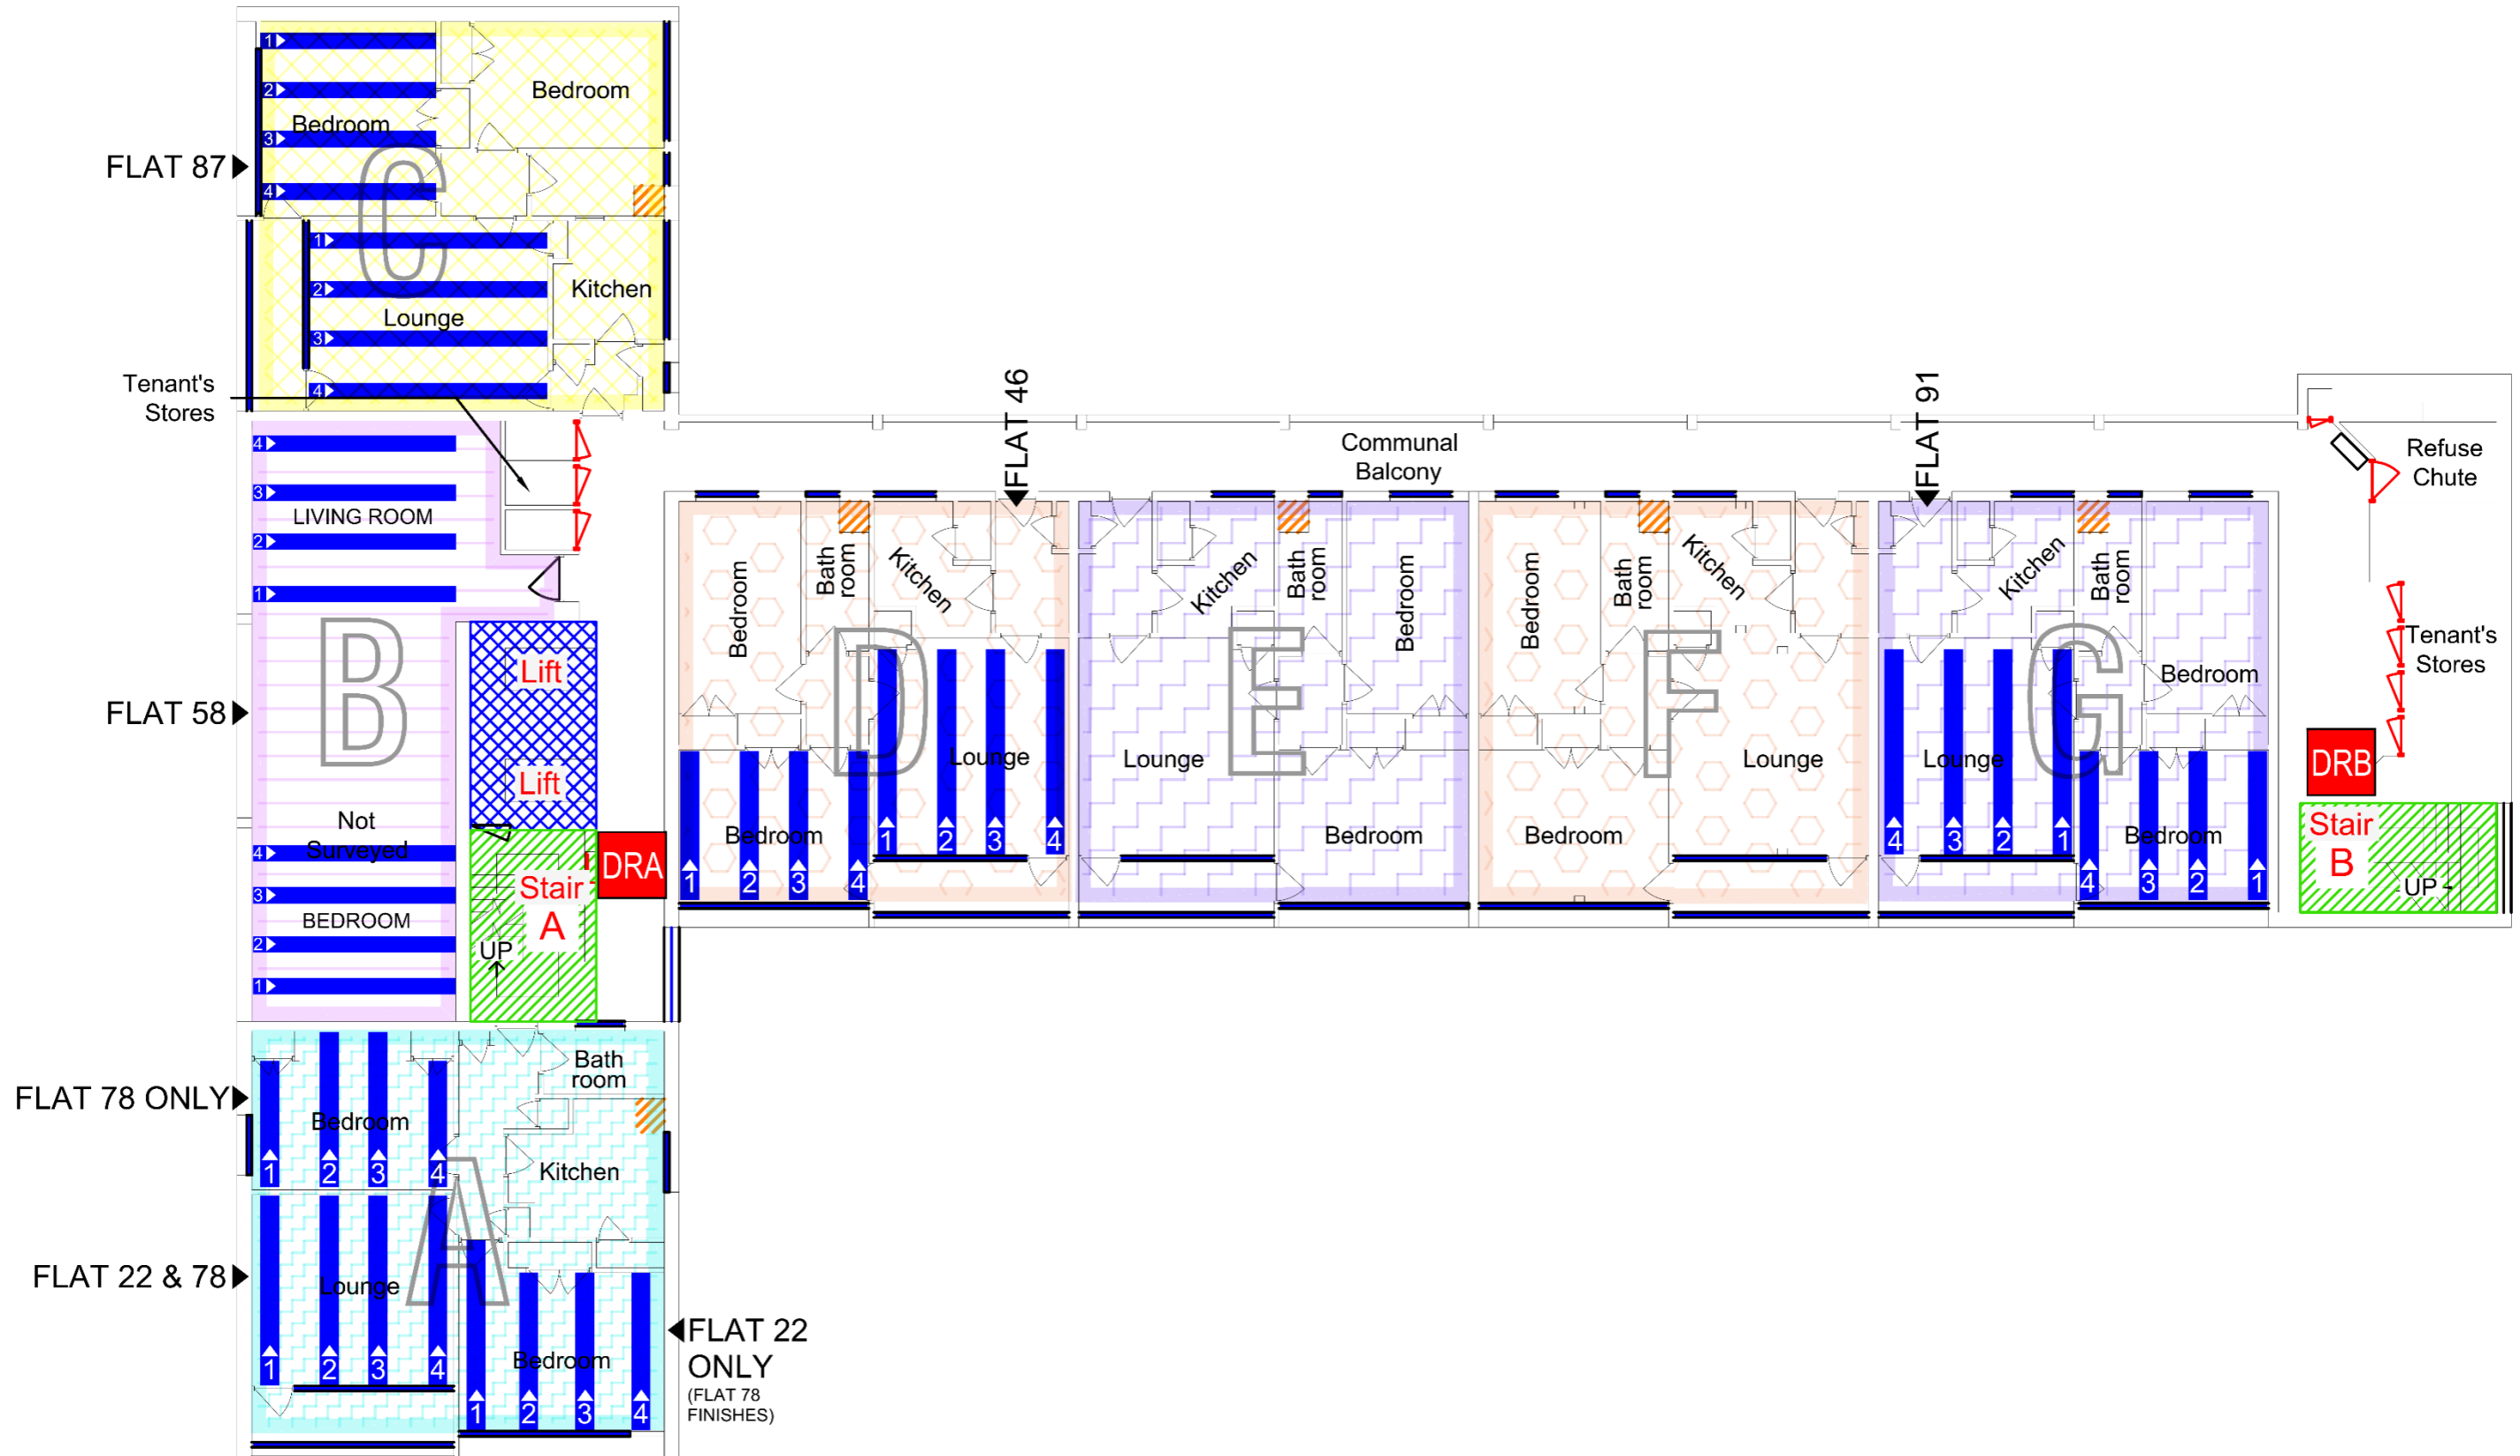
Key Plan 1: Overview of cover metre scan locations

In addition, a measured cover meter survey was carried out on the soffit on a number of flats to establish the existing condition of the cover provided to the precast beam rebar.
