**ST JUDES – JOHN COZENS
STRUCTURAL ROBUSTNESS ASSESSMENT**

BRISTOL CITY COUNCIL
November 2024

ST JUDES- JOHN COZENS STRUCTURAL ROBUSTNESS ASSESSMENT

November 2024

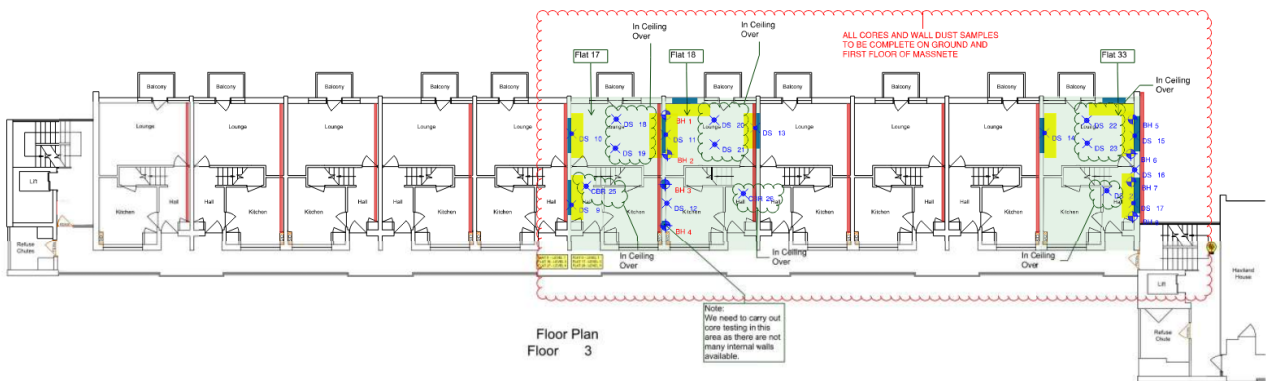
Figure 8 – Third floor plan for John Cozens showing the flats inspected.

The floor plans shown in Figures 8 & 9 highlight the locations of the investigations undertaken within the block. Flats 17, 18, 33 and 43 were subjected to the intrusive opening up works.

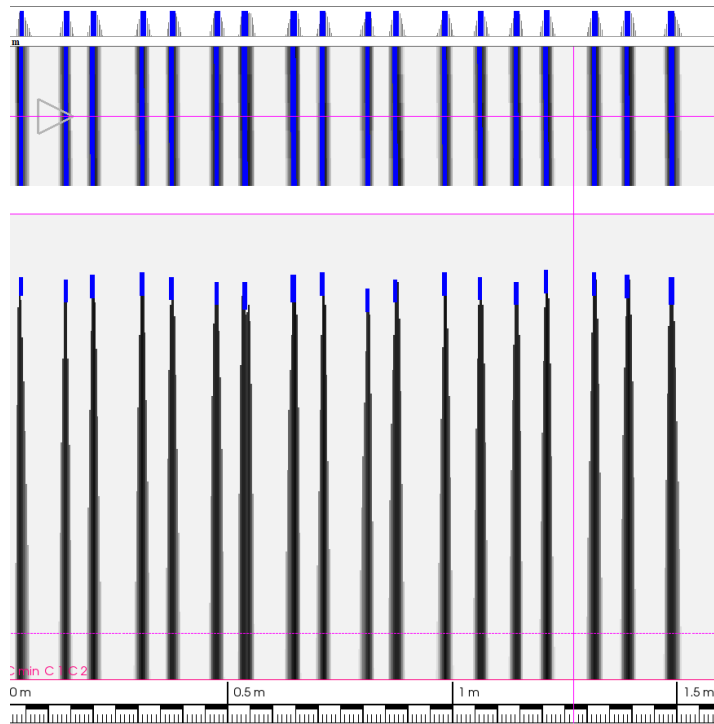
Figure 17 - Ferro scan of John Cozens floor soffit

- Scans of the gothic beam floors with the ferro scanner identified the bottom reinforcement size, spacing and diameter.

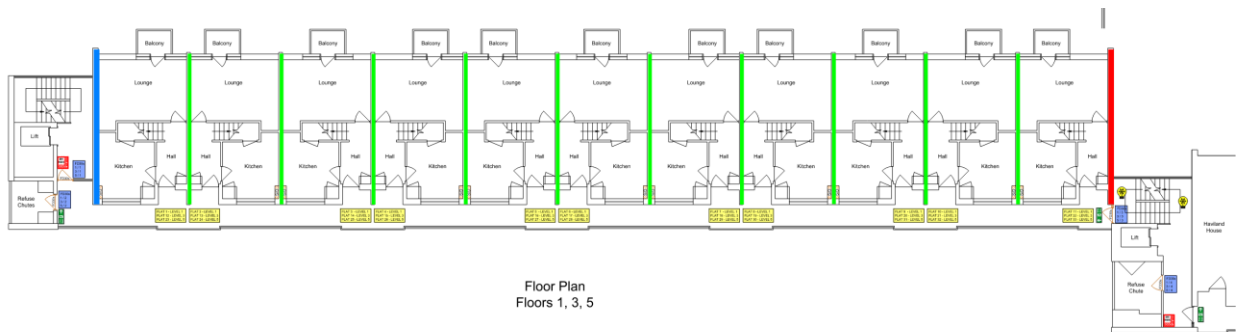
Figure 18 – John Cozens typical floor layout showing "key element" locations

The key elements, herein referred to as In-situ Flank Walls (shown in Blue), Precast Cross Walls (Green), Precast Flank Walls (Red) and Floor Slabs, were investigated to understand the construction. The construction of each is outlined below, with details of the embedded reinforcement and any notes against the element for variations in construction observed during the scanning & intrusive investigations.

The investigations into the flank walls show that one flank wall is in-situ reinforced concrete and the other is precast as highlighted in Figures 18. The flank walls were found to blockwork inner leaf to the inside face of the flank wall, likely as a previous remedial action.

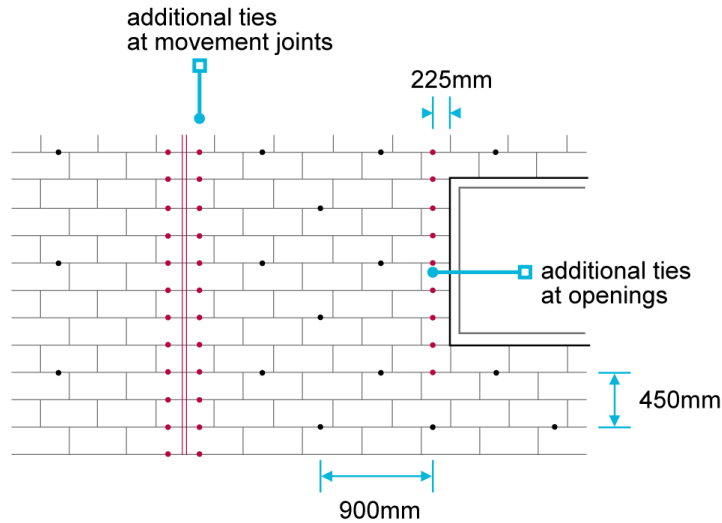
Figure 27 - Typical Wall tie detail (Ref NHBC Standard 6.1.18)

The external front and back walls that infill between the structural cross walls are a double skin blockwork wall constructed from 75mm light weight blockwork with window and door openings inset. The masonry walls were noted in many instances to not be properly tied across the cavity and tied to the structural cross walls.

As indicated in Figure 27 wall ties across a cavity should generally be provided at 450mm vertical centres and 900mm horizontal centres, with additional ties provided around openings. In most instances one or two ties were found in the external wall panels and no additional wall ties were found around window and door openings. Additionally, there were limited ties between each masonry skin and the structural cross walls. It was noted that the cross walls had cast in wall ties, however most cases these had not been used when building the walls. The instructive investigations only allowed this to be reviewed in the inner skin of the cavity wall and therefore assessment of the outer skin cannot be made.

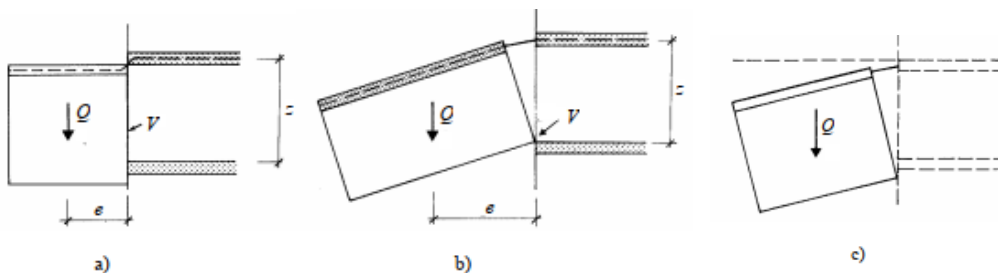
Figure 35 - Examples of collapse mechanisms for a cantilevering wall above a damaged area, a) joint slip mechanism, b) rotation mechanism, c) combined slip-rotation (fib, 2008)

Unsatisfactory - Unable to Mobilise Alternative Load Paths

The inability to mobilise alternative load paths combined with the anticipated failure of elements under accidental loading conditions could result in any one of the below mechanisms occurring.
