**ST JUDES – LANGTON HOUSE  
STRUCTURAL ROBUSTNESS ASSESSMENT**

**BRISTOL CITY COUNCIL**  
January 2025

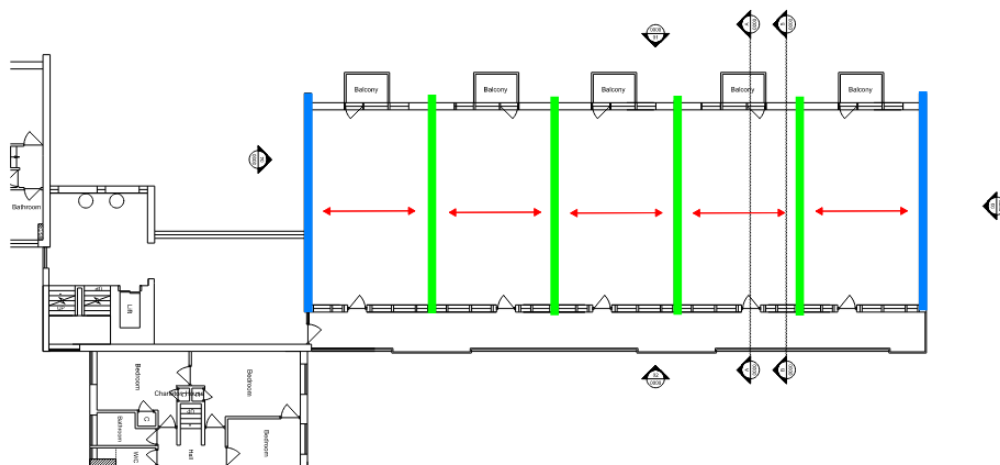
Figure 17 – Langton House typical floor layout showing "key element" locations.

The key elements, herein referred to as In-situ Flank Walls (shown in Blue), In-situ Cross Walls (Green), and Floor Slabs (Red Arrows), were investigated to understand the construction. The construction of each is outlined below, with details of the embedded reinforcement and any notes against the element for variations in construction observed during the scanning & intrusive investigations.

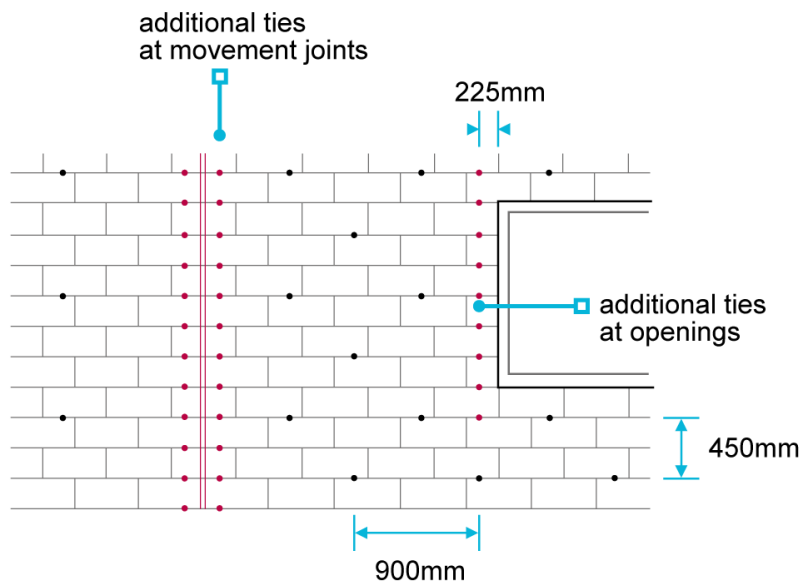
Figure 21 - Typical Wall tie detail (Ref NHBC Standard 6.1.18)

As indicated in Figure 19 wall ties across a cavity should generally be provided at 450mm vertical centres and 900mm horizontal centres, with additional ties provided around openings. In most instances one or two ties were found in the external wall panels and no additional wall ties were found around window and door openings. Additionally, there were limited ties between each of the masonry skins and the structural cross walls. The instructive investigations only allowed this to be reviewed in the inner skin of the cavity wall and therefore assessment of the outer skin cannot be made.
