# Cotham & Redland

Character Appraisal & Management Proposals

September 2011

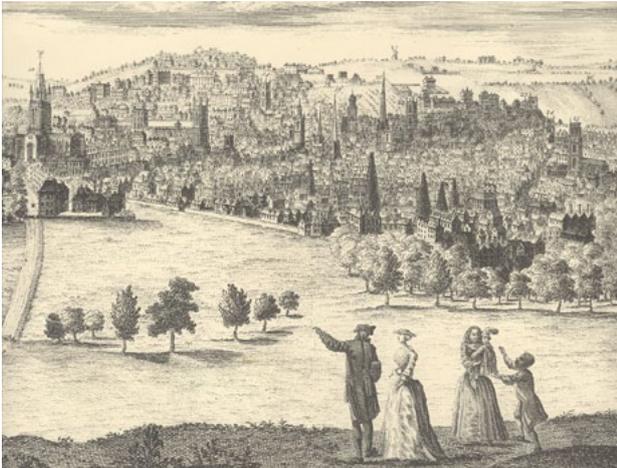
Figure 1: Detail from 'South East Prospect of Bristol' by S & N Buck, 1734 showing Cotham Lodge & the windmill on the brow of the distant hill

5.11 S & N Buck's Prospect of Bristol, 1734, shows Cotham to be open fields, the only buildings being a four-sailed windmill sited on the top of the hill and a palatial gabled residence to the east (Cotham Lodge). The mill was recorded from c. 1670 onwards. By the 18<sup>th</sup> century it had developed into a snuff manufactory, but in 1779 it was rebuilt as an observatory or prospect tower, Cotham Tower (demolished in 1953).

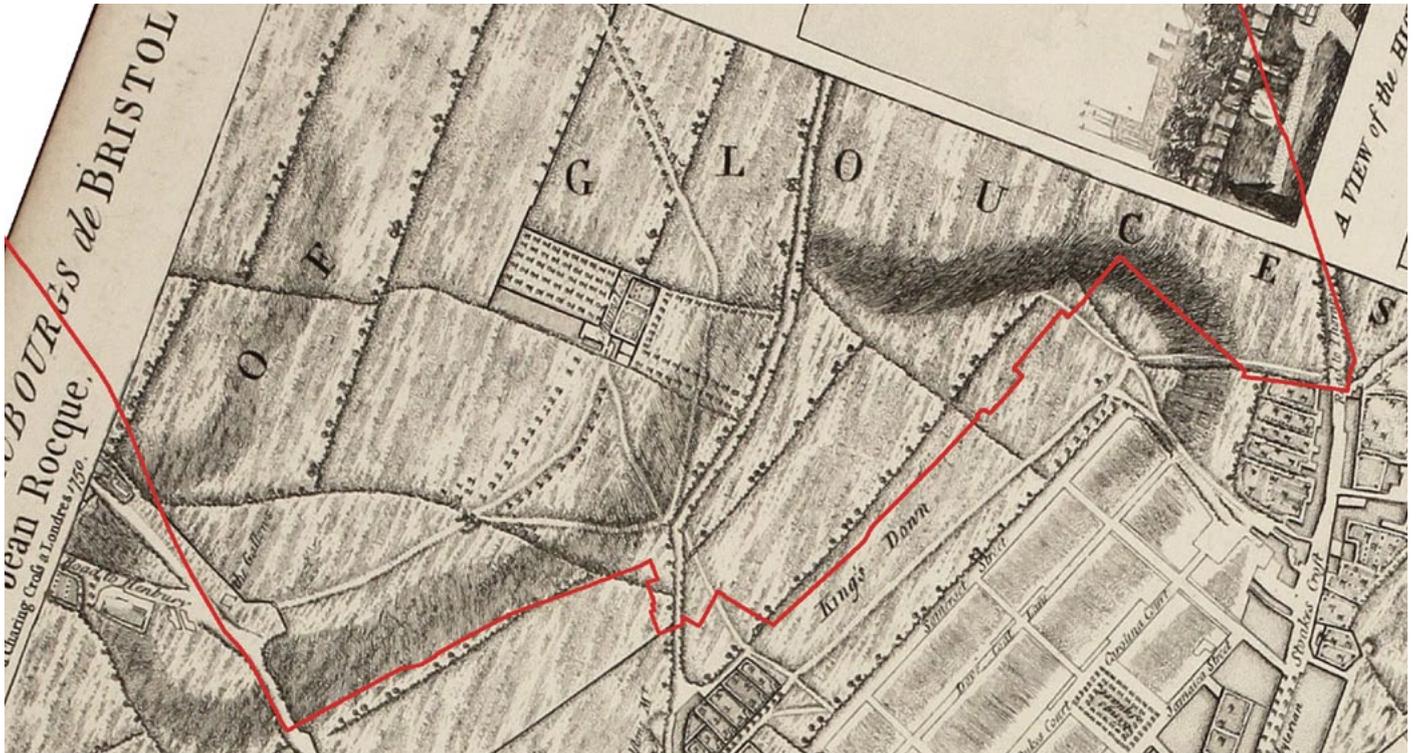
Figure 2: Extract from John Rocques' Plan, 1742, shows how early tracks translated into subsequent road layouts. A path running from Cotham Lodge via the mill to the Gallows, roughly follows the route of Cotham Road; the path running south east from Cotham Lodge forms Cotham Road South. The Gallows are shown close to the western boundary. The line of Lovers' Walk is shown by the avenue of trees leading NNW.

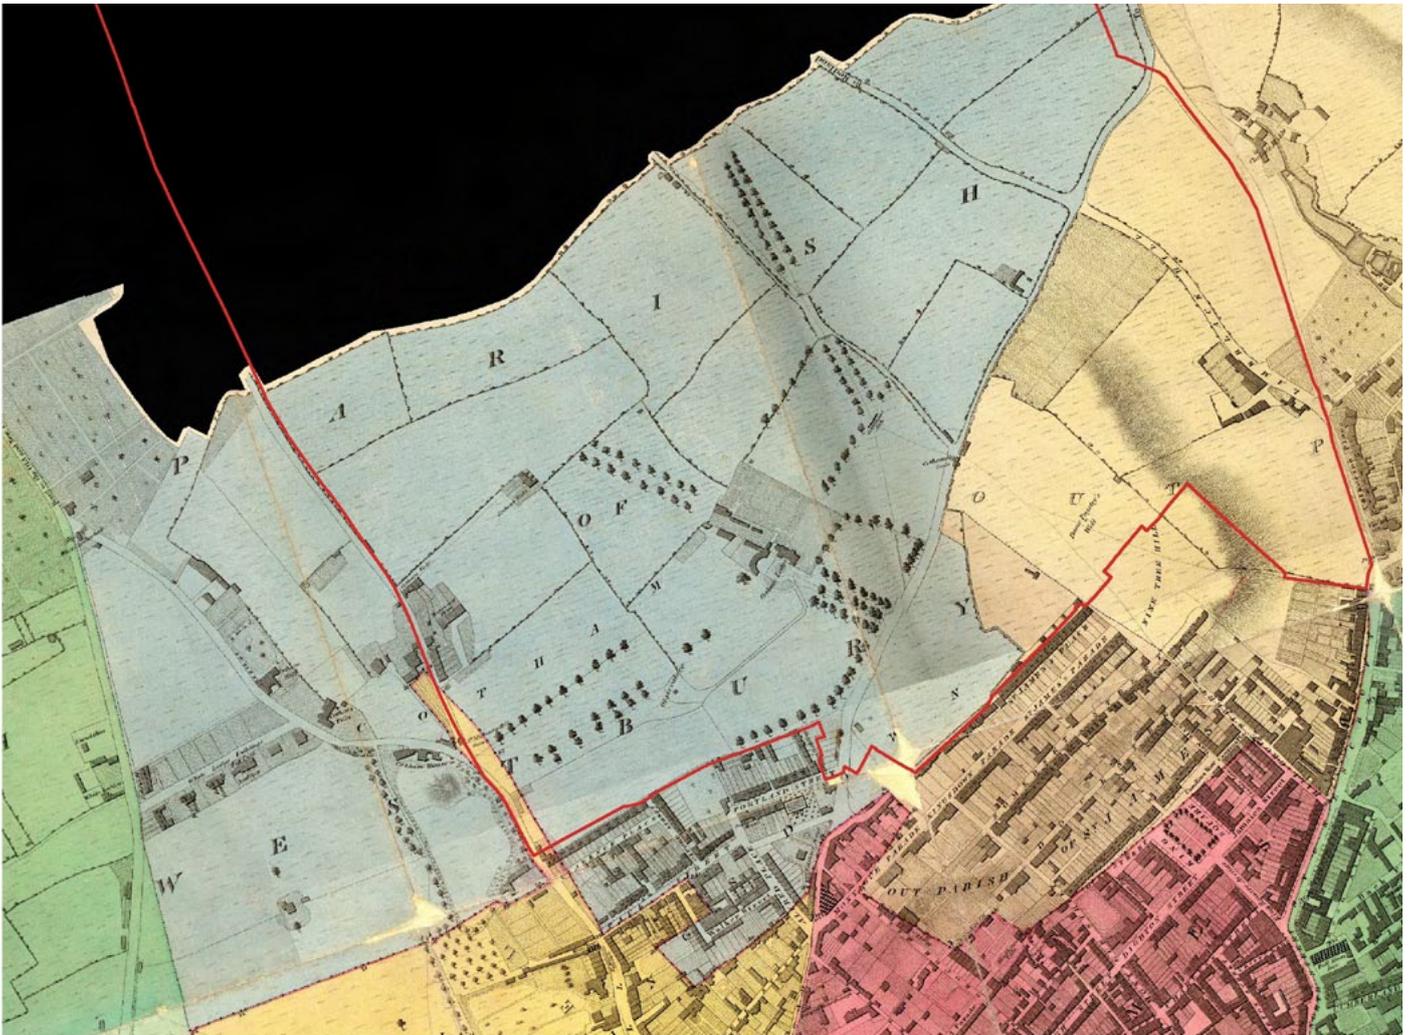
Figure 6: Extract from Plumley & Ashmead's 1828 survey (©BCC HER)

5.21 Development is starting to emerge e.g the large villas north of Cotham Road and a short terrace along Hampton Road, between the field boundaries that later become Cotham Lawn Road and Cotham Vale. Redland Green remains as an area of open 'common' land crossed by footpaths and approached by a road from Redland Court. The road does not extend north towards Redland Green Farm but turns west towards Redland Chapel, which became Redland Green Road.

5.22 The avenue of trees from Cotham Brow to Cotham Lodge became the line of the highway of Cotham Park when housing was developed in the later 19<sup>th</sup> century. A tree-lined avenue running from Cotham Road to Redland Court is also shown, this was developed as Cotham Grove in the later 19<sup>th</sup> century but part survives as the western side of Redland Grove / Lovers' Walk.

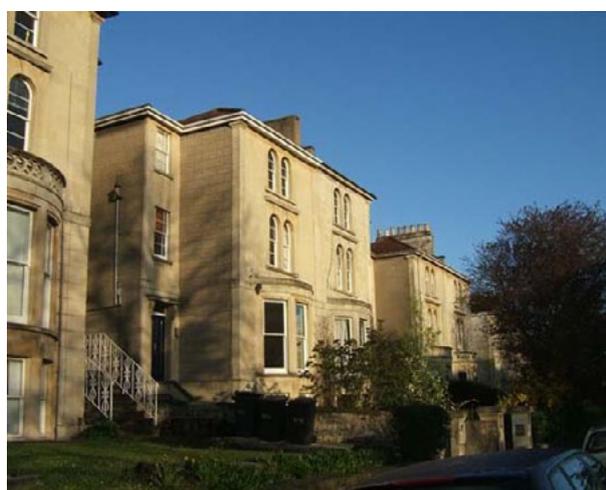
Figure 14: Typical Cotham semi

6.1.9 The large semi-detached villas tend to sit back from the road behind a front boundary wall and short garden, with a larger garden extending to the rear. Traditional plots on terraces are long and narrow, with fronting directly onto the street or behind a boundary.

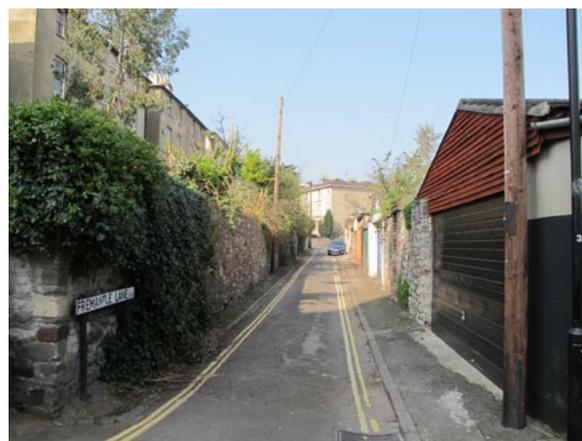
Figure 15: Intimate route, Fremantle Lane

6.1.9 Occasionally intimate streets of mews or cul-de-sacs are set behind the principal Victorian streets. Examples include Fremantle Lane, Gibson Road and Sydenham Lane (St Matthews Area), Clyde Lane and Elliston Lane (West Redland Area). These are characterised by their smaller scale of development, with properties accessed via narrow routes and directly addressing the street, never higher than two storeys.

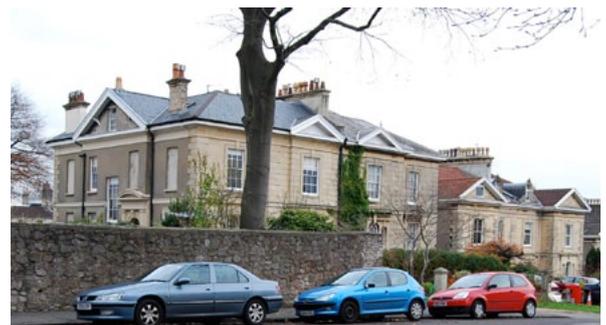
Figure 23: Nos. 4 - 10 Cotham Park, ashlar faced early Victorian villas

7.1.1d Cotham Road and Cotham Park contain a cluster of fine mid 19<sup>th</sup> century villas and detached houses, whose detail, size and execution is richer than the housing stock elsewhere. Containing over 20 listed villas, Cotham Road is of particular architectural significance. Architectural style ranges from Neoclassical (nos. 18 & 20 Cotham Road), Italianate (no. 16 Cotham Park) to Tudor Revival (no. 45 Cotham Road). Nos. 4 - 14 Cotham Park is a group of paired early Victorian villas (Grade II).

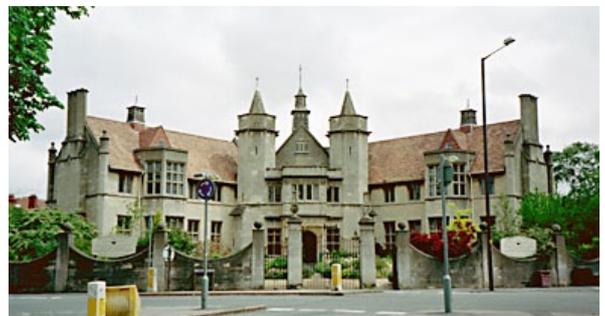
Figure 24: Western College, Cotham Road

7.1.1c Development and growth emerged in this character area before radiating north and eastwards. Consequently, the area has some of the Cotham & Redland's oldest buildings and most significant heritage assets, reflected in the high proportion of listed buildings; including two Grade II\* (Cotham Parish Church and Western College).

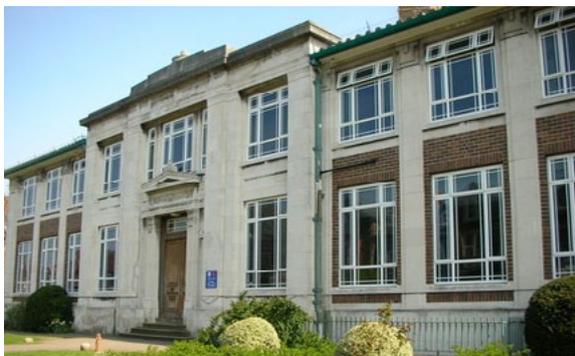
Figure 26: Cotham School, Cotham Lawn Road

7.1.1f **Unlisted Buildings.** Cotham School is a largely intact inter-War composition in limestone with brick details. Nos. 18 - 28 (even) Cotham Park have merit as a group of late Victorian semi-detached houses with distinctive roof forms, and Norman Shaw influences.

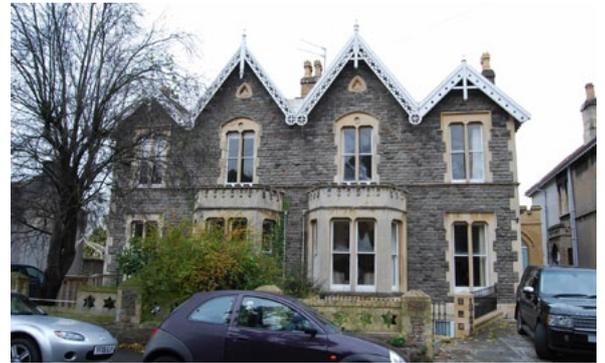
Figure 31: Trelawney Road, Victorian facade with decorative bargeboards

at nos. 1 - 5 (odd), an early 19<sup>th</sup> century terrace (Grade II) of distinctive Georgian houses. On the southern side houses are elevated, with front gardens set behind high retaining walls. The northern side has a more consistent, Victorian, character with Pennant stone, ashlar dressings and painted bargeboards uniting the variety in individual style.

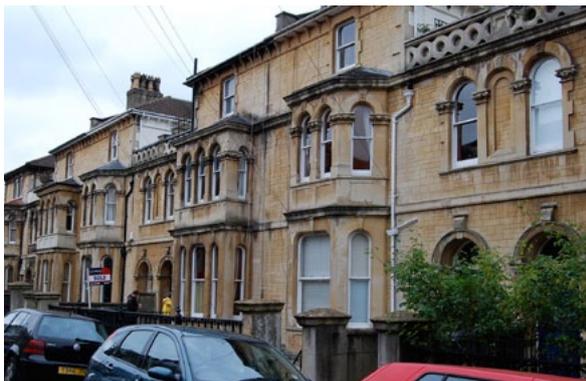
Figure 30: Nos. 11 - 23 Cotham Vale

7.1.2f Unlisted Buildings. Unlisted Buildings. Trelawney Court is a distinctive Arts and Crafts house on the corner of Cotham Vale/Trelawney Road by James Harry La Trobe. A group of unlisted buildings of merit are at nos. 11 - 23 (odd), a short mid-Victorian terrace faced with limestone ashlar, in an Italianate style. Relatively intact group of three early 20<sup>th</sup> century buildings nos. 47a - c Ravenswood Road, with their original steel windows.

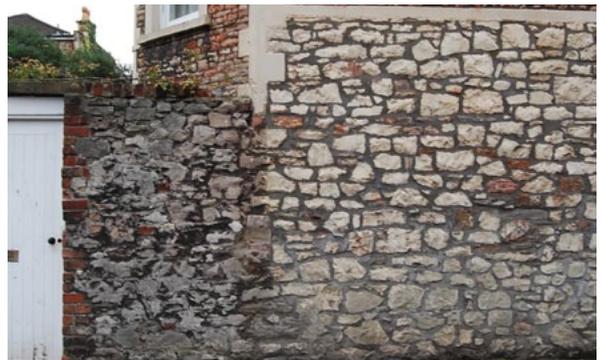
Figure 32: Stone walling materials, Kenilworth Road

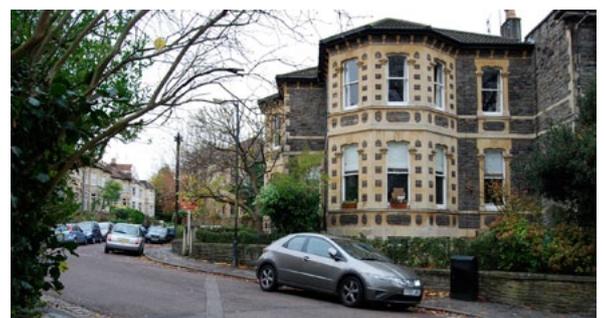
Figure 34: Ravenswood Road looking west

7.1.2c Ravenswood Road runs east-west, with late-Victorian semi-detached houses lining the southern side, which express to the general architectural character of the area. There is a strong, regular facade with repeating bay windows between Archfield Road and Montrose Avenue (south side). The distinctive bend between Woodstock Avenue and Montrose Avenue adds visual interest, as houses project forward at the corners. Houses appear to be two storeys in height - a massing moderated by semi-basement floors and attic storeys with dormer windows.

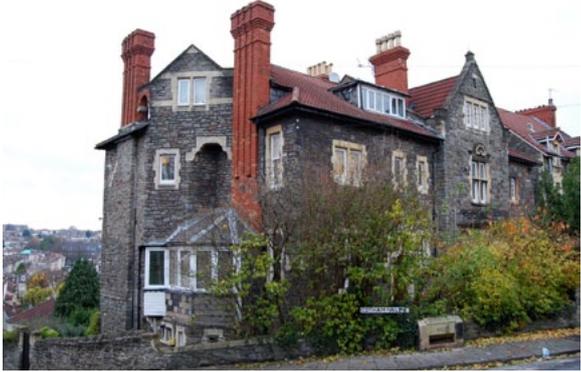
Figure 36: Unlisted Building of Merit, Trelawney Court

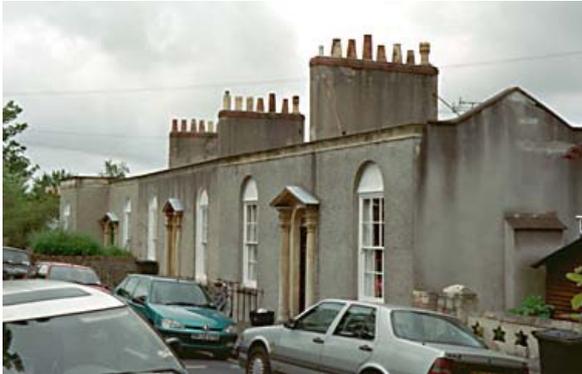
Figure 37: Nos. 1 - 5 (odd) Trelawney Road

7.1.2h Landmarks. The railway line behind the long red rubble wall lining Meridian Road. Nos. 1 - 5 (odd) Trelawney Road (Grade II listed) stand out in the local context owing to their distinctive style - built along a slope, they have a ground floor and basement to the road and two storeys to the rear.

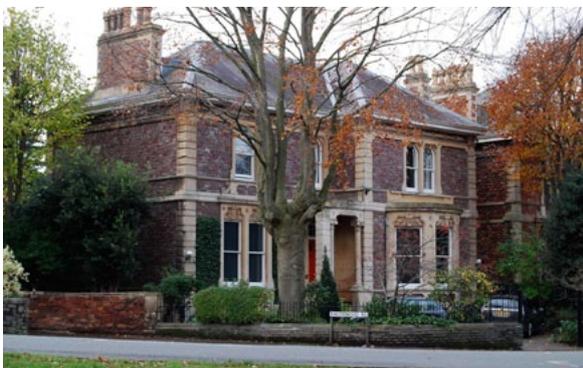
Figure 38: 31 Redland Grove, detached villa with purple rubble walling

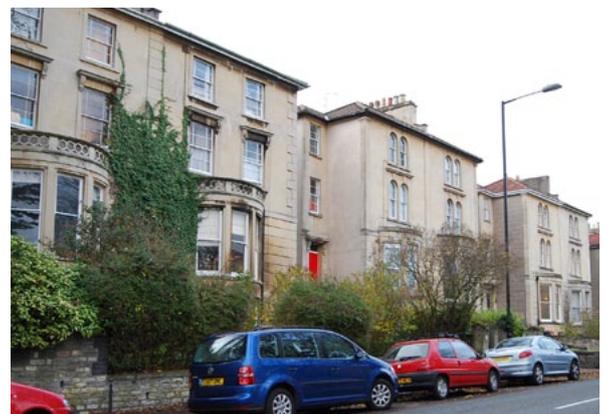
Figure 41: Cotham Grove, 3-storey over semi-basement

7.1.3f Cotham Grove, Cotham Brow and Redland Road have a more consistent character lined with grand with semi-detached villas, 3-storeys over semi basements. There is a strong palette of limestone ashlar facing and stucco render.

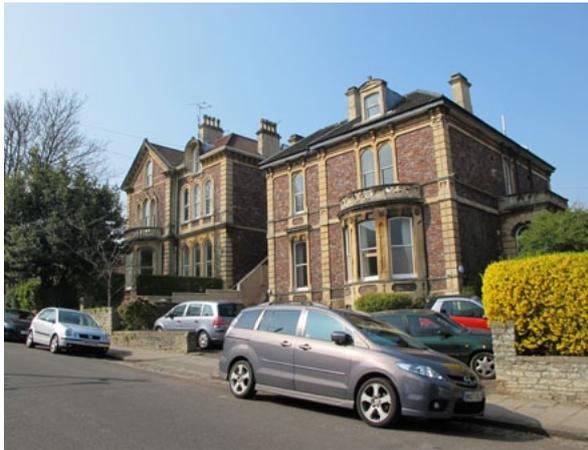
Figure 43: Red Pennant villas with limestone details, Cotham Park North

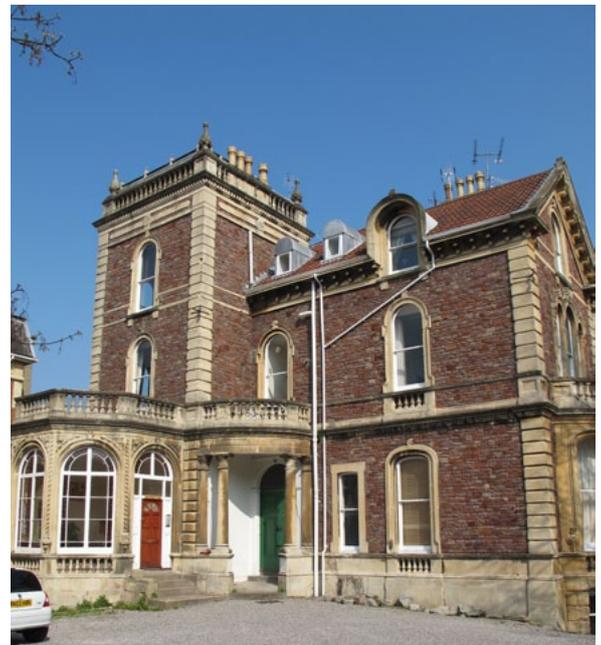
Figure 44: Archfield Court

7.1.3g Unlisted Buildings. This character area has inherited a good stock of fine Victorian buildings that make a positive contribution to the overall sense of place. Cotham Grove contains 11 identical pairs of semi-detached villas laid out regularly along the full length of the road, which are of group merit. Christ Church, Redland Road, is an ornate Pennant and limestone building with a large gabled entrance with side lancets, above a large decorative window flanked by tall 'spirelets'. The former St Nathanael's Church was built 1873-5 by John Bevan, and is a sizeable well-detailed building in Pennant sandstone, now the Elmgrove Community Centre. Archfield Court is also distinguished by its richness of detailing and large square tower.

7.1.3i Landmarks. The red Pennant and limestone tower of Archfield Court provides a distinctive landmark feature, particularly when viewed from the north. The two former churches on Redland Road are also landmark buildings in the local context.

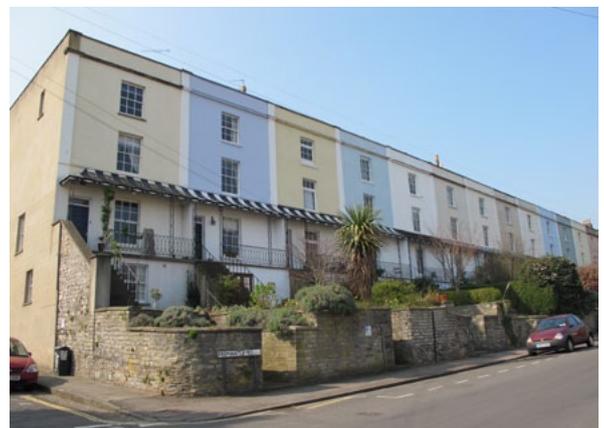
Figure 50: Fremantle Road, Grade II listed terrace

7.1.4d Of the relatively few listed buildings in the Conservation Area as a whole, a number populate this character area. (Including properties on Gibson Road, Fremantle Road, St Matthews Church). Beyond these, there is a high quality and unity of built fabric in the area, with a strong architectural character given by the consistent material palette and neo-Classical treatment.

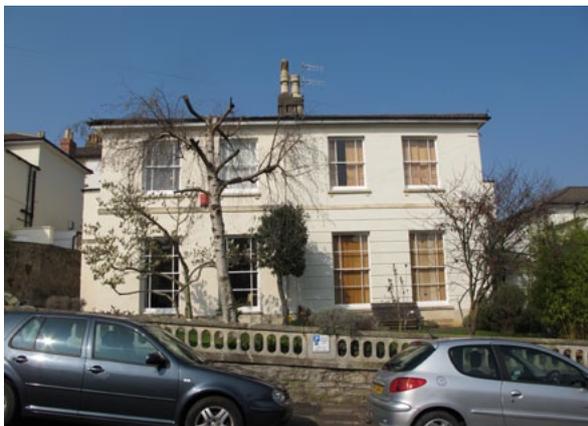
Figure 51: Typical Victorian semi, Clare Road

7.1.4e **Unlisted Buildings.** Most of the unlisted buildings in the area are character buildings, which make a positive contribution to the overall character and sense of place of the wider Conservation Area. Nos. 141 - 157 (odd) Cheltenham Road are a group of three early Victorian tripartite villas. Tamworth Place, a terrace at nos. 2 - 23 Arley Hill, is also a strong unlisted group. Drayton House, no. 54 Arley Hill, and the substantial paired neo-Classical villas at the corner of Cotham Brow/Arley Hill are of merit owing to their scale and richness of detail. The rubble and stone neo-Gothic villa with gabled roof and tall stone chimney stacks on the corner of Sydenham Road/Cotham Brow is also of particular merit.

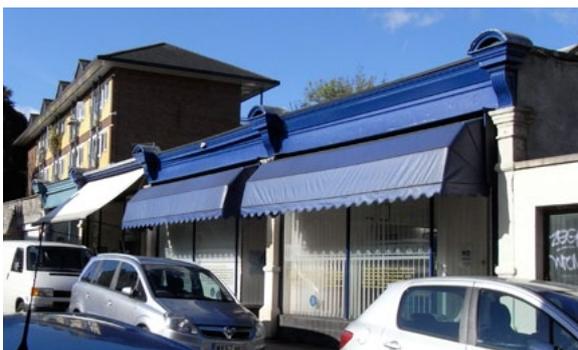
Figure 58: 1a-d Chandos Road

7.1.5e **Unlisted Buildings.** An interesting group of single-storey shop units are at nos. 1a-d Chandos Road, c. 1900. Away from Chandos Road are the terraced streets extending southwards. Stanley Road has uniform terraces on both sides, of 2-storeys over semi-basements, built in limestone Ashlar. Collingwood Road, Cowper Road, Brighton Road, Lansdown road and Roslyn Road are non-uniform terraces of 2 and 3-storeys, with some bays, united by a strong building line and consistent palette of materials.

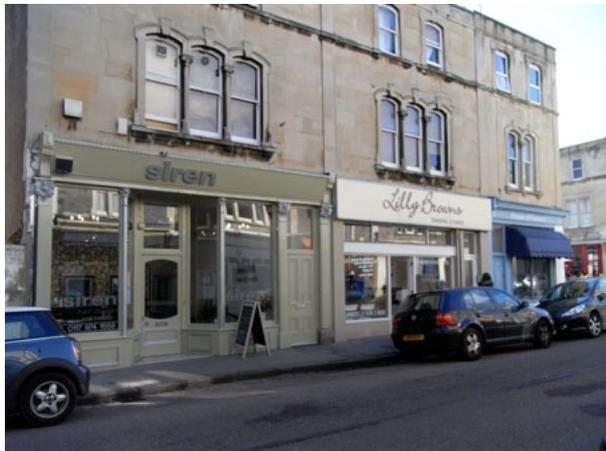
Figure 60: Traditional timber shopfronts

7.1.5f **Other Heritage Assets.** Surviving traditional shopfronts or surrounds and signage are a particular asset in this area. Front boundary treatments, typically walls of sandstone rubble with limestone dressings also give a strong line and add interest and variety of scale to the more residential streets. A number of buildings are enriched by carved architectural details e.g the carved decorative heads on the triangular pediments of nos. 5 - 11 Chandos Road, which give quality and interest to individual buildings and the wider street scene. The War Memorial on the north side, next to the church, is a historic landmark.

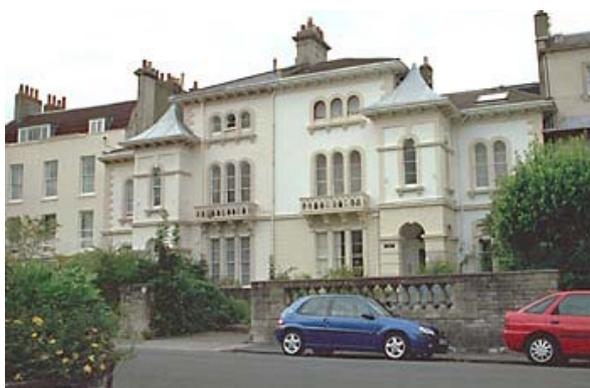
Figure 69: Nos. 71 - 73 Lower Redland Road

7.1.6f No. 157 Redland Road and no. 69 Lower Redland Road are both late 18<sup>th</sup> century, stucco rendered in a Classical style. Mid 19<sup>th</sup> century buildings include nos. 71 - 73 lower Redland Road (Grade II), an unusual ornate symmetrical pair of stucco/limestone villas with 2-storey outer blocks set back and linked to the middle section by 2-storey porches with tented, leaded roofs. Next door, no. 75 is also mid 19<sup>th</sup> century (Grade II); the 'florid' balcony railing on the first floor piano nobile is particularly fine.

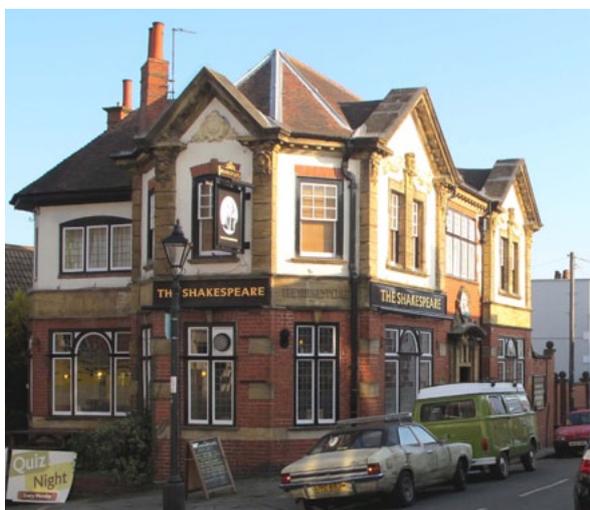
Figure 70: Shakespeare PH

7.1.6g A small but significant retail centre exists towards the east end of Lower Redland Road, which includes a group of c. 1901 traditional shopfronts. Opposite, the Shakespeare PH, no. 70 Lower Redland Road, was built in 1903 on the site of an earlier Shakespeare Inn (1867). This is a local landmark / building of merit. On the opposite corner of Woolcott Street was the local post office, closed in 1998; this is now a property agency but still retains its shopfront and retail character.

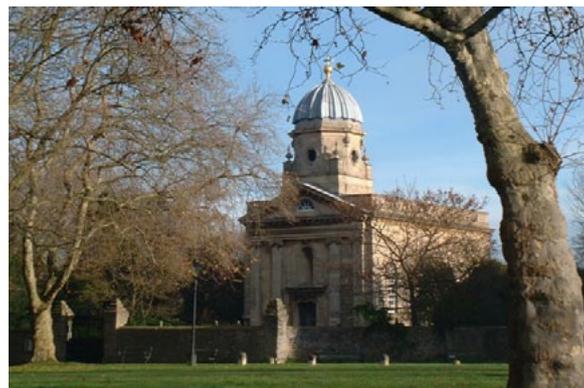
Figure 72: Redland Chapel, Redland Green

7.1.7d Perhaps the most architecturally significant asset and landmark building in the Conservation Area is the Georgian parish church Redland Chapel (Grade I); built by John Strahan in 1742 as a private chapel for Redland Court, though it was not consecrated until 1790. Built of limestone ashlar in a Baroque style, its form is relatively simple, with a stone to a simple design with a large engaged portico to its west front. Most distinctive 'pepper pot' tower and octagonal leaded cupola and gilded ball and cross. The Chapel eventually became the parish church when the parish of Redland was separated from Westbury-on-Trym in 1942 and, unusually, has no dedication to a patron saint.

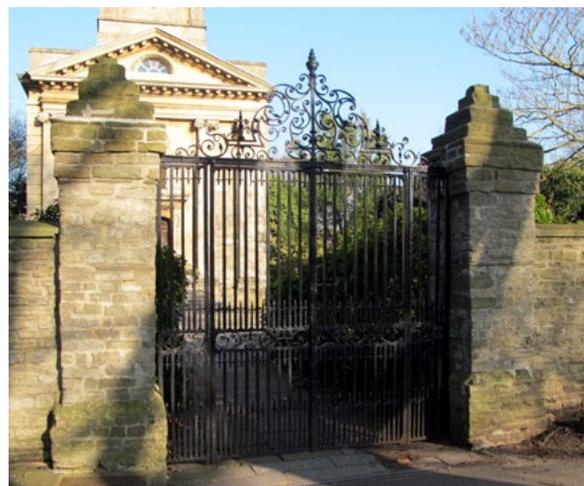
Figure 73: Redland Chapel gates

7.1.7e The perimeter walls, piers and gates to the Chapel churchyard are all Grade II\*, 1743 in coursed lias rubble and elaborate wrought iron gates. Within the Chapel grounds are a mass of different trees including some historic Yews, which provides sanctuary for wildlife plus amenity and landmark value.

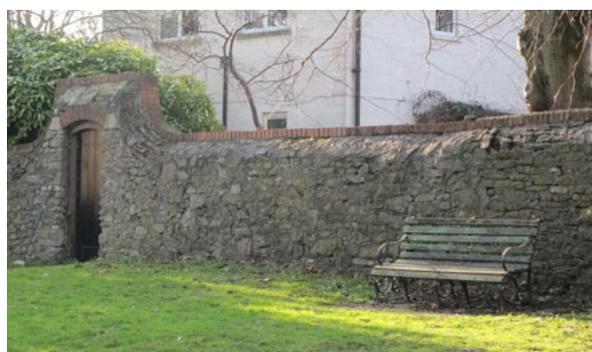
Figure 75: Vicarage boundary, Redland Green

7.1.7g **Other Heritage Assets.** The rubble wall rounding Redland Road and Redland Green Road dates from the early 18<sup>th</sup> century and marks the original boundary of Vicarage House (Grade II no. 157 Redland Road). In the south section is the John Bryant and Emily Clifford Memorial Drinking Fountain (Grade II). The wall running along the boundary with the St Oswald's flats is the remains of a field boundary wall. A large stone in the Green is also a historic landmark, its exact origins are unknown, though it is marked on the OS first edition. Running south from Redland Chapel are a series of low stones, historic boundary markers of consecrated ground. The Redland Road retaining wall also marks 1 mile to Stokes Croft.

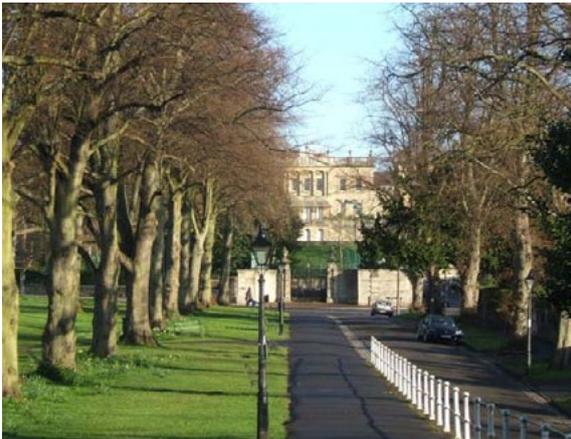
Figure 78: Redland Court viewed from Redland Grove

7.1.7n Redland Court (Grade II\*) was built by John Coussins in 1732, who replaced the earlier manor house with the limestone ashlar Classical palace-fronted building of today. The central pediment and bottle balustraded parapet, with decorative urns, are particularly prominent in long views.

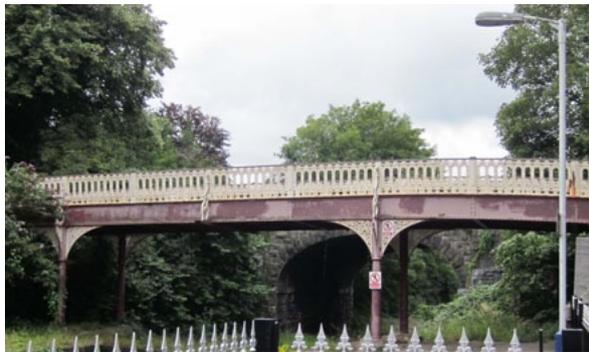
Figure 81: Cast iron footbridge over railway line, from Redland Station

7.1.7q **Other Heritage Assets.** The cast iron footbridge (Grade II) over the railway provides an attractive element in Lovers' Walk; it is also a historic landmark.

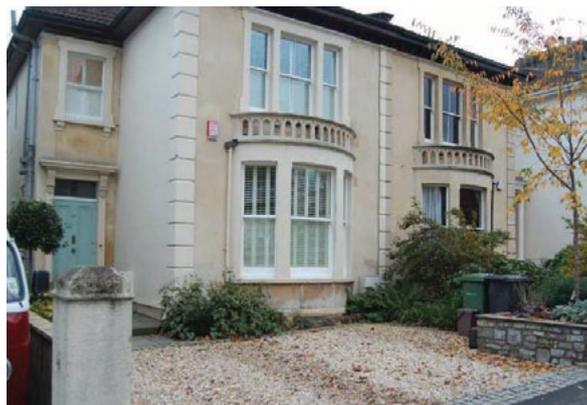
Figure 82: Zetland Road houses

7.1.8f Zetland Road gently slopes and has a significant number of commercial buildings to the eastern end. Generally shop fronts closest to the Gloucester Road are of poor quality. Buildings nearest Gloucester Road are unusually 3-storey terraces, with pedimented dormers and mansard roofs. The earliest residential buildings are on the south side and have ashlar stone frontages and single storey bow windows with decorated parapets.

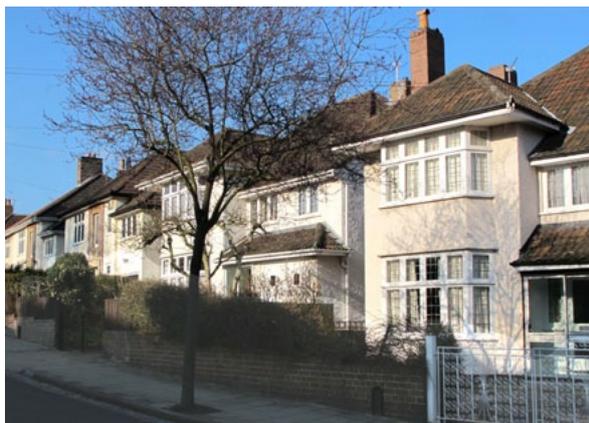
Figure 83: Redland Court Road

7.1.8h Redland Court Road was largely built in 1930s, some earlier buildings exist at the southern end. Houses are mostly 2-storey with tiled pitched roof; façades of rendered brick with timber casement windows with leaded lights. Front gardens are a good size, many have been partly converted into parking spaces while retaining most of the front wall and planting. On Redland Court Road the semi-detached villas have attached garages; many are now built over to form two-storey links.

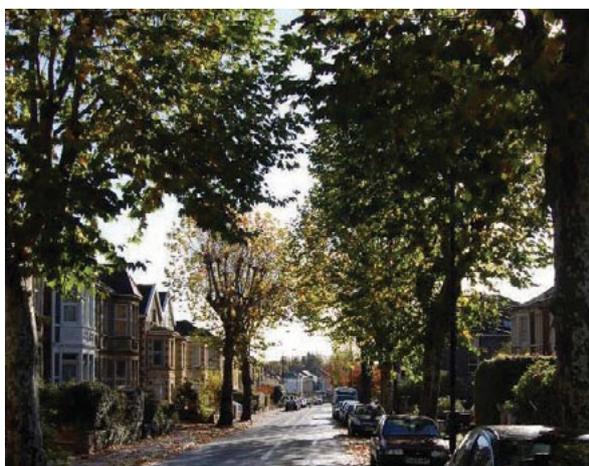
Figure 84: Cranbrook Road

7.1.8k Cranbrook Road is a well-used thoroughfare, its character changes from the more urban treeless southern end to the relatively verdant area between Carnarvon and Kersteman Roads. A number of buildings have carved acanthus mullion heads to the windows, decorated stone panels at first floor level and decorated string courses. At the northern end, houses are more varied with turrets and terraces and some Arts & Crafts stylistic influences.

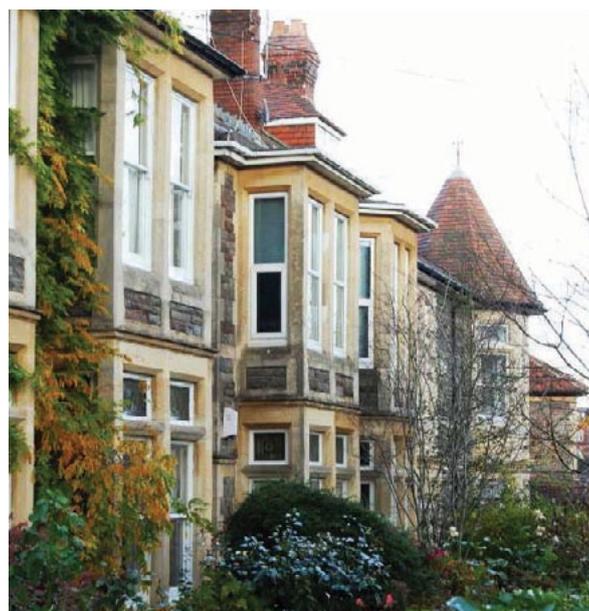
Figure 85: Canarvon Road facades

7.1.8n Carnarvon Road, Edgecombe Road, and Glentworth Road run southwest/northeast and reflect many of the area characteristics although Carnarvon Road is more varied with a few houses having turrets, castellations, square & single storey bays and a greater use of decorated terracotta tiles at first floor level. Because of the number of road crossings on Carnarvon Road, more buildings show their side and rear facades, garages and rear gardens.

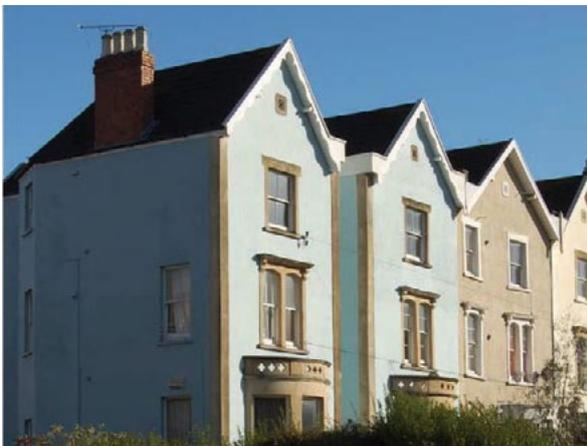
Figure 86: Grouped buildings of merit, Redland Road/Zetland Road

7.1.8p **Other Heritage Assets.** The four houses at the junction of Zetland Road with Redland Road stand out in amongst their context and are a group of merit. Walls are of stucco with Bathstone detailing; first floor windows have stone canopies.

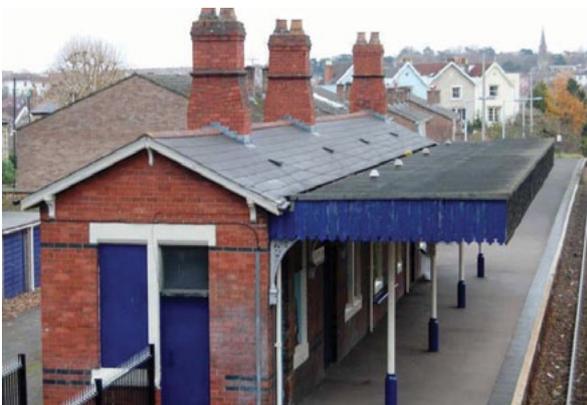
Figure 87: Redland railway station, South Road

7.1.8q Redland Railway Station was built in 1897 and is simple utilitarian red brick, with little ornament apart from dark brick string courses and gable brackets. The painted platform canopy has decorated cast iron brackets and columns, and timber dagger board fascia (chimneys added later). It is an unlisted building of merit and local landmark.

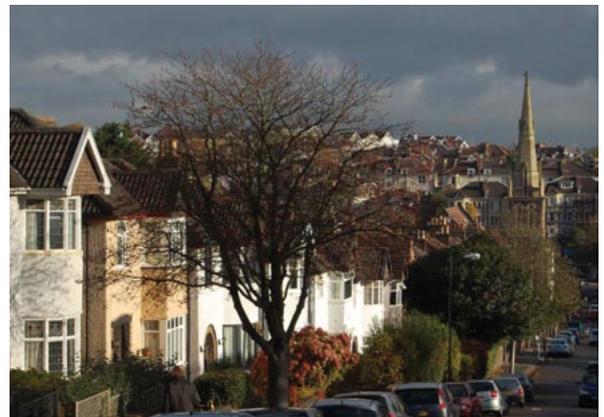
Figure 88: Spire of former Trinity Church viewed from Kersteman Road

7.1.8o **Landmark Buildings.** Former Trinity Church (now flats) at the junction of Cranbrook/ Kersteman Road 1907 by Phillip Munro in a Scottish Gothic style in Pennant sandstone with Limestone details. The spire is a landmark feature, particularly viewed from the top of Kersteman Road.

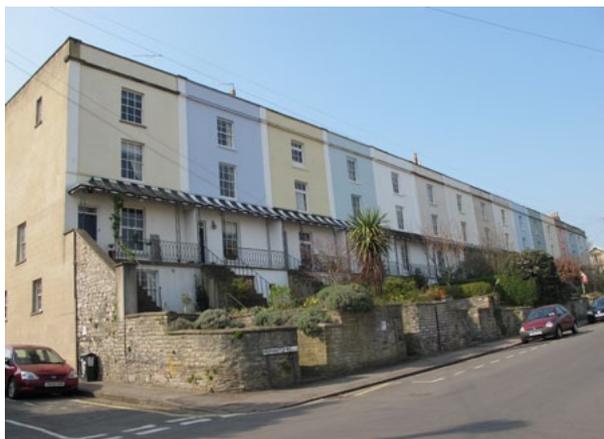
Figure 89: Fremantle Road terrace, 1840s

7.2.3 The earlier buildings in the Conservation Area are generally situated in the southern portion, where the c. 1840s terraces and grand villas, have their architectural style rooted in an earlier Regency heritage. The earliest style was the continuation of the terrace pattern, in an adaptation of the classical Regency architectural design (e.g Fremantle Road c. 1840). The earlier villas and terraces adopt symmetry and ordered detailing: continual parapet, string courses, piano nobile and a vertical emphasis are all used.

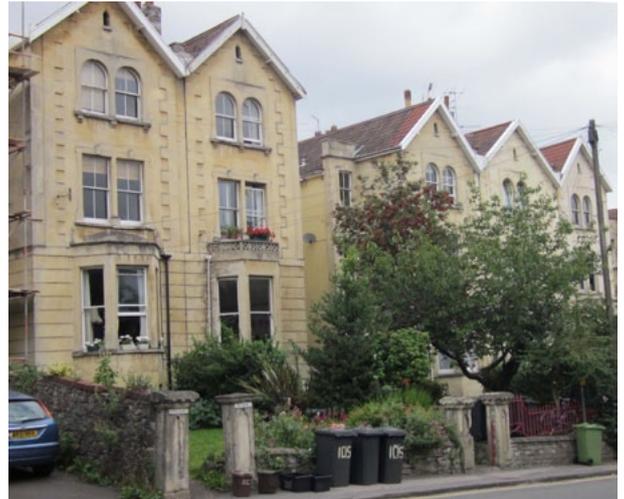
Figure 90: Typical Cotham semi, Cotham Brow

7.2.4 Smaller and higher density two storey terraces off Chandos Road continued to be developed from the 1860s and 70s. Though more commonly, between the 1850s and 70s the fashion tended towards semi-detached suburban villas to accommodate the growing middle-class Victorian populous.

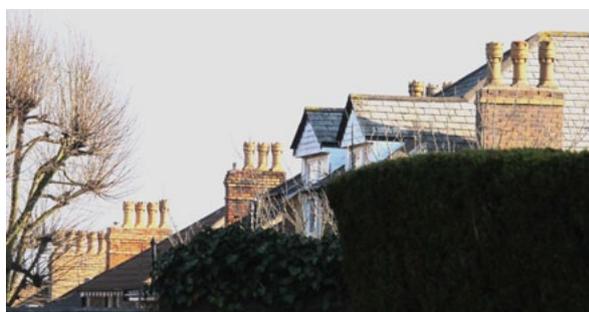
Figure 92: Woodstock Road roofs

7.3.4 **Chimney stacks and pots** form striking features when seen against the skyline. Replacement or removal of chimney pots and stacks is discouraged. The pairs of houses on Woodstock Road have grouped stacks, distinctive as the road drops down the contour of the hill, most of which retain their numerous clay pots.

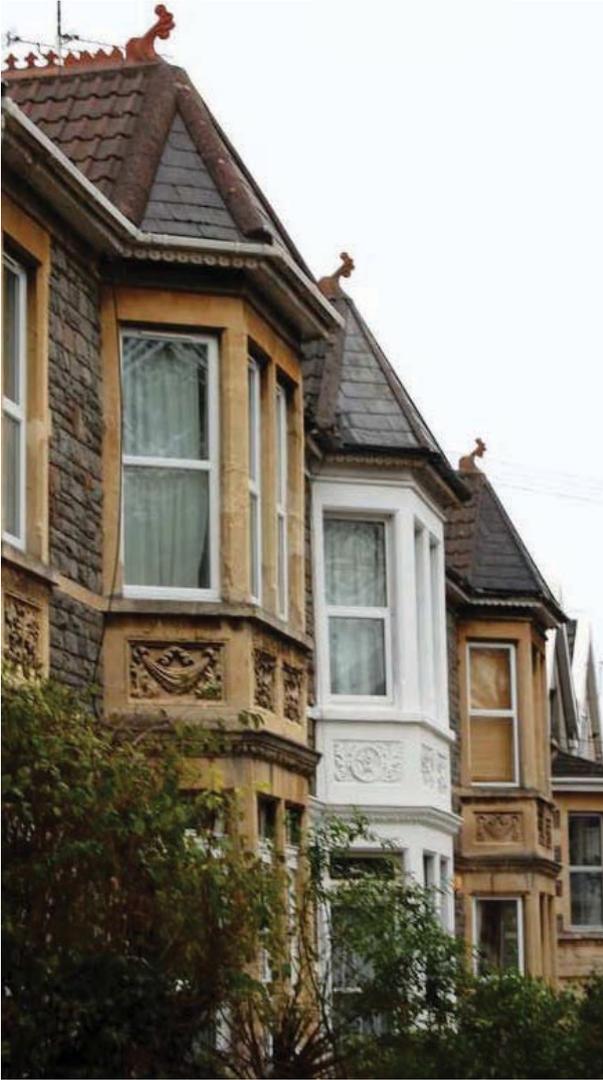
Figure 94: 2-storey canted bays

7.3.7 Throughout much of the Conservation Area, bay windows form a strong rhythmic verticality to the facades, which is balanced by the horizontal fenestration and various stone string courses. Bays vary considerably, the most common are the two-storey canted bays, with 3 or 4 double hung sashes per floor. Generally the older sash bays have stone mullions which the new casement windows don't have. A small proportion of sashes have high level stained glass panels.

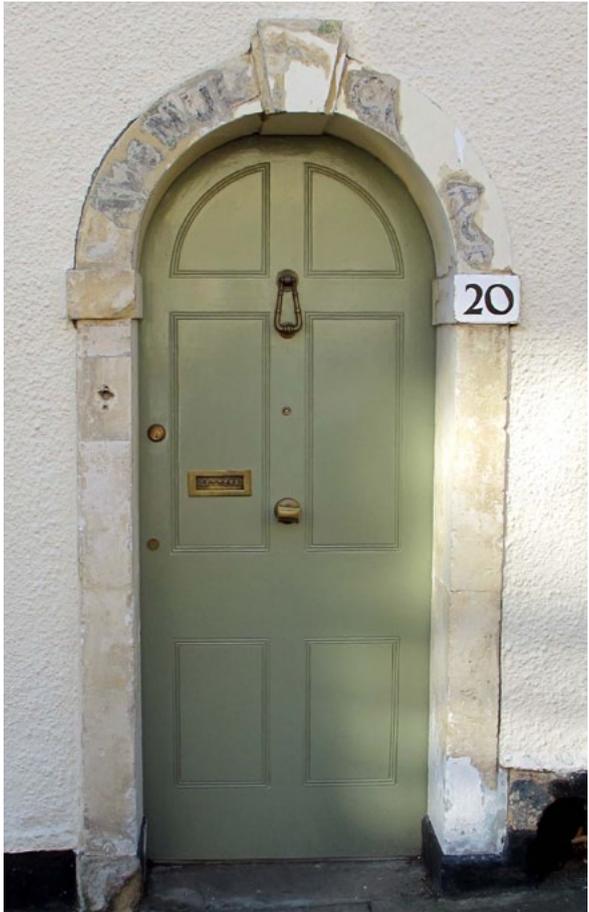
Figure 95: Flush-panel door with limestone surround, Luccombe Hill

7.3.7 Doors and surrounds, where the original has been retained and well maintained add greatly to the character and appearance of individual buildings and to the wider street scene. Front doors vary throughout the area, most common examples are 6-panels. Rectangular fanlights are a common feature, many later Victorian buildings have stained glass fanlights or side panels.

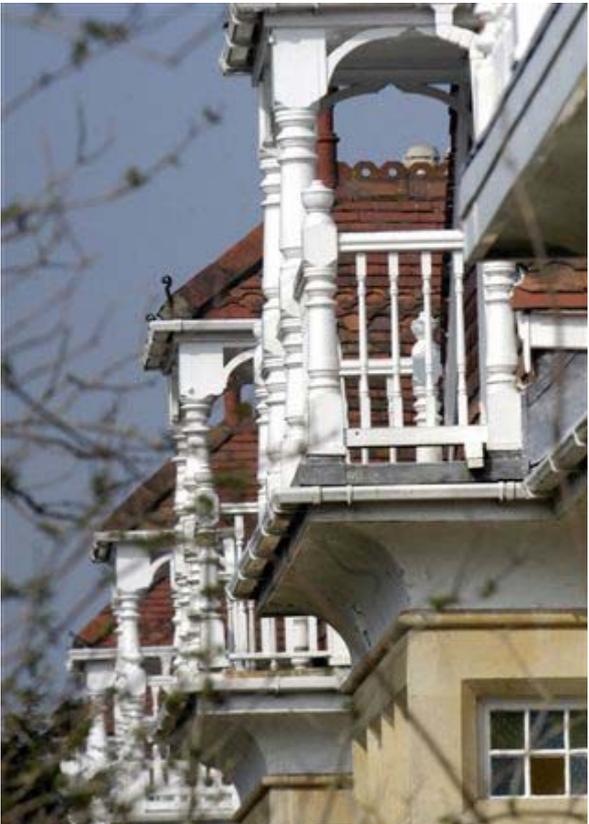
Figure 96: Timber balconies, Cotham Park

7.3.9 Balconies In a few instances, low level roofs over doors and windows have decorated timber brackets forming roof bearers, there are also a small number of timber balconies.

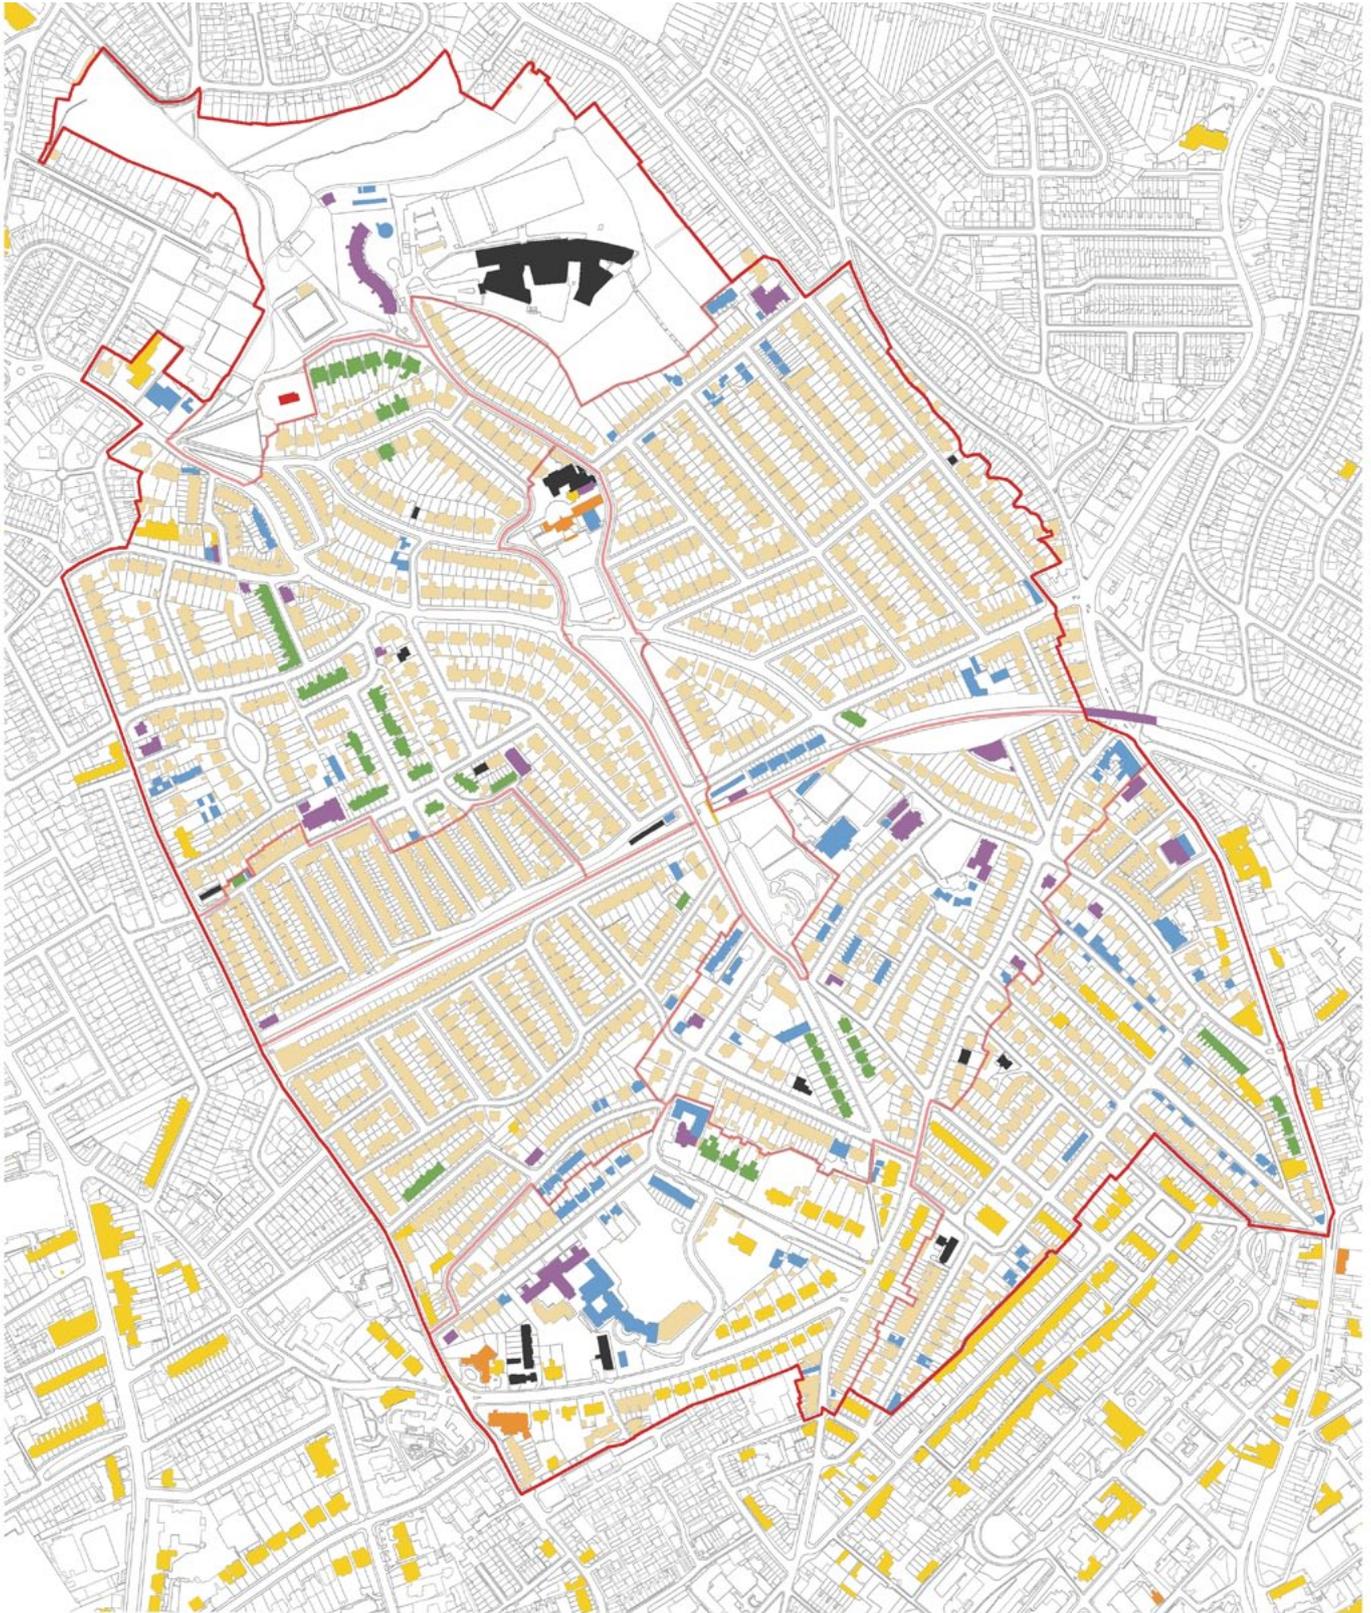
# Map 6: Cotham & Redland Conservation Area Relative Merit of Unlisted Buildings

- Character Areas
- Building Types**
- Building of Merit
- Grouped Buildings of Merit
- Character Buildings
- Neutral Building
- Negative Building

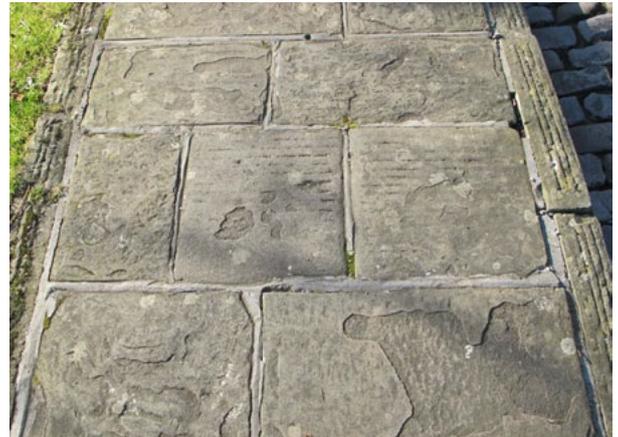
Figure 97: Pennant pavement and kerb, Redland Green

7.6.4 The protection and appropriate maintenance of traditional street surfaces would ensure the preservation of local character; schemes to appropriately restore or reinstate street surfaces could greatly enhance the Conservation Area. Stone kerbs with asphalt and removal of Pennant Stone slabs where they still exist should be avoided. Pavement build outs should be in appropriate materials and traditional cobble highway edges maintained. Any street works including line and signs must be in keeping with the area.

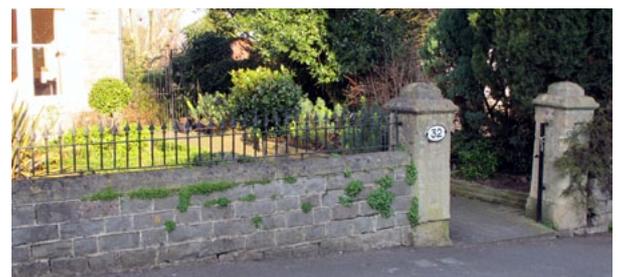
Figure 98: Traditional boundary treatment, Woodstock Road

7.6.6 Early railings have a simple style, usually in Wrought Iron, then became more elaborate during Victorian times as technology in cast iron developed. Many railings were lost during World War II for munitions; those to basement areas were left to prevent accidents in the black-out. More recently, new drives and off-street parking have seen the subsequent removal of boundary treatments, to detrimental effect.

7.6.7 In order to retain the character and special interest of the Conservation Area, listed or unlisted traditional boundary walls, gates, gate piers and railings should be preserved, sympathetically restored or reinstated. When railings are repaired, the posts should be lead soldered and individually set into the stone coping to prevent corrosion of the foot of the post. Stone should be left unpainted or rendered and failing walls sensitively repaired.

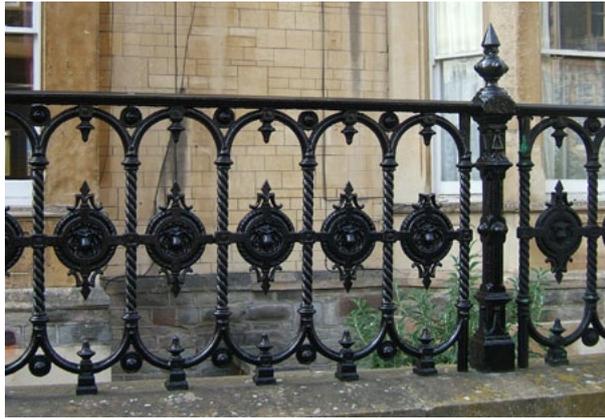
Figure 99: Cast iron railings, Cotham Vale

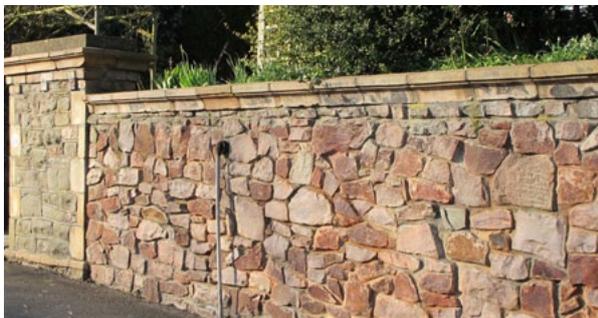
Figure 100: Brandon Hill stone retaining wall, Woodstock Road
