# Cotham & Redland

Character Appraisal & Management Proposals

September 2011

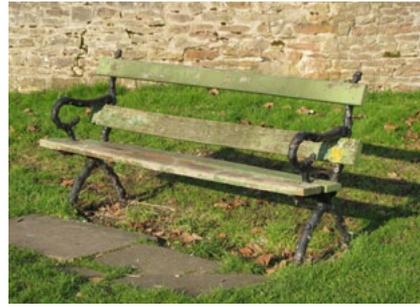
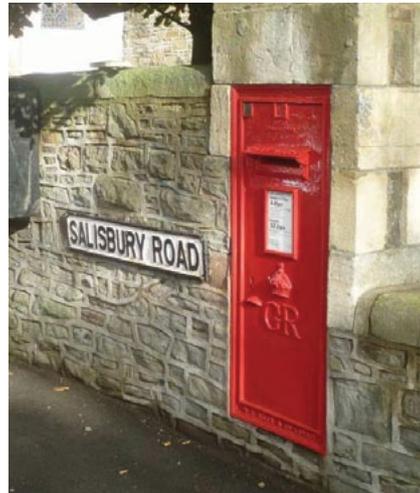
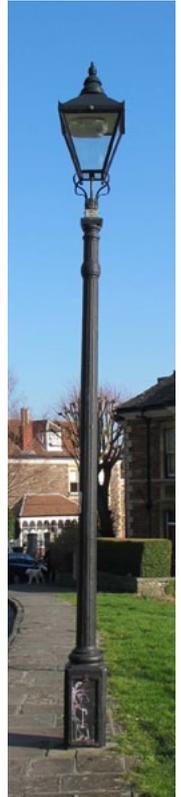
Figures 101 - 103: Cast iron bench; restored fluted lamp standard, Redland Green. Traditional letter box and road sign, Salisbury Road

7.6.8 The Cotham & Redland Conservation Area has a fascinating collection of historic street furniture, some of which is listed. Street furniture, including letter boxes, lamp standards, and other details, enlivens the street scene but also reflects the history of the area. The appropriate maintenance and protection of this is important, as is the need to prevent modern street clutter detracting from its setting.

7.6.9 BCC owns and manages 34,000 street lights across the city. A 2004 lighting strategy for Conservation Areas, stipulates that existing cast iron street lights will be kept and maintained with appropriate lanterns and brackets and where lighting levels are to be raised, cast iron columns will be installed between existing columns outside listed buildings. RCAS, the local amenity society in Cotham & Redland co-ordinates initiatives to restore and paint traditional lamp columns in the area.

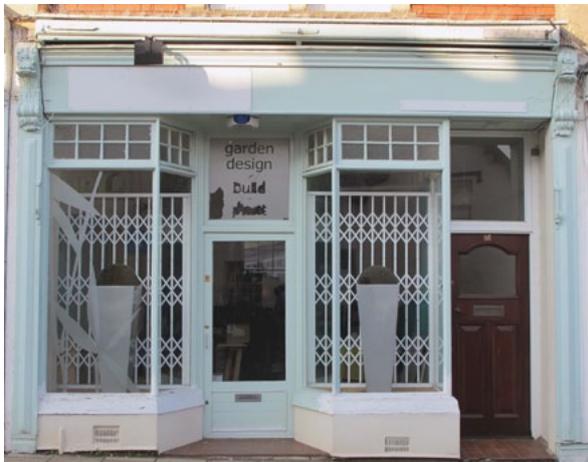
Figure 104 : Traditional timber shopfront, Lower Redland Road

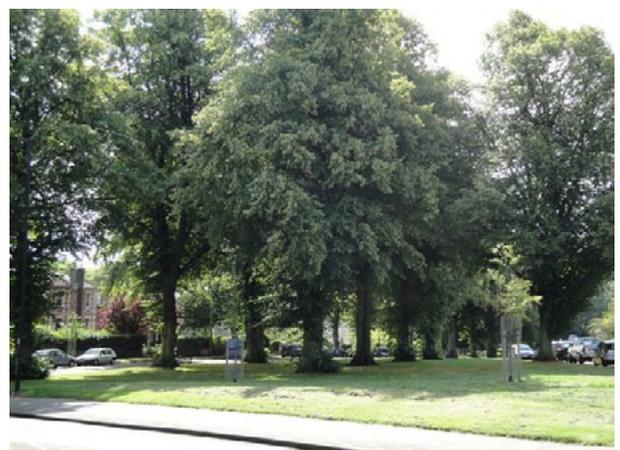
Figure 107: Redland Grove / Lovers' Walk

7.7.5 The Conservation Area has inherited two historically significant and locally valuable public green spaces: Redland Green to the north, which includes the allotment gardens at its fringes; and Redland Grove (Lovers' Walk) and Cotham Gardens in the centre. In the overall context of the Conservation Area the distribution of public parks and gardens is relatively poor - making the contribution of individual trees and private planting even more important.

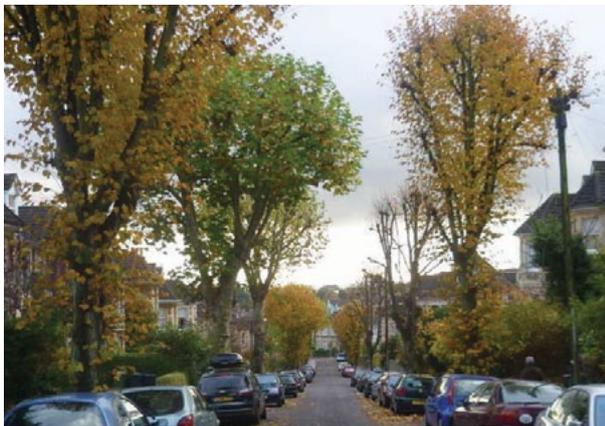
Figure 108: Pollarded street trees, Limerick Rd

7.7.6 Tree planting arrangements vary across the Conservation Area. Some streets are lined with an avenue of trees, the London plane being the characteristic species. Mature planes are usually heavily pollarded by BCC in order to minimise subsidence damage to nearby properties; the pollarded tree has become a characteristic feature in itself.

9.17 Trees are a vital part of the character of the Conservation Area. Although much work to trees requires consent, any loss of trees without suitable replacement will impact negatively on the verdant character. Street trees are managed through pollarding; where this is done severely it can cause epicormic growth and consequent loss of visual amenity.

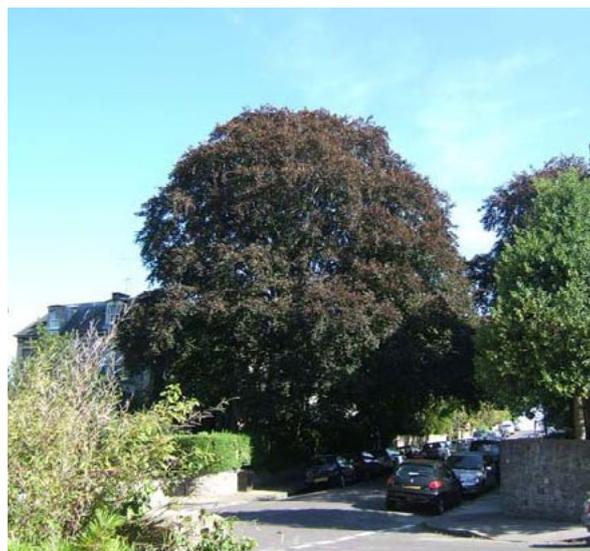
Figure 109: Copper beech, Archfield Road

7.7.9 Of the larger garden trees there is huge diversity, although ‘characteristic’ garden trees include holm oaks, limes, sycamores, birches and spruces. Copper beech trees make a particularly important contribution in the Conservation Area, often providing a terminal feature at the end of streets or their size or dark canopy coverage setting them apart from their context.

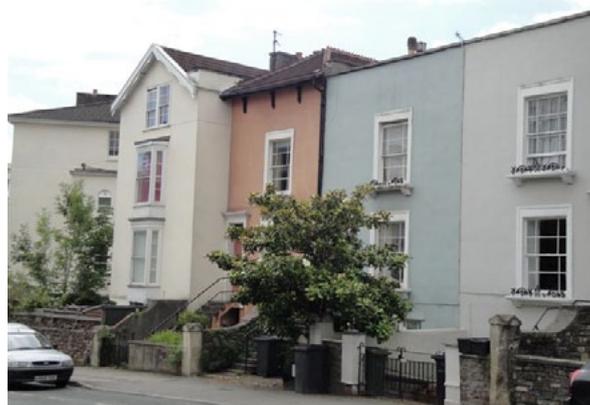
Figure 110: Small front garden tree

7.7.10 Medium and small trees also play an important role, especially in streets with small front gardens, too narrow for street trees. These smaller specimens are more decorative and add value in a more domestic context. Trees in back gardens are also of local value, where they benefit surrounding residents and contribute to biodiversity.

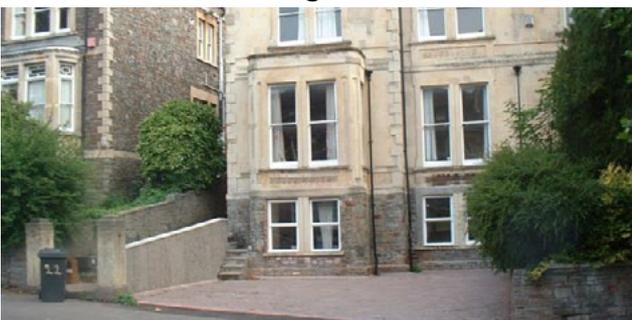
Figure 113: Loss of front garden

9.4 There is a real pressure for on-street parking throughout the Conservation Area. The loss of traditional garden plots and boundary walls, hedges or railings to infill or off-street parking is impacting on the landscape quality and biodiversity value of the area and resulting in a loss of front garden trees. Where original front gardens have been lost, this is impacting negatively on the street scene as well as on the associated dwelling.

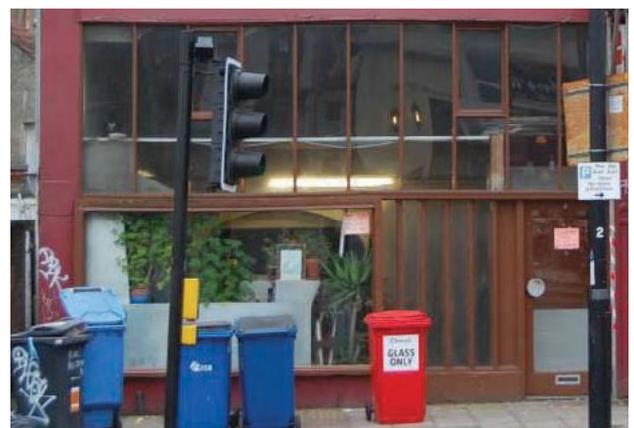
Figure 114: Poor quality shopfront

9.8 Poor quality replacement shopfronts, internally illuminated or over-size signage can have a dramatic effect on the quality of the street scene. This is particularly problematic along Zetland Road.

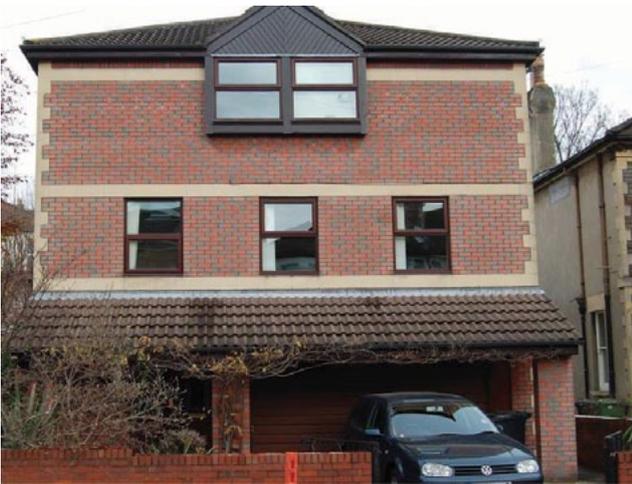
Figure 115: Poorly designed infill

9.9 New development or infill that fails to respect the character of an area, or ignores the predominant building lines, scale, proportions, details or materials etc. can cause serious harm to the special interest of the Conservation Area. Side extensions are particularly damaging where a glimpsed view between houses is lost.

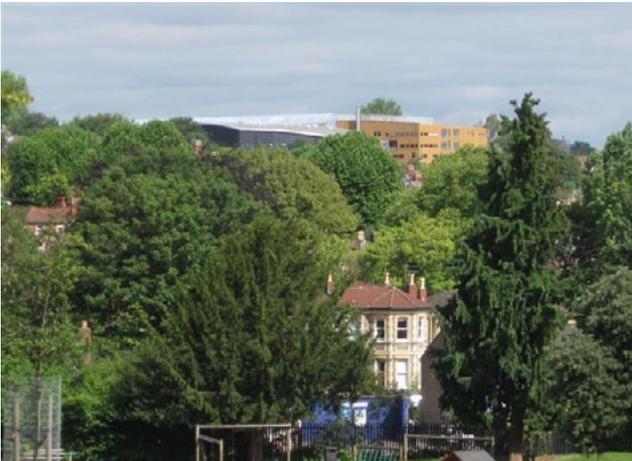
Figure 116: Redland Green School has a negative impact when viewed from the south

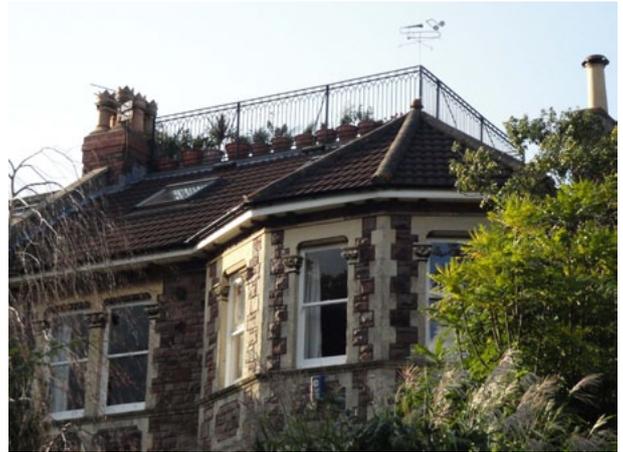
Figure 117: Roof terrace

9.10 Where poor quality replacement doors and windows, especially in uPVC, or roof level extensions have been inserted these have had a significant and detrimental impact on the architectural integrity of individual buildings. Roof-level extensions are particularly detrimental, especially when they interrupt the consistency of a group, are poorly detailed or over-sized. Roof gardens can also detract from the appearance of the Conservation Area when they the building is in a prominent location fronting the highway.

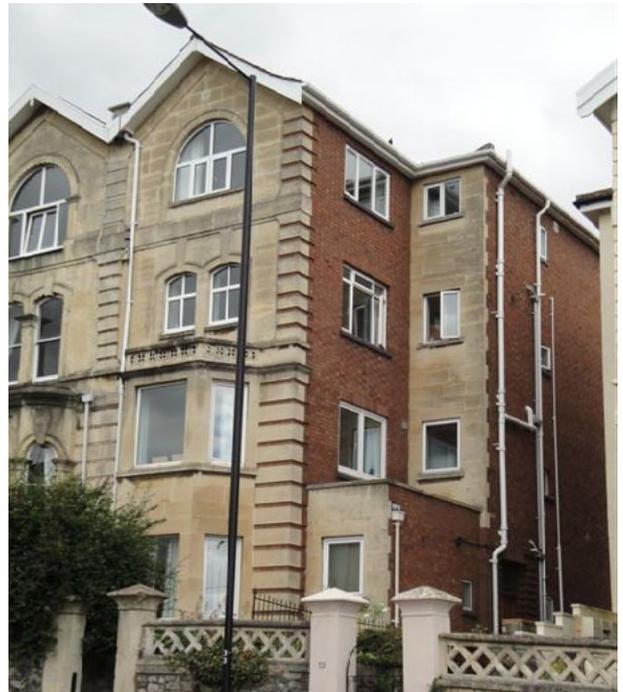
Figure 118: uPVC windows, Redland Road

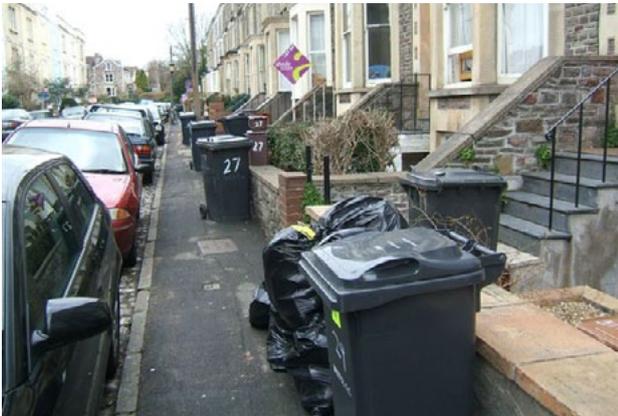
Figure 119: Proliferation of bins on the pavement

9.14 Refuse, litter and graffiti all undermine the quality of the environment and contribute to a sense of neglect in some streets. The proliferation of wheelie bins and recycling boxes clutters the pavements and impedes pedestrian movement, particularly on collection days.

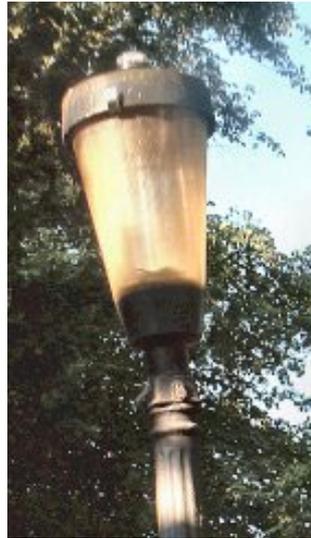
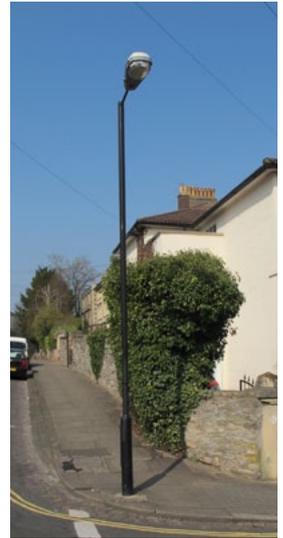
Figures 120 & 121: Unsympathetic lamp head and post
